Technical Service Information

FORD 4F50N 1-2 SLIDE / BANG

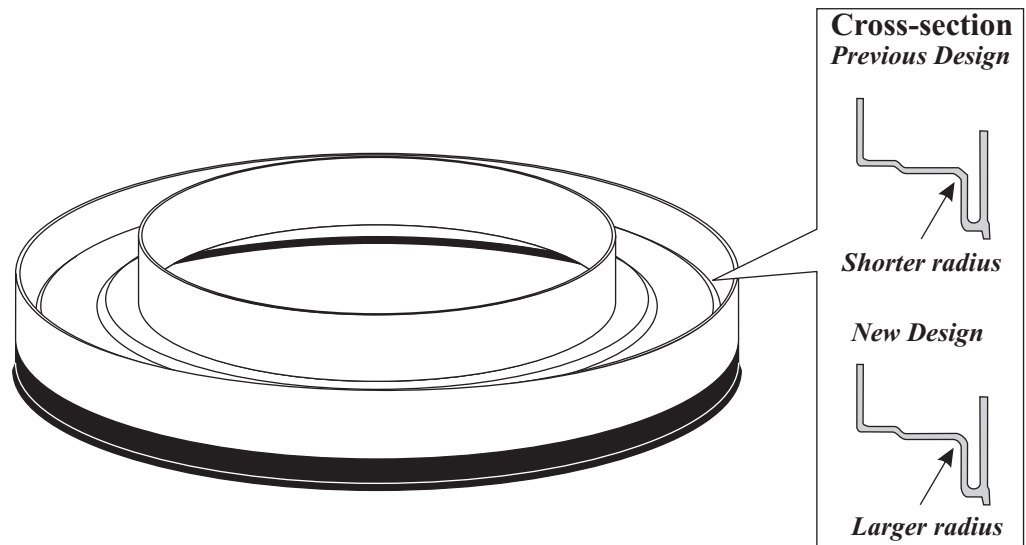
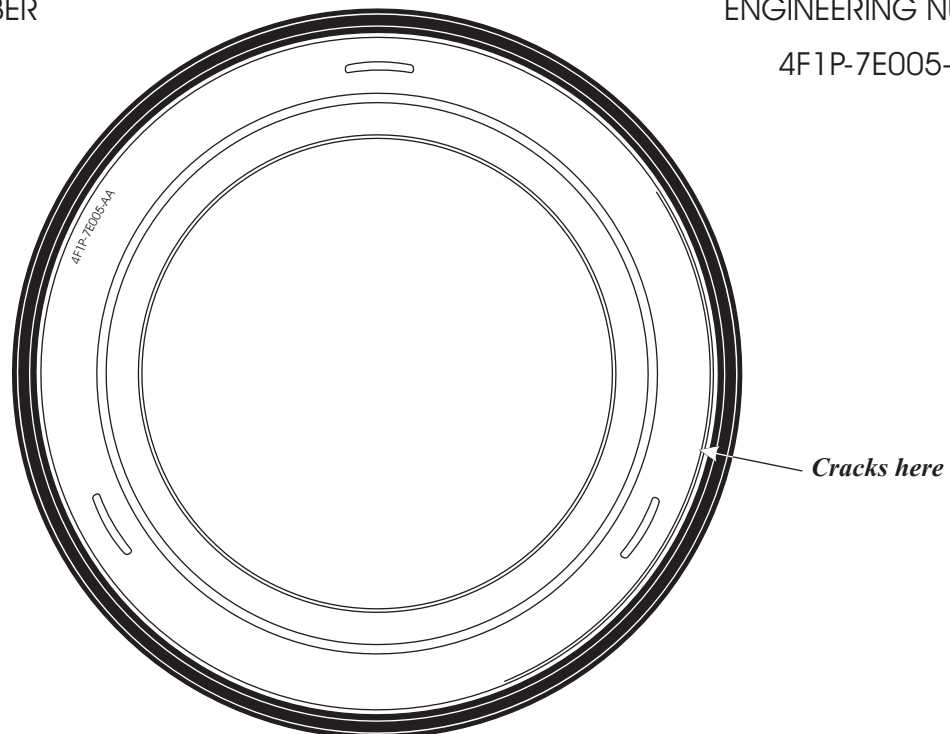
Figure 3

CAUSE: The cause may be, a cracked Intermediate Piston, as shown in Figure 3, or a weak 1-2 Capacity Modulator Valve Spring. Note: 2004 and Up 4F50N are equipped with the 1-2 Capacity Modulator Valve that controls the rate of application of the Intermediate Clutch, like the previous 1-2 Capacity Modulator Valve on the AXOD/AX4S. See Figure 4.

An updated piston can be identified by the engineering number printed on the bottom side of the piston as seen in figure 3. This number is slightly different than the part number.

INTERMEDIATE PISTON TOP VIEW

PREVIOUS DESIGN
ENGINEERING NUMBER
F88P-7E005-AA

NEW DESIGN
ENGINEERING NUMBER
4F1P-7E005-AA

CORRECTION: To correct this condition, replace the Intermediate piston with an updated piston from Ford or from your parts distributor as some distributors sell the O.E. pistons. Install a heavier spring into the 1-2 Capacity Modulator valve line-up. Note: the 2-3 Capacity Modulator Valve spring is the same as the 1-2 , if a firmer 2-3 upshift is desired , a firmer spring can be used there also. See Service information for available aftermarket replacement springs. *Note: the 1-2 and 2-3 Capacity Modulator Valve springs are identical so 2 aftermarket springs can be used, to cover 2nd and 3rd gear shift feel, per transmission overhaul.*

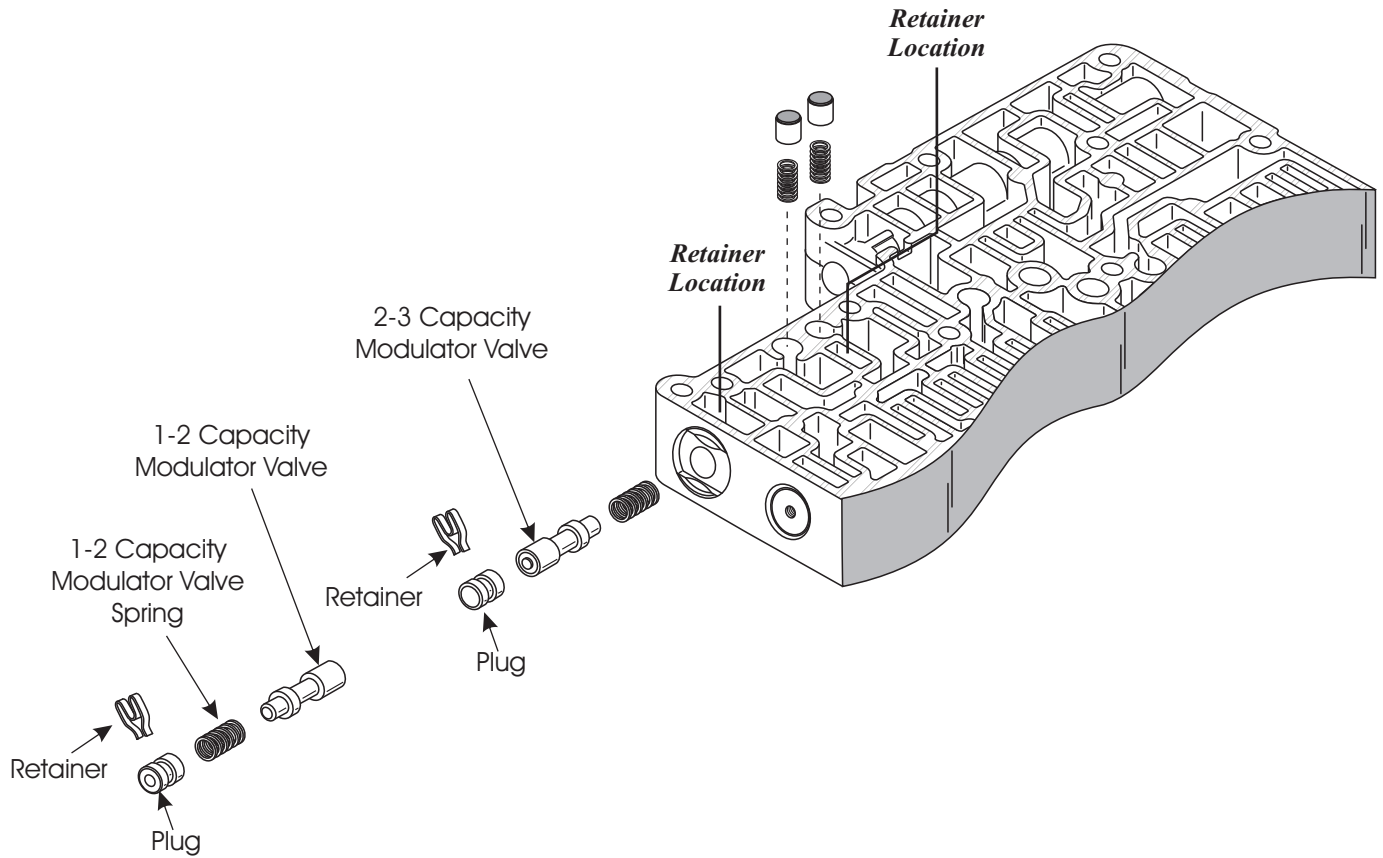
Figure 4

2004 AND UP 4F50N 1-2 CAPACITY MODULATOR VALVE SPRING LOCATION

Note: The 1-2 and 2-3 Capacity Modulator valve springs are the same
