# Technical Service Information

## **DODGE/CHRYSLER/JEEP 45RFE NO MOVEMENT AFTER OVERHAUL**

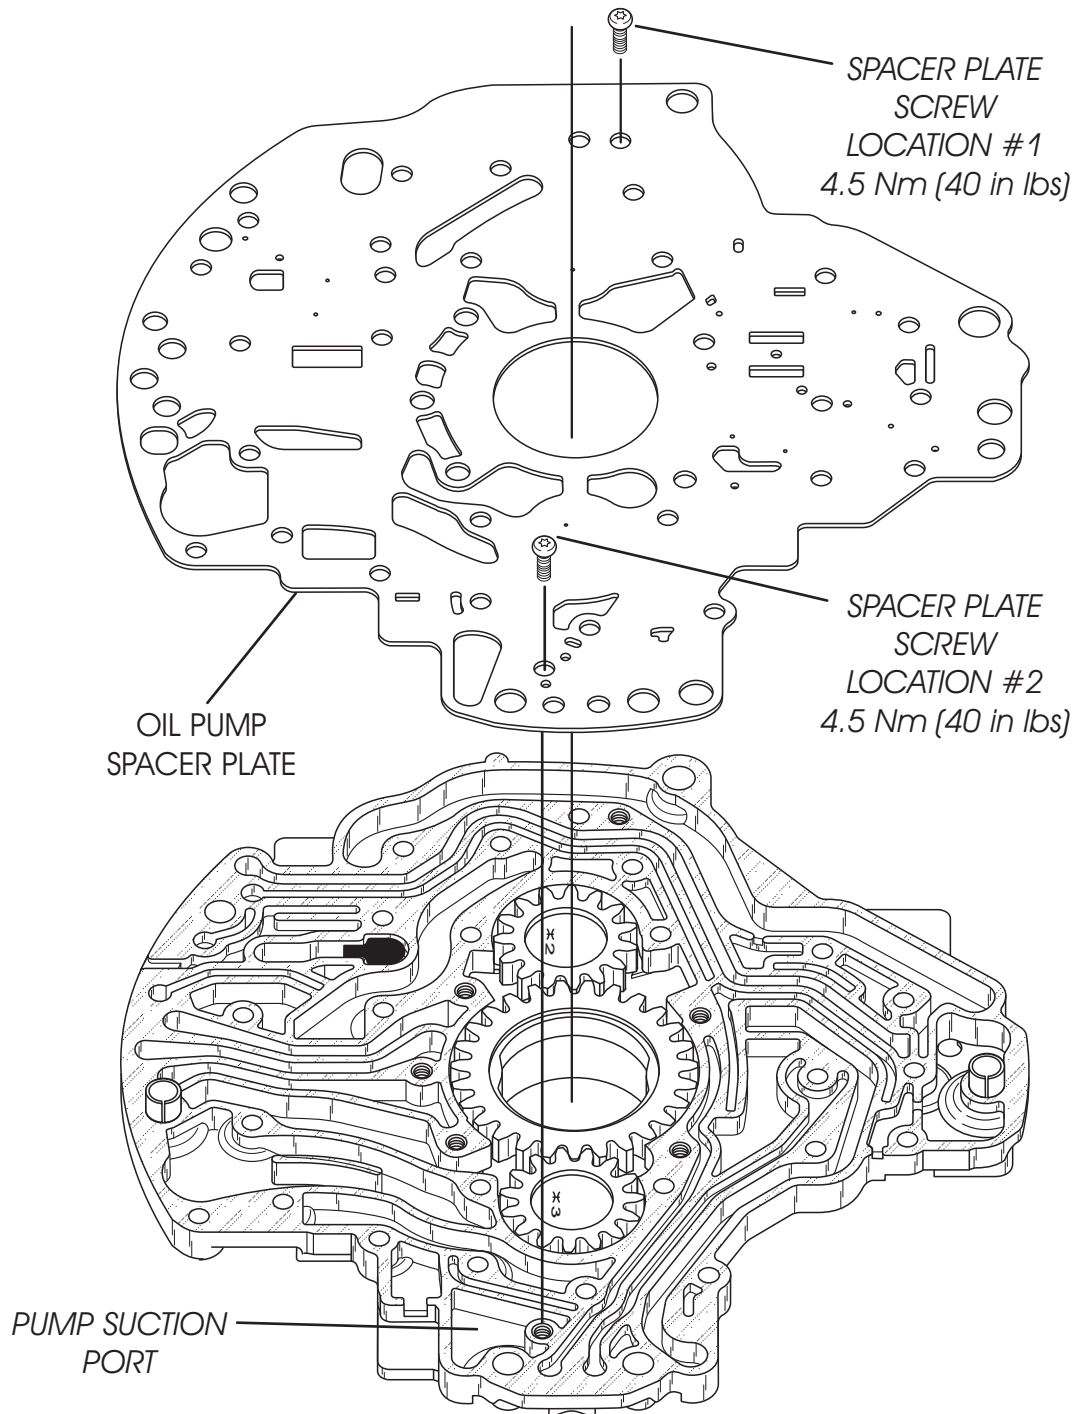
Figure 1

**COMPLAINT:** After an overhaul, a DODGE/CHRYSLER/JEEP vehicle equipped with 45RFE transmission may exhibit a complaint of no movement.

**CAUSE:** One cause may be the Pump Spacer Plate Hold Down Screws in the pump assembly missing. With all the bolts holding this pump together, a brief glance at the pump spacer plate hold down screws may make them appear unnecessary, however, when the location of one of the screws is taken into consideration, their necessity is understood. The pump spacer plate hold down screw locations are shown in the diagram in Figure 1. Take a look at the Spacer Plate Screw Location #2. This Spacer Plate Screw location is directly adjacent to the Pump Suction Port. With this screw missing from the plate, a hole/leak of approximately .190" is immediately opened in the pump suction circuit. Much like having a tremendous amount of pump gear clearance. This huge leak flows to the outside of the pump and creates enough of an air leak that the pump cannot create enough vacuum to pick up transmission fluid from the pan through the filter.

## PUMP SPACER PLATE HOLD DOWN SCREWS

**CORRECTION:** Install and tighten the Pump Spacer Plate Hold Down Screws to 4.5 Nm (40 in lbs).
