Technical Service Information

ALLISON 1000 SERIES

TCC CYCLING OR SURGE

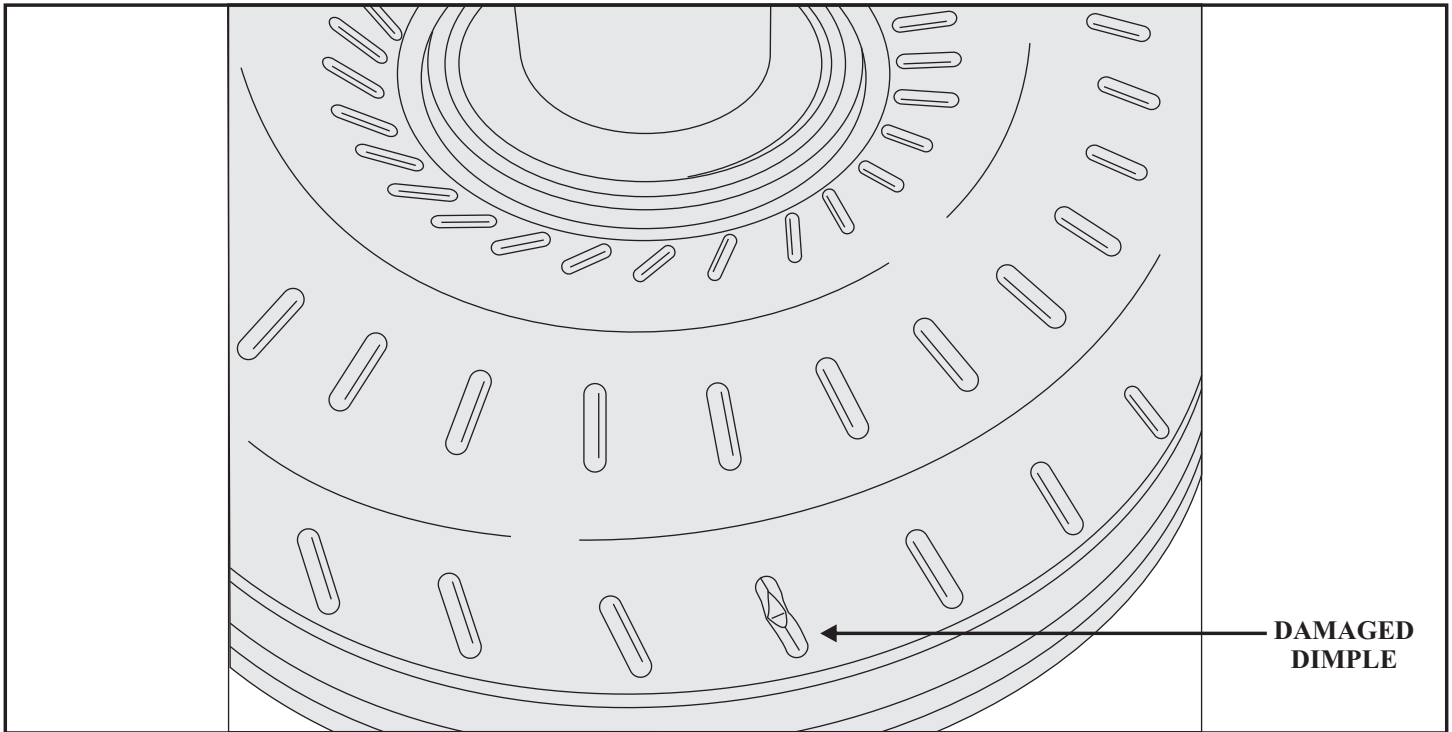
Figure 1

CAUSE: The replacement torque converter had damaged dimples on the outside housing, Refer to Figure 1). Since the engine speed sensor is located in the bellhousing and is excited by the dimples on the outside of the converter, (Refer to Figure 2), the damaged dimples created a glitch in the engine speed signal. This glitch or “hiccup” in the engine speed signal was enough to cause the TCC related problems.

CORRECTION: When a replacement converter is used, be sure the dimples on the outside are not damaged. Care must be exercised in handling both the original and the replacement converters.
