Technical Service Information

DODGE/CHRYSLER/JEEP 45RFE TORQUE CONVERTER CLUTCH ENGAGEMENT ISSUES

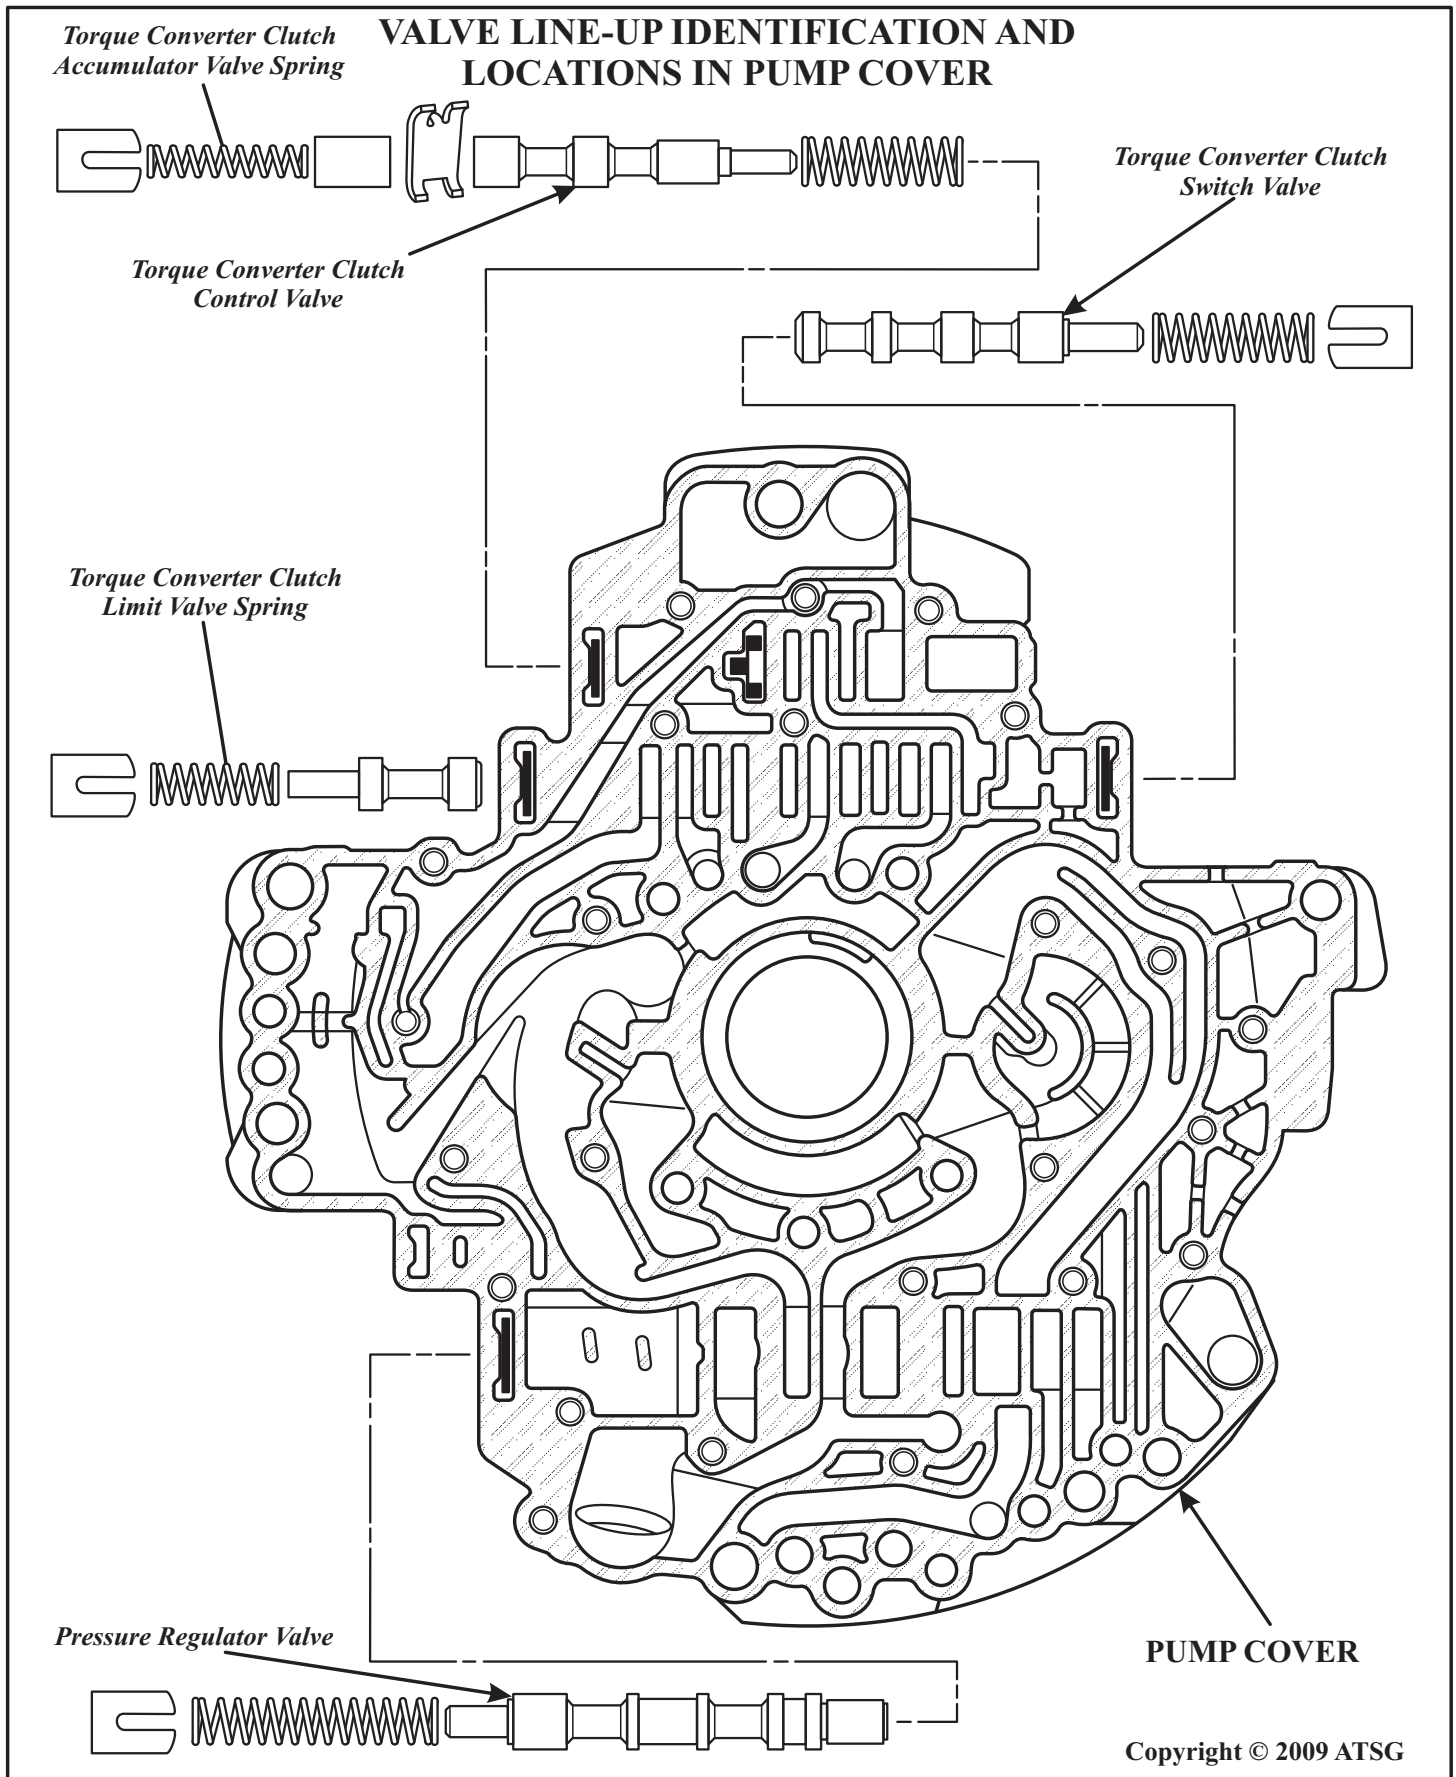
CAUSE: One cause may be broken springs in the Pump Assembly. A broken TCC Accumulator Valve Spring may cause a harsh engagement during TCC apply. A broken TCC Converter Limit Valve Spring may cause the engine to stall or stumble during a garage shift into Reverse or Drive.

Refer to Figure 1 for TCC Accumulator Valve and TCC Converter Limit Valve Spring location in the pump assembly.

CORRECTION: Replace the TCC Accumulator Valve Spring for harsh TCC apply. Replace the TCC Converter Limit Valve Spring for engine stall or stumble during garage shifts.
