Technical Service Information

SATURN VUE & ION

2-3 FLARED SHIFT

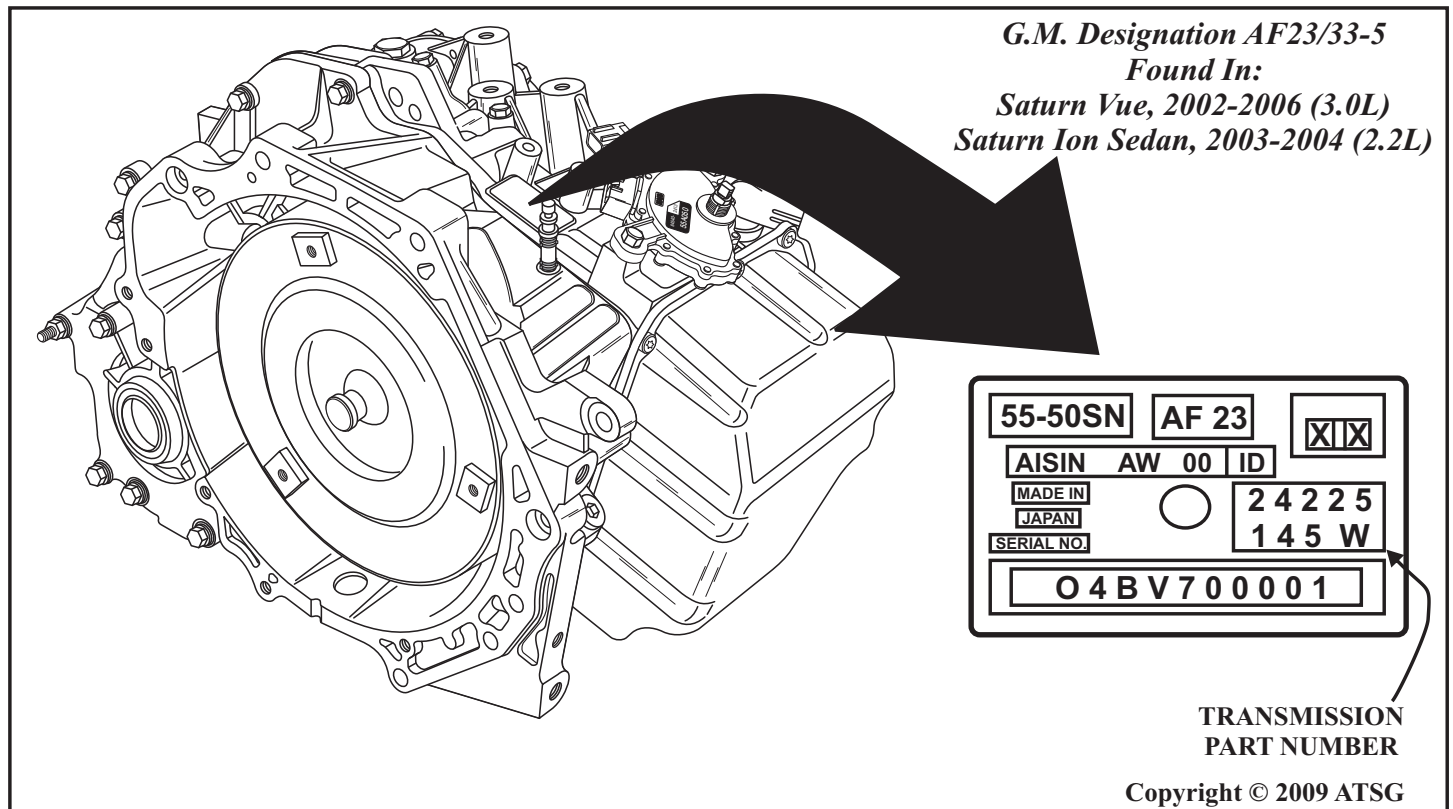
Figure 3

Check the identification tag on top of the transmission for the part number as illustrated in Figure 3, and compare it to the chart in Figure 2.
