Technical Service Information

ZF6HP26

TRANSMISSION FLUID LEAK

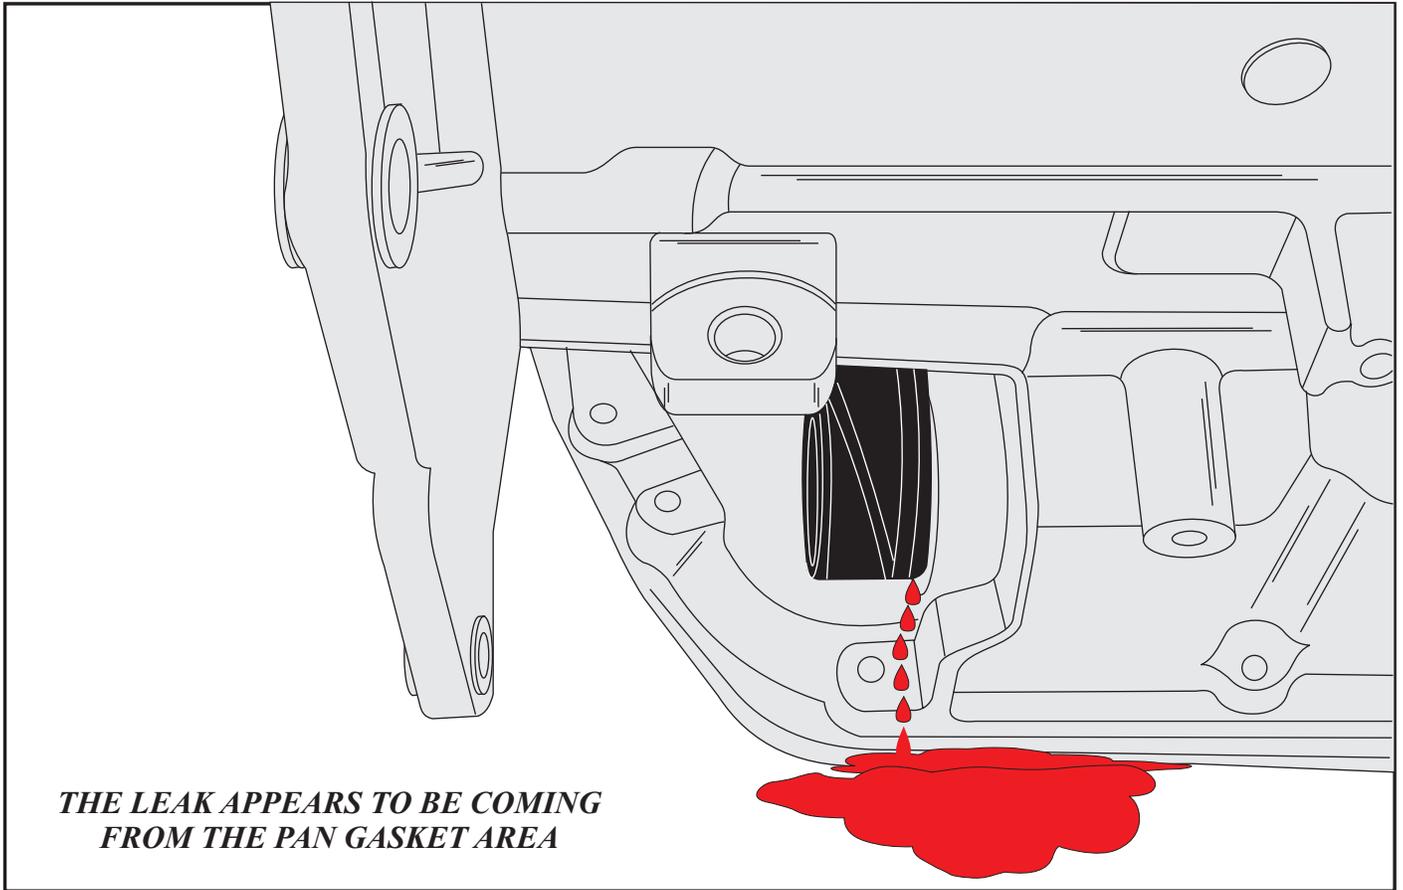
Figure 1

COMPLAINT: The transmission appears to be leaking from the pan gasket, (Refer to Figure 1).

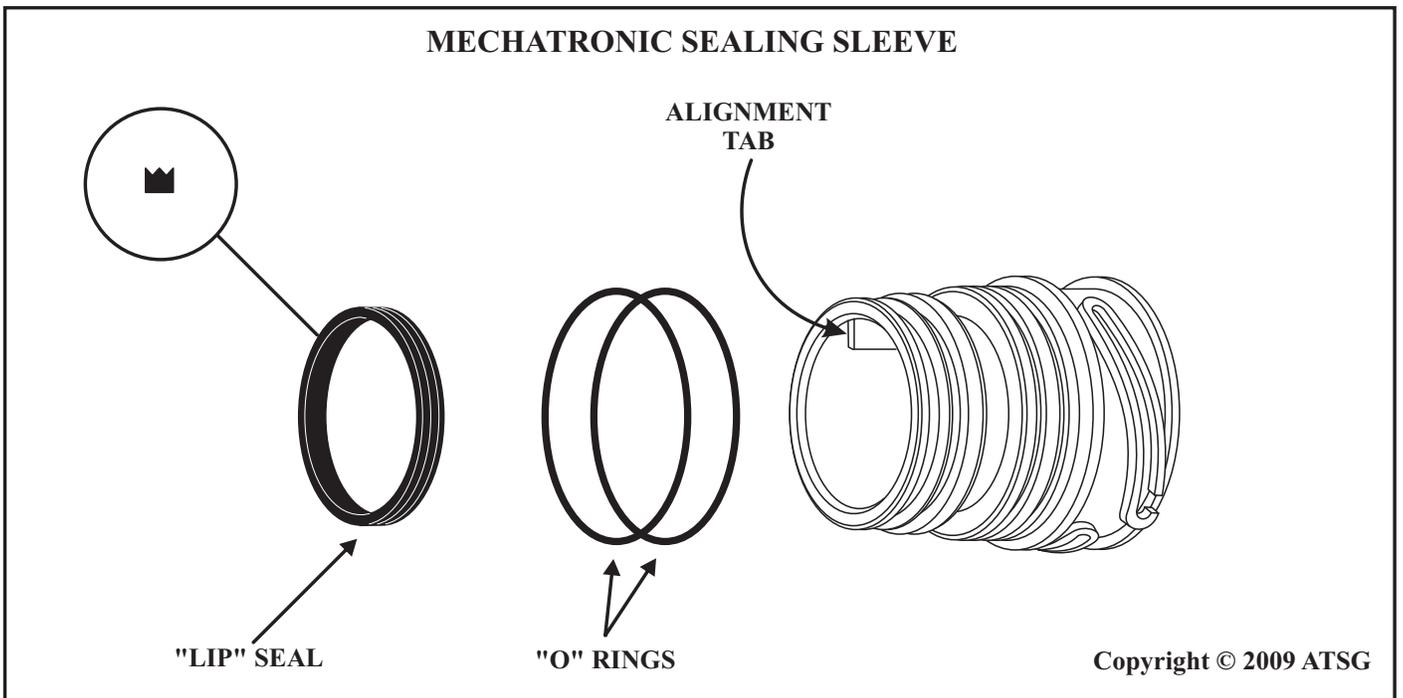
Figure 2

CAUSE: The Mechatronic Sealing Sleeve o-rings (Refer to Figure 2) is leaking and running down along the pan rail giving the appearance that the pan gasket is leaking.

CORRECTION: Replace the Mechatronic Sealing Sleeve.
