## SATURN VUE WITH AF33-5 TRANSMISSION

### LIMP MODE WITH CODE P0717 SET

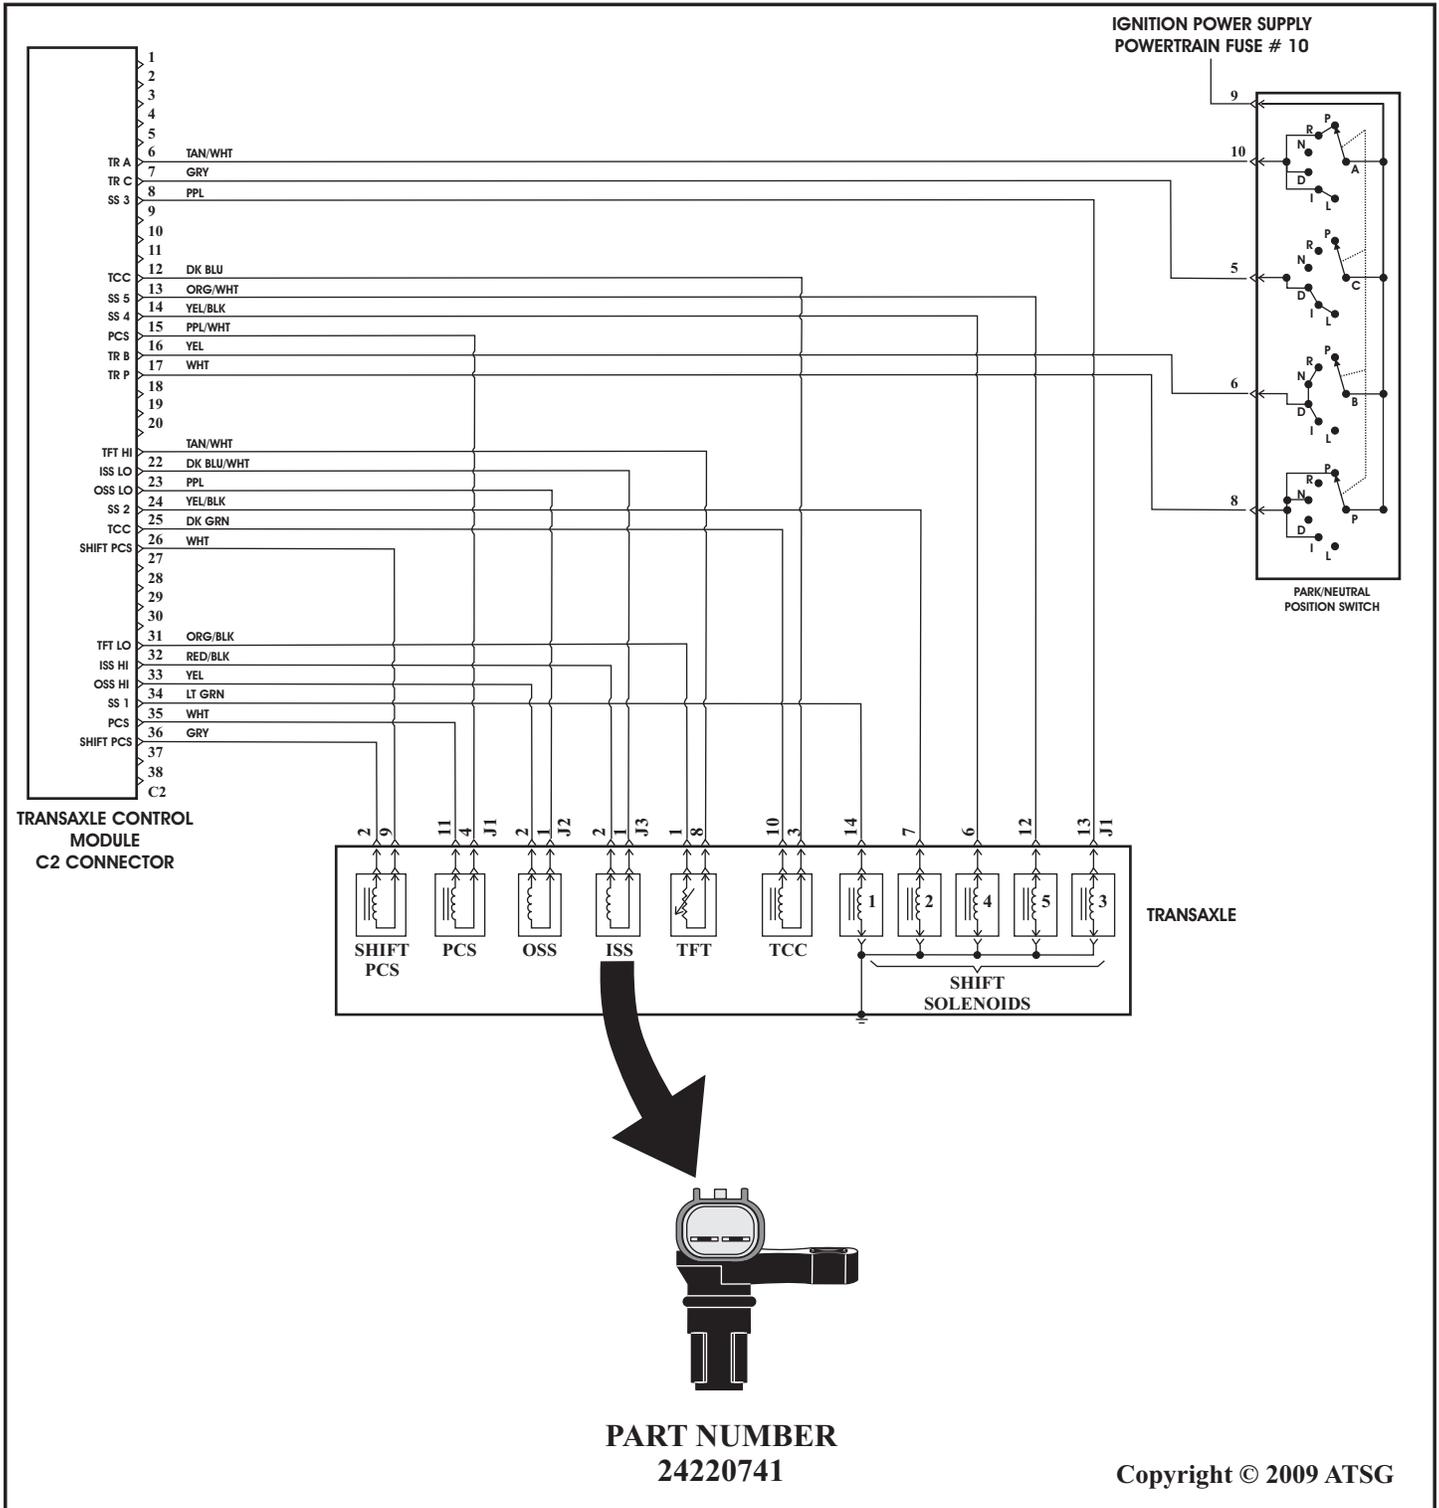
**CAUSE:** The Input Speed Sensor like the output speed sensor are two wire Hall Effect type sensors. They are supplied system voltage on the “ISS/OSS HI” circuit and then produce a toggled voltage signal on the “ISS/OSS LO” circuit, as seen in the electrical schematic in Figure 1 as well as TCM connector view and terminal assignment in Figure 2. The voltage signal is unique in as much as the low end of the signal is 0.6 volts, and the high end of the signal is 1.6 volts. This means that the actual switched voltage is one volt.  
For those that have the AF33-5 GM Technician’s guide, the explanation of the ISS operation is extremely confusing because the guide states that “*the sensor is supplied a reference voltage of 0.6 volts. It also stipulates that the size of the output voltage does not depend on a rotation number and is fixed at 1.4 volts*”. This is misleading at best.

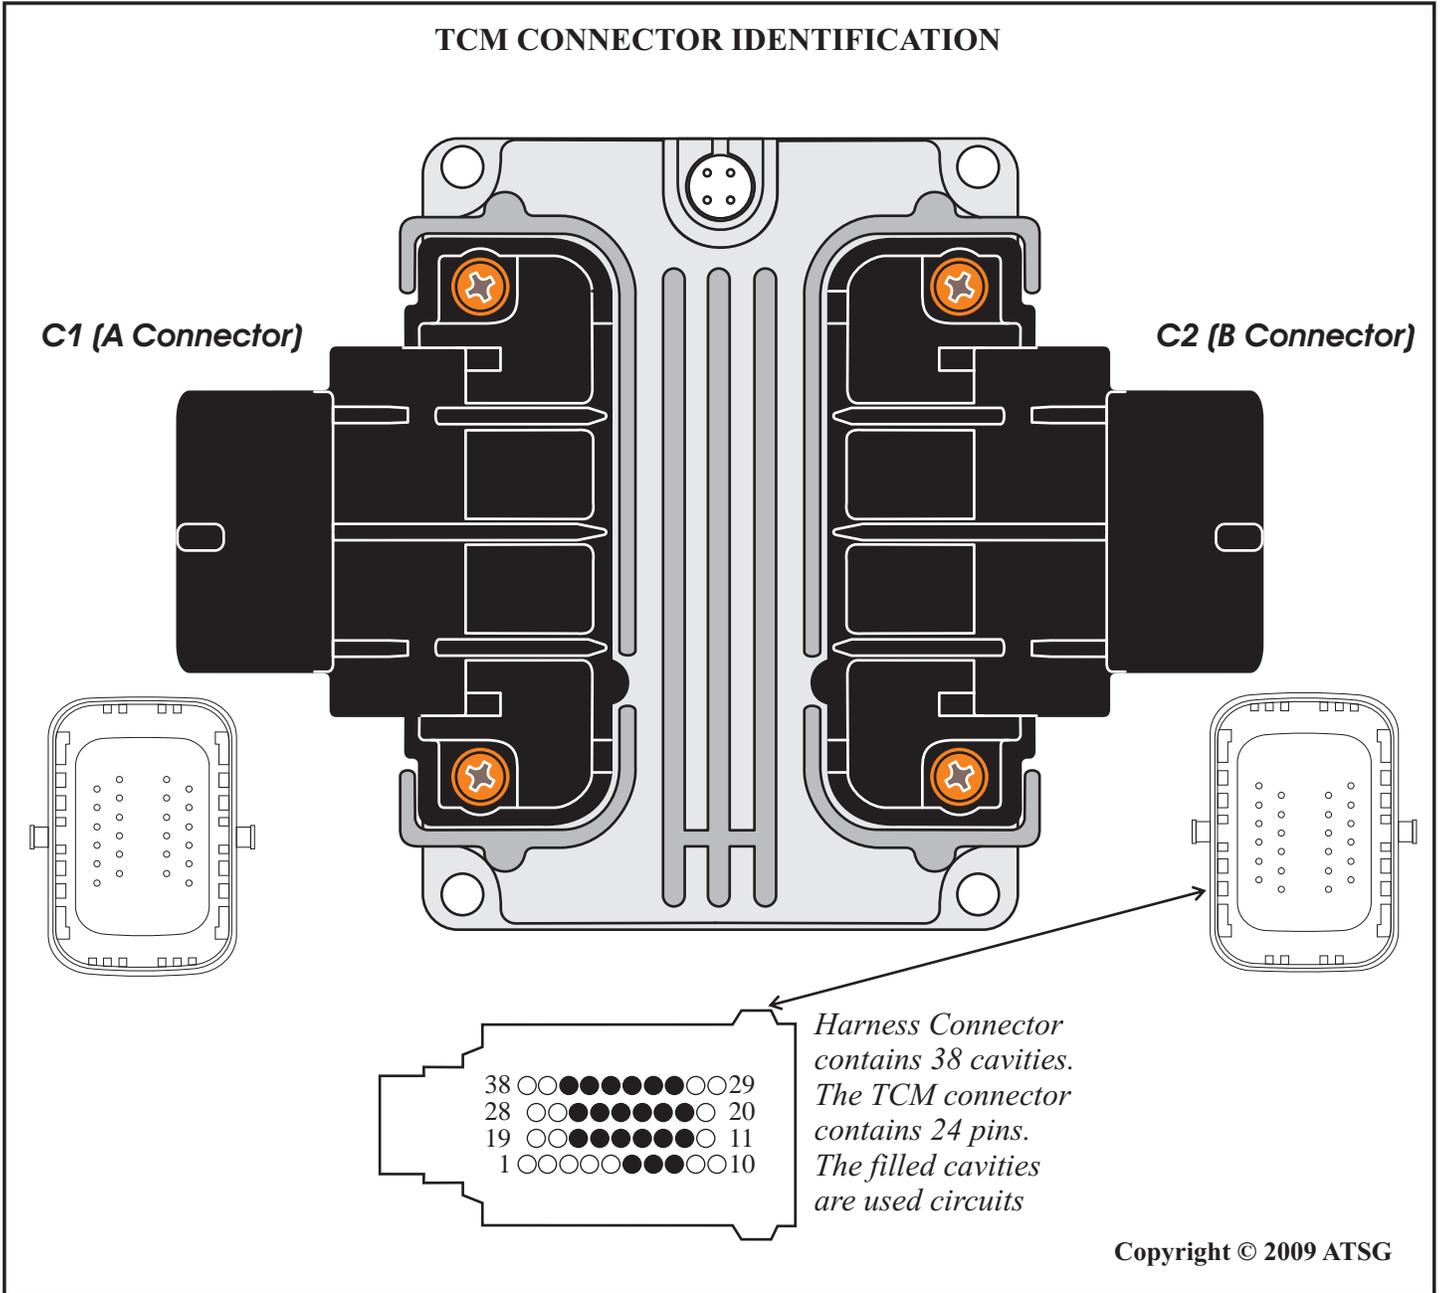
Figure 2

The scan tool displayed an engine rpm of 776, but the ISS parameter was zero. With the ignition on, engine off, the voltmeter indicated that the ISS signal wire had 7.6 volts on it while the OSS signal wire had 1.6 volts. This could only mean that the ISS signal wire was shorted to power or the sensor was bad. The ISS was unplugged and checked for voltage, there was none, this lead to a faulty ISS.

**CORRECTION:** Once the ISS was replaced, the signal readings were normal, the ISS rpm and engine rpm were close to each other.
