Technical Service Information

MERCEDES BENZ 722.6

TCM FLUID CONTAMINATION

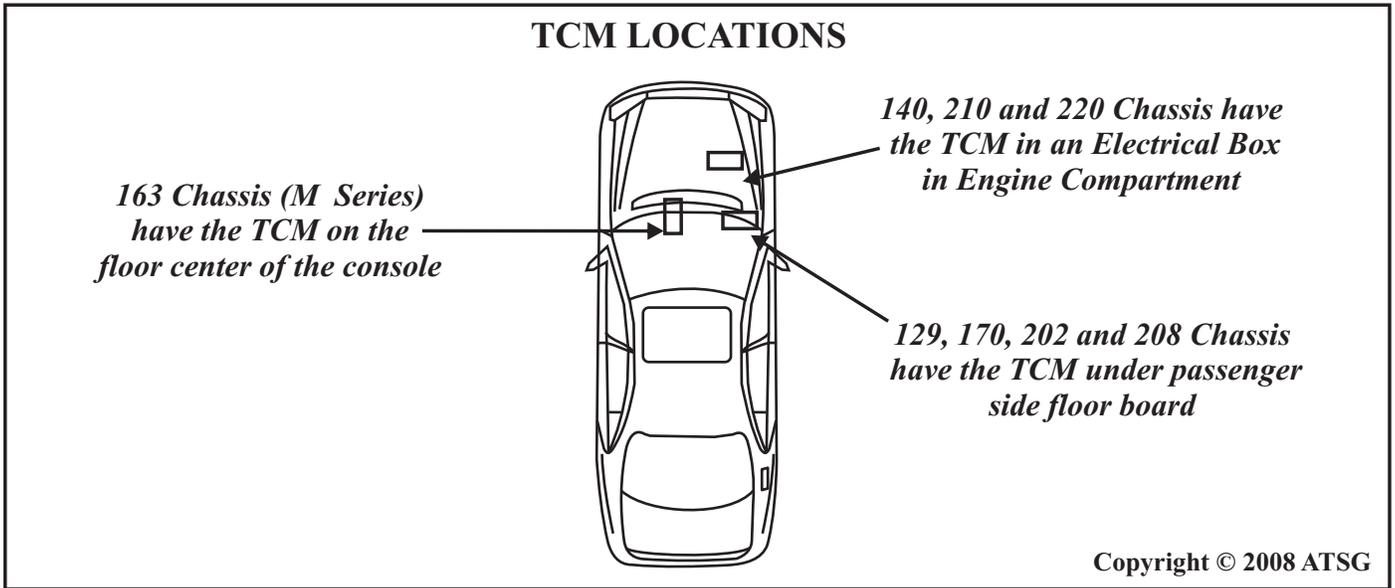
Figure 1

COMPLAINT: The vehicle may experience intermittent speed sensor or solenoid codes with reoccurring limp mode. When the technician locates the TCM, (Refer to Figure 1), to do some electrical checks, the TCM is found to be full of transmission fluid.

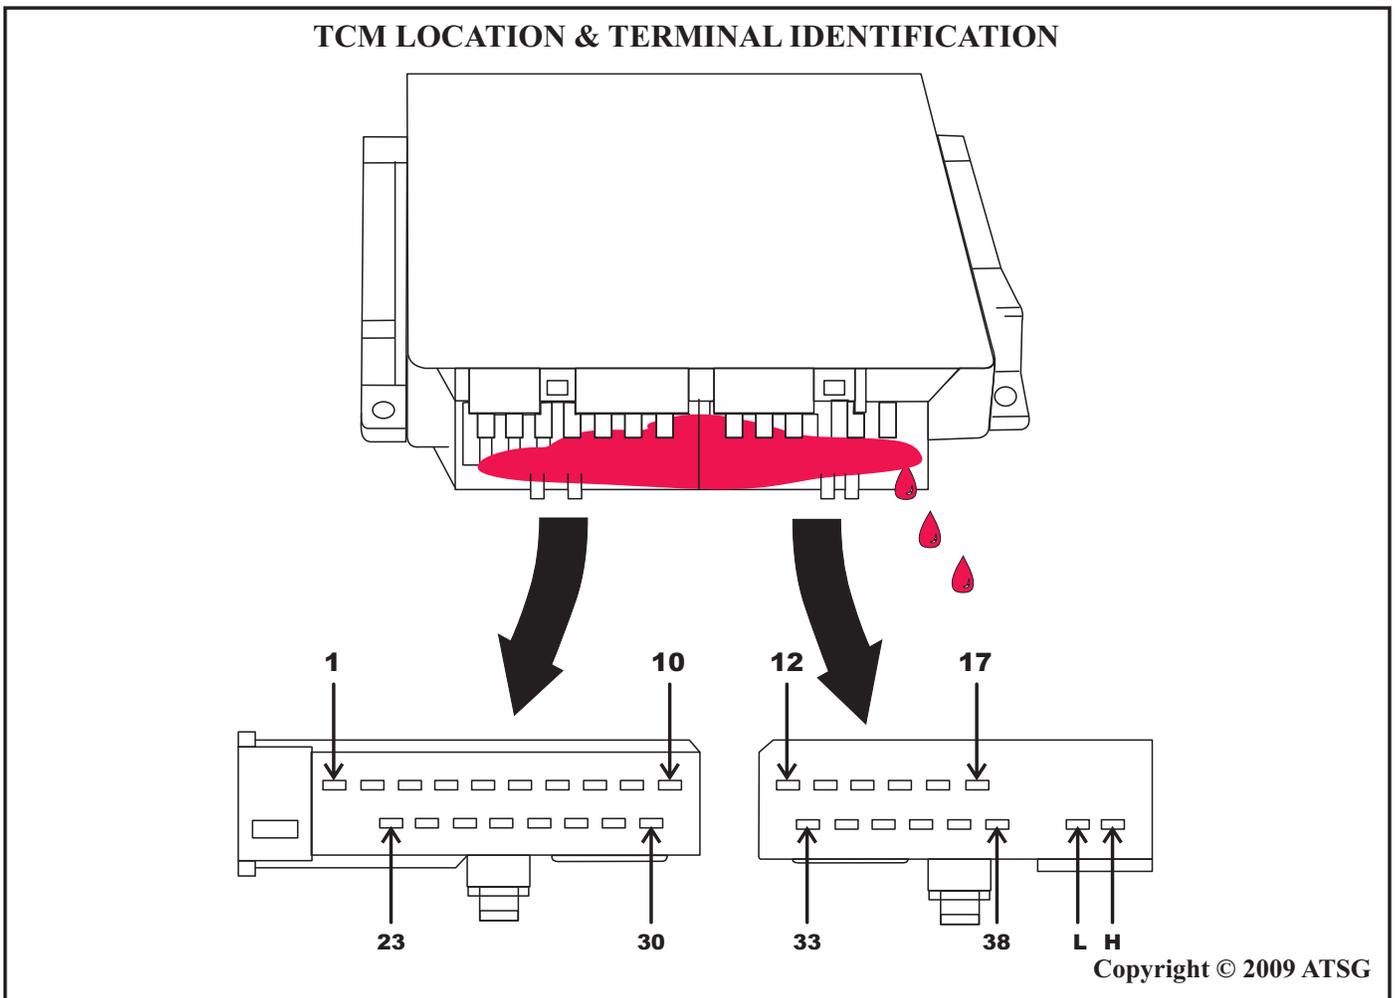
Figure 2

CAUSE: Transmission Fluid has worked its way up the wiring between the transmission case connector and the TCM through capillary action. As a result of this action, the TCM has been filled with fluid, (Refer to Figure 2).
This has nothing to do with the with seal condition on the conductor plate or the vehicle harness connector, even with good seals this will occur, (Refer to Figure 3).
