Technical Service Information

FORD AX4S, AX4N, 4F50N NO THIRD GEAR

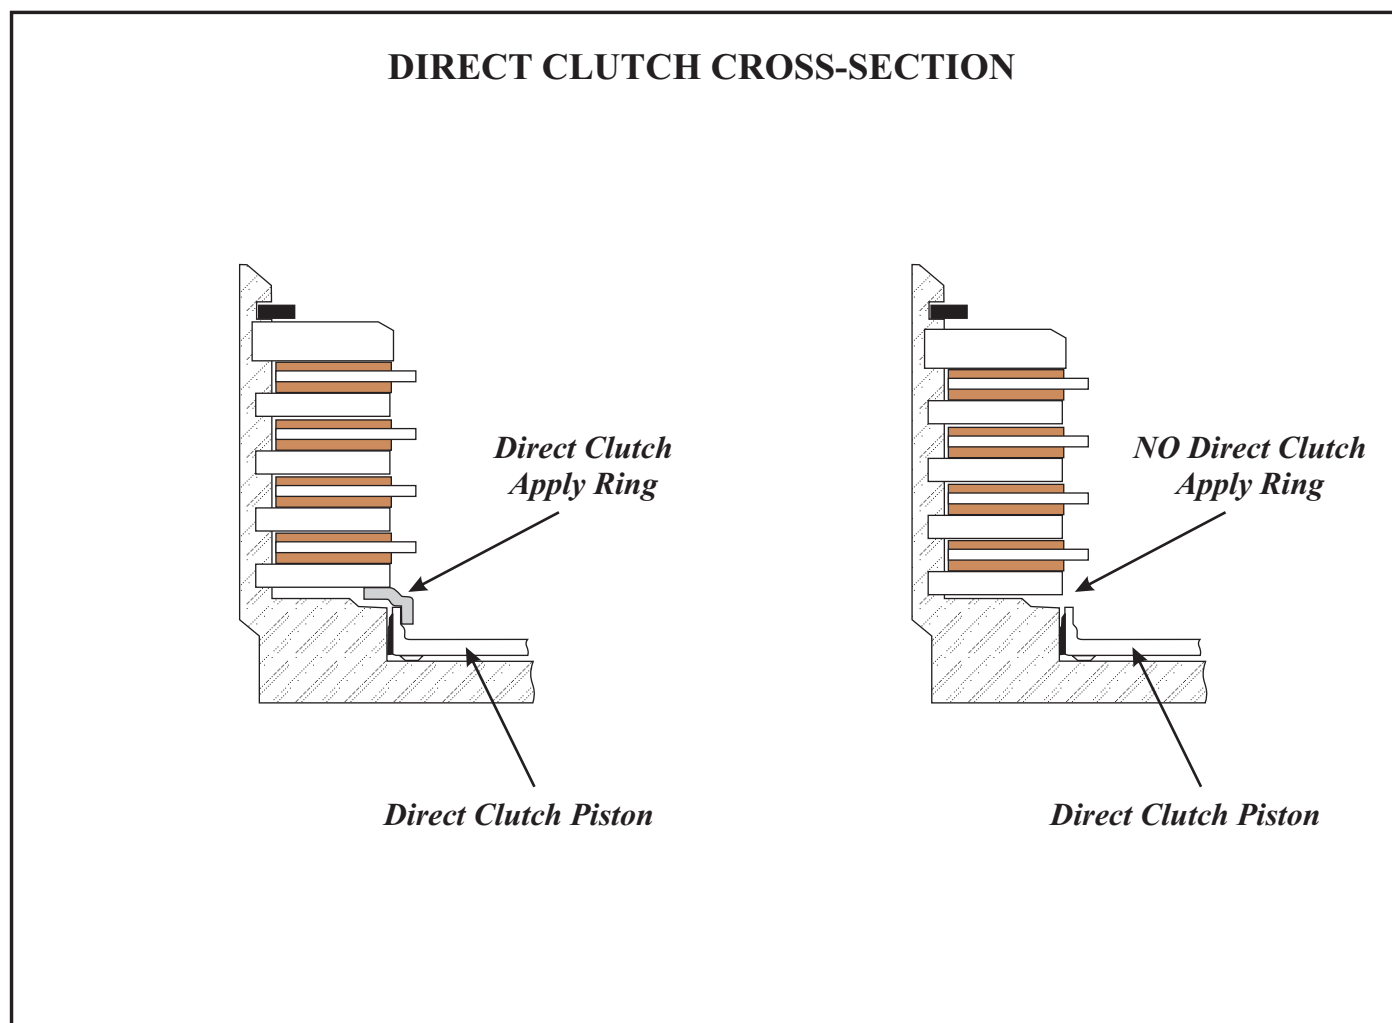
CAUSE: The cause may be that during overhaul, the direct clutch bonded piston was replaced and the apply ring was not transferred to the new piston. Refer to the cross-sectional view in Figure 1 which shows that when the apply ring is left off, the Direct clutch piston will not contact the Direct clutch bottom steel.

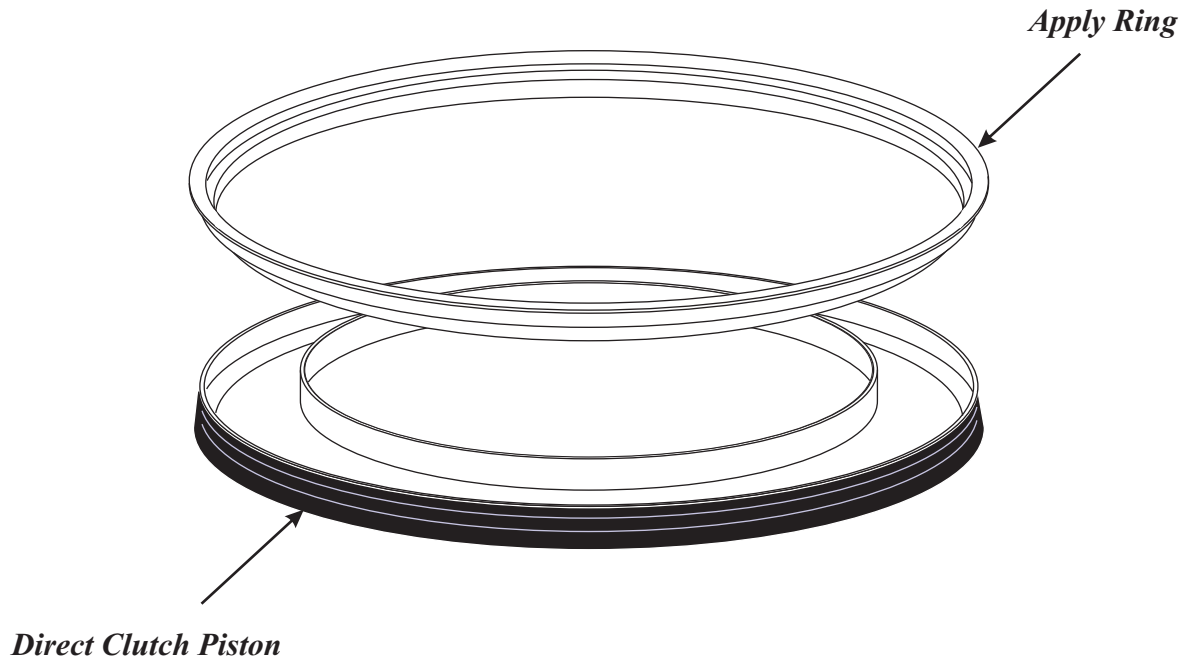
Figure 2

DIRECT CLUTCH PISTON AND APPLY RING

CORRECTION: To correct this condition ensure the apply ring is assembled onto the Direct Clutch Piston as shown in Figure 2.
