Technical Service Information

GM 6T70/75

I/O SPEED SENSOR ISSUES

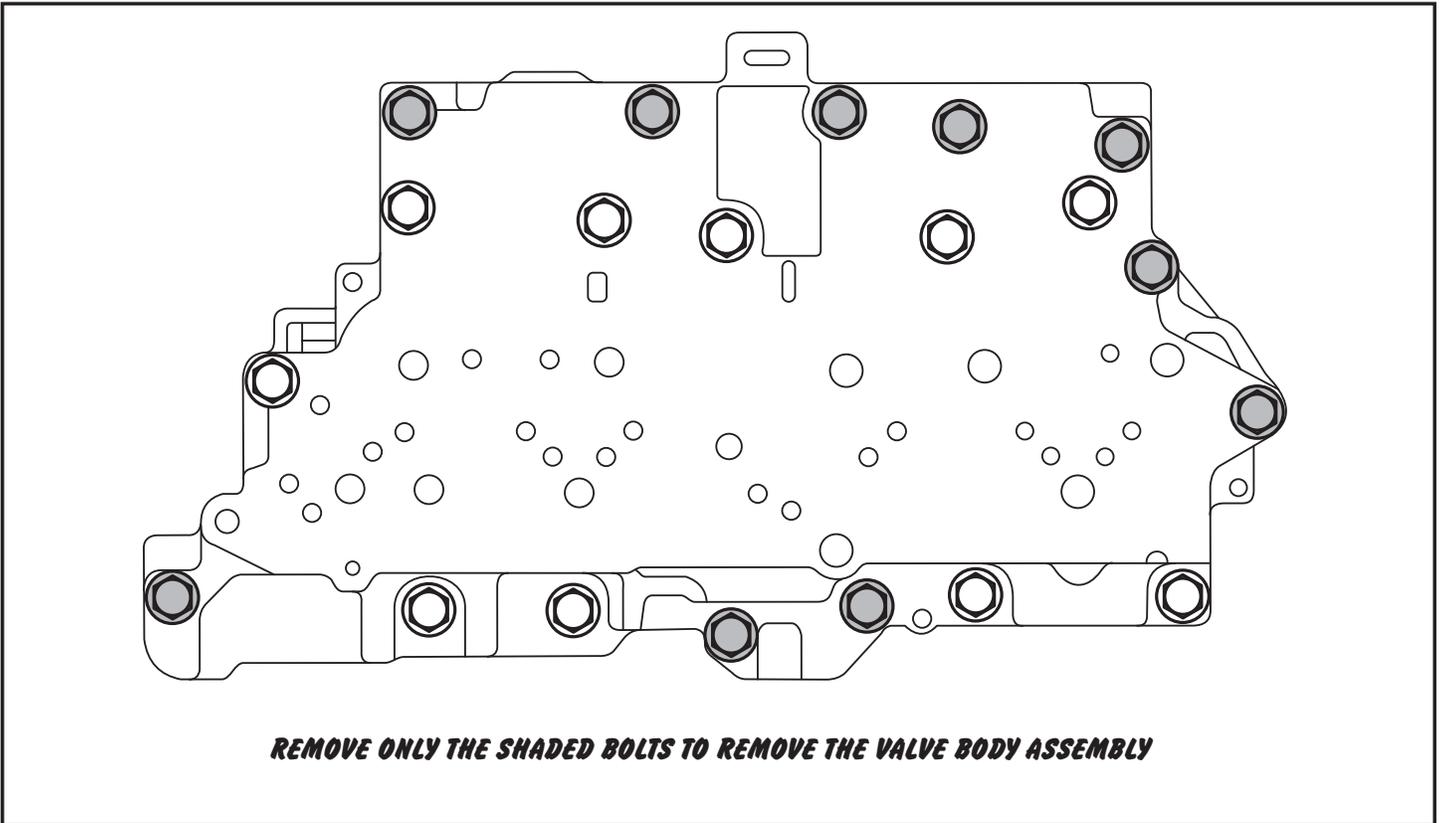
CAUSE: The Input and/or Output Speed Sensors are faulty.

CORRECTION: Use a scan tool to check input and output rpm and replace the defective speed sensor(s).

To replace the ISS or OSS speed sensor, the valve body will have to be removed. Remove only the shaded bolts shown in Figure 1 to remove the valve body assembly. The location of the speed sensors is explained in Figure 2.
