Technical Service Information

SUBARU 4-ATAXLE - PHASE II

NO REVERSE

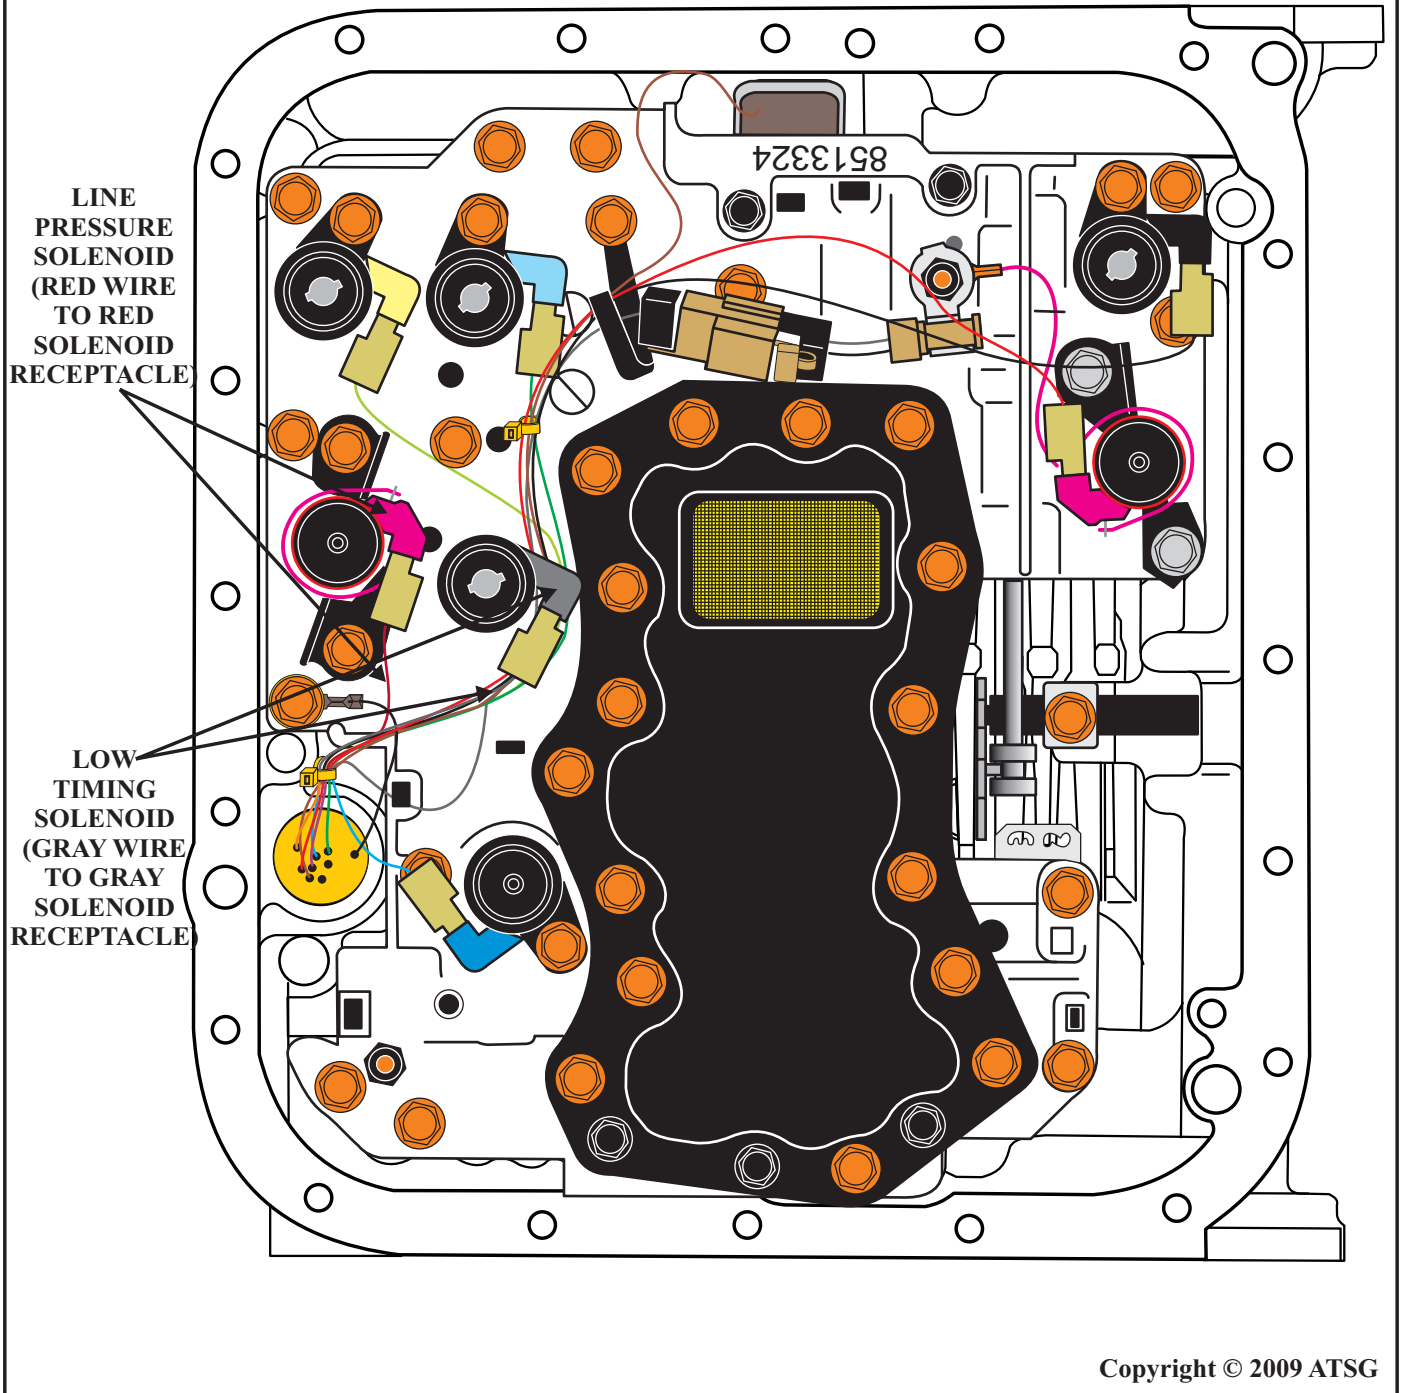
CAUSE: The Low Clutch Timing and Pressure Control Solenoid connectors have been switched.

CORRECTION: Because the Pressure Control and Low Clutch Timing Solenoids are in close proximity of each other, it is easy to switch their connectors. The connector ends are all the same color and are interchangeable, however, **the wire color should match the solenoid connector**, Refer to Figure 1 for solenoid identification.

SOLENOID & TCM GROUND LOCATION

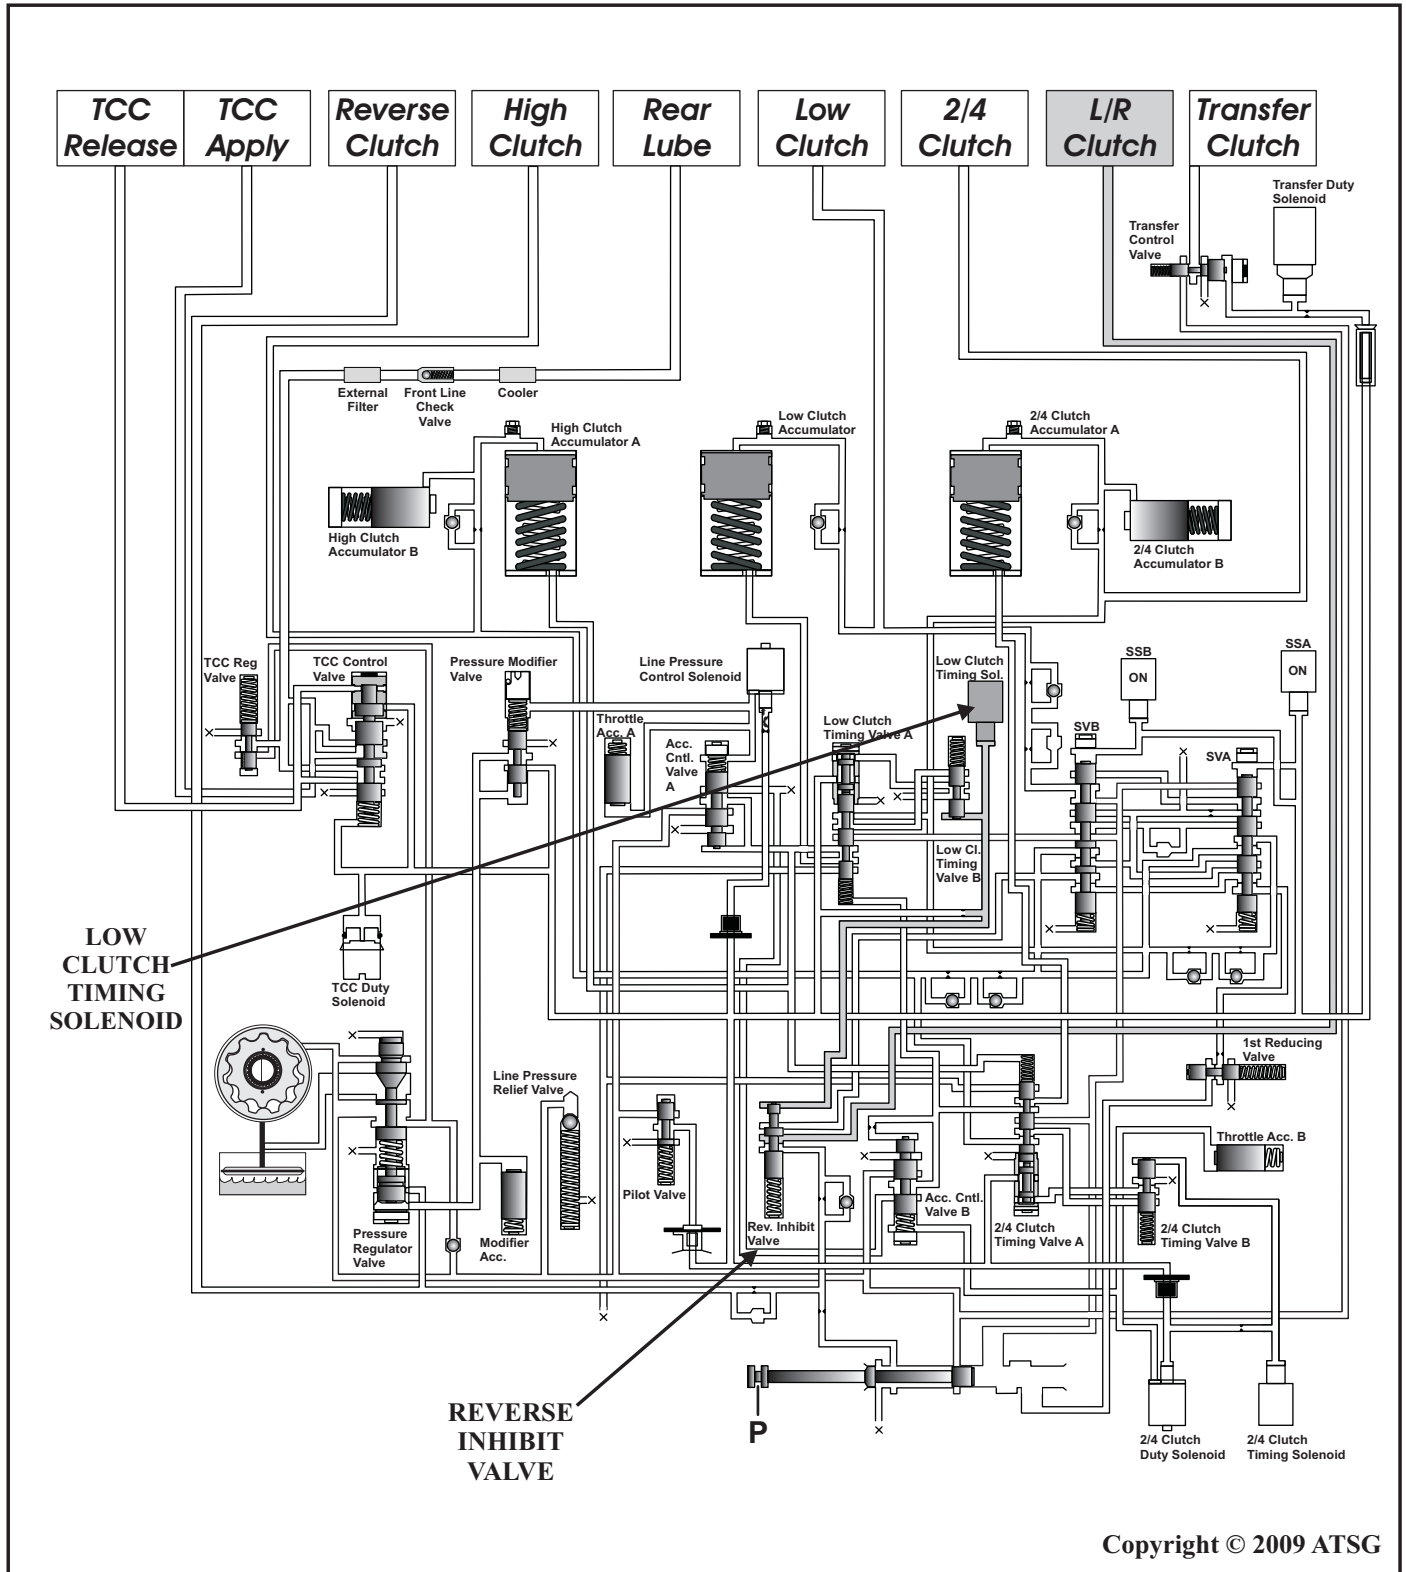
Figure 2

The no reverse condition is a result of the Low Clutch Timing Solenoid running all the time due to the Pressure control Solenoid connector that is plugged into it. This causes oil to stroke the Reverse Inhibit Valve as seen in the hydraulic schematic in Figure 2. When the shift lever is in the reverse position and the engine is turned off, The Low Clutch Timing Solenoid is also turned off thereby draining the reverse inhibit circuit at which time the valve spring strokes the reverse inhibit valve in the opposite direction which will now momentarily charge the Low/Reverse clutch circuit causing momentary reverse engagement.

NO REVERSE & DELAYED FORWARD ENGAGEMENT
