Technical Service Information

FORD AX4N/4F50N N-D DELAY/BANG

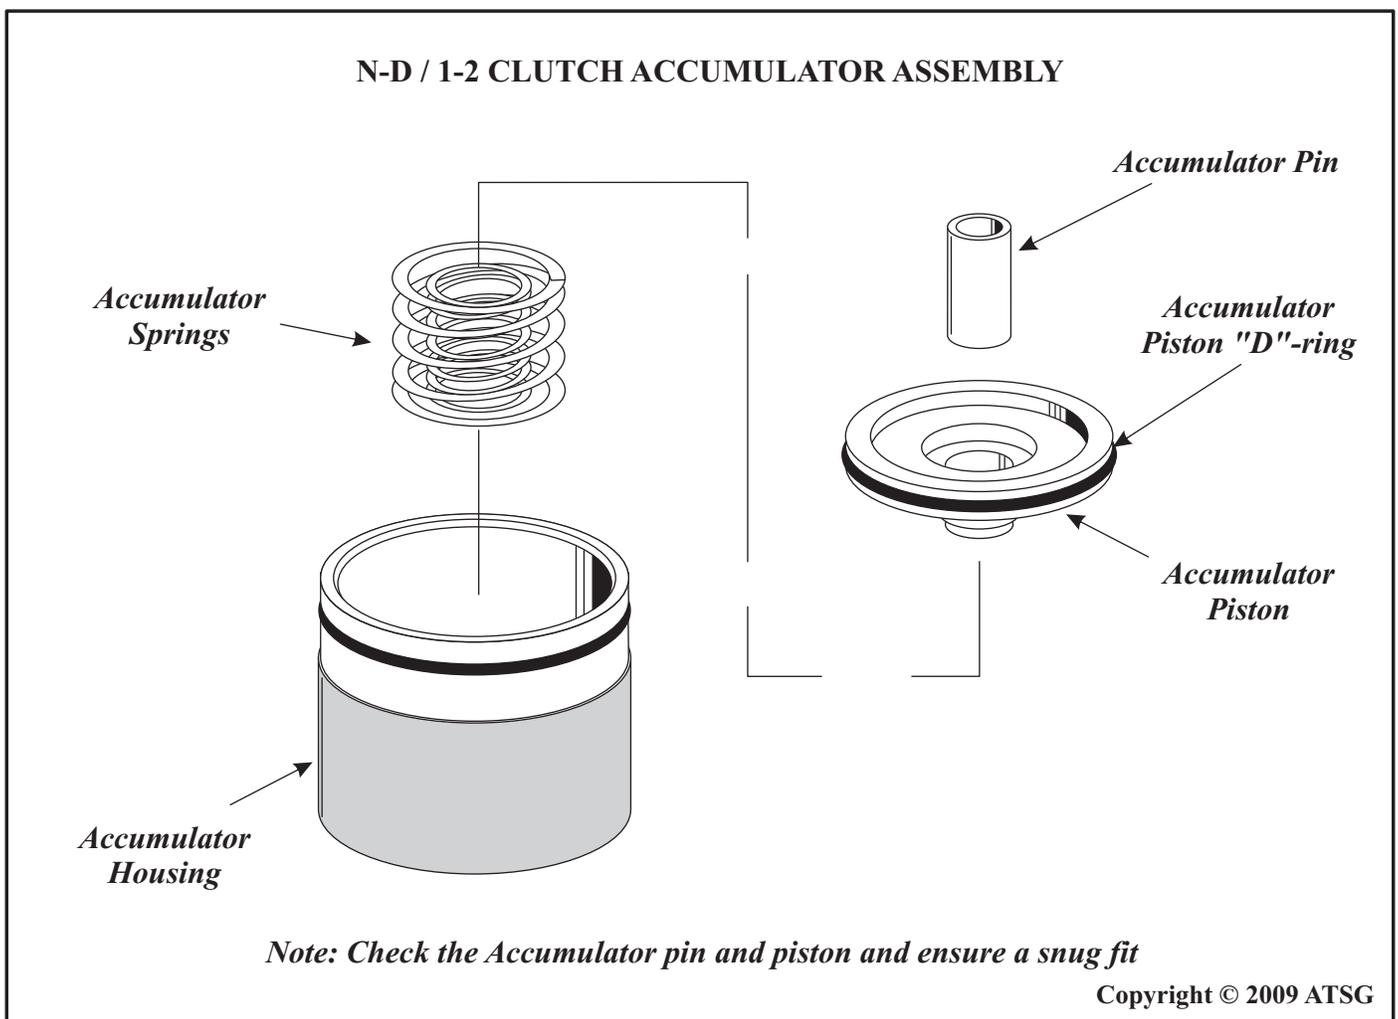
CAUSE: The cause may be, a worn 1-2 Clutch Accumulator pin and piston causing a slow engagement into Drive. This slow engagement will cause the PCM to elevate line pressure which causes the harsh / bang on engagement. Refer to Figure 1 for the identification of the 1-2 Accumulator pin and piston. Refer to Figure 2 for a cross-sectional view of the 1-2 Clutch Accumulator hydraulic circuit.

N-D / 1-2 CLUTCH ACCUMULATOR ASSEMBLY

CORRECTION: To correct this condition, ensure that the Accumulator pin and piston have a snug fit, replace as necessary.

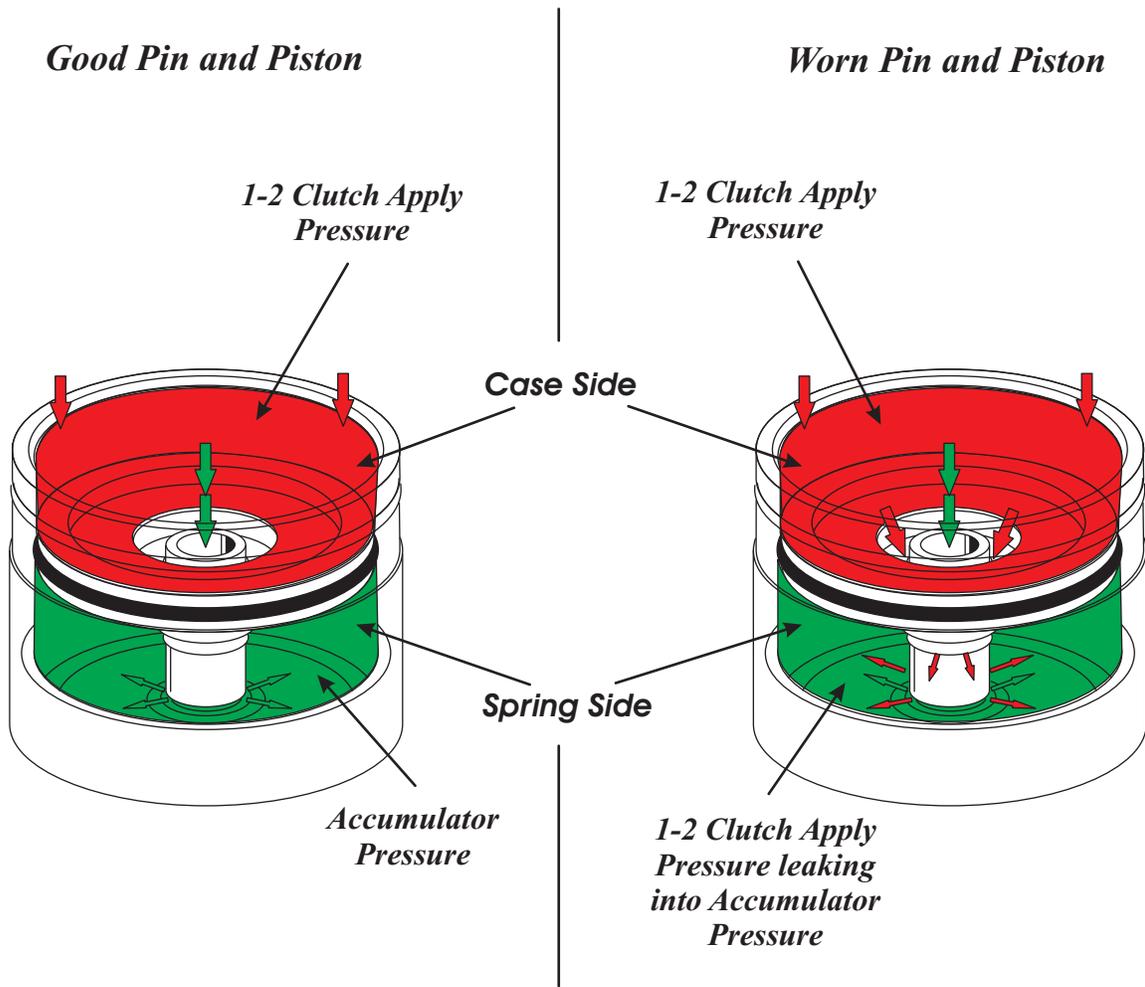
Figure 2

Note: Accumulator Pressure is fed thru the pin to the spring side of the Accumulator Piston, when the Pin wears it will allow 1-2 Clutch Apply pressure to leak into the Accumulator Circuit causing a slow engagement of the 1-2 Clutch.
