BMW/2000 AND LATER ISUZU 4L30E NO REVERSE, BINDS IN 2ND

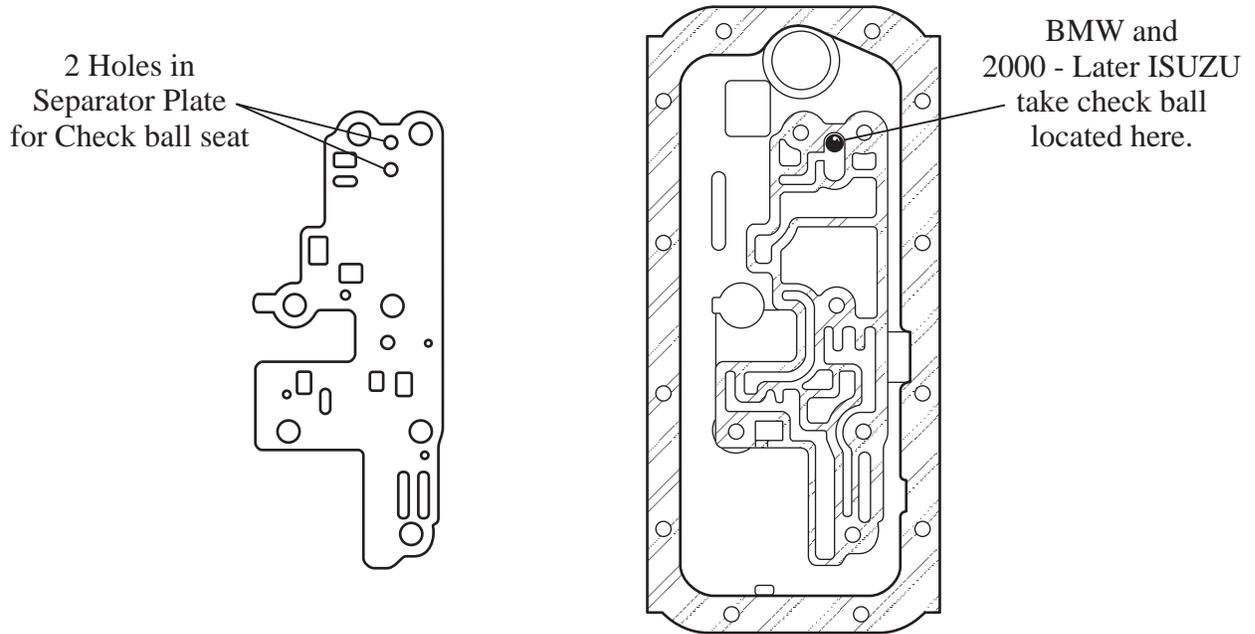
Refer to Figure 1 for location of the check ball in the adapter case housing, and the spacer plate identification. Refer to Figure 2 for a diagram of the BMW and 2000 and later ISUZU center support housing assembly which utilizes the “Reverse Inhibit” valve.

ADAPTER HOUSING CHECK BALL LOCATION AND SEPARATOR PLATE ID.

CORRECTION: Install the check ball in the adapter housing.

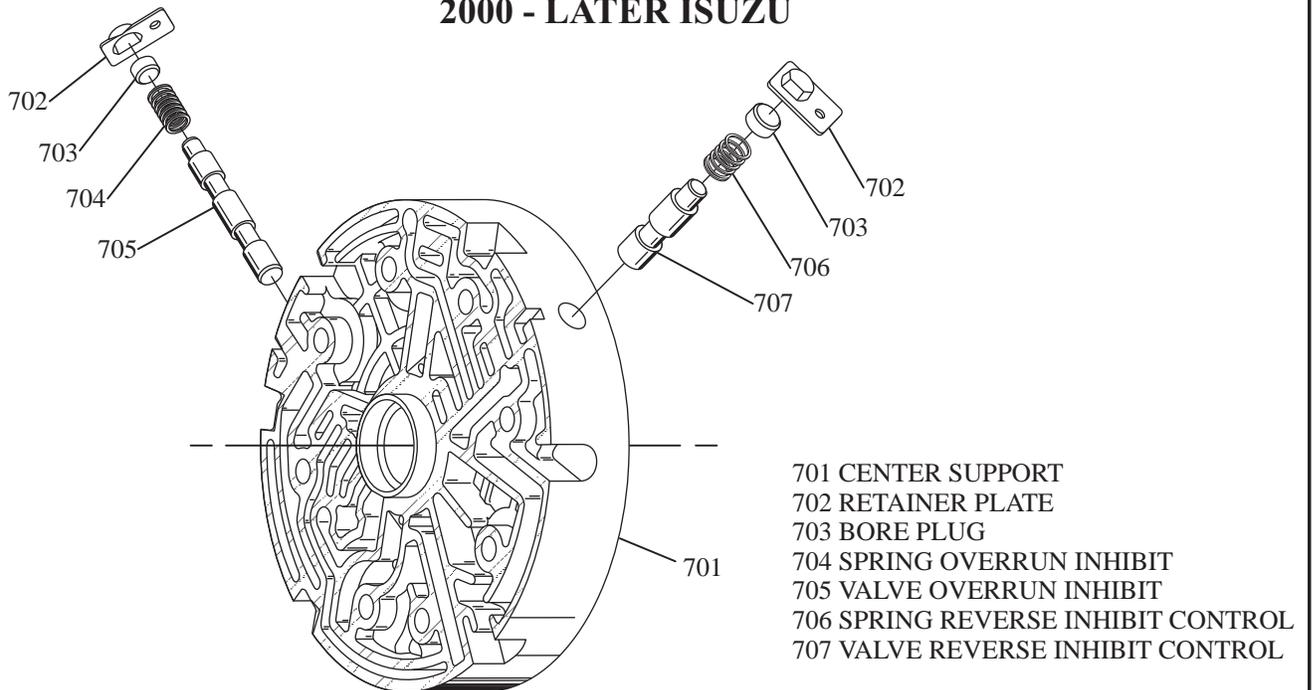
Figure 2

CENTER SUPPORT ASSEMBLY BMW AND 2000 - LATER ISUZU

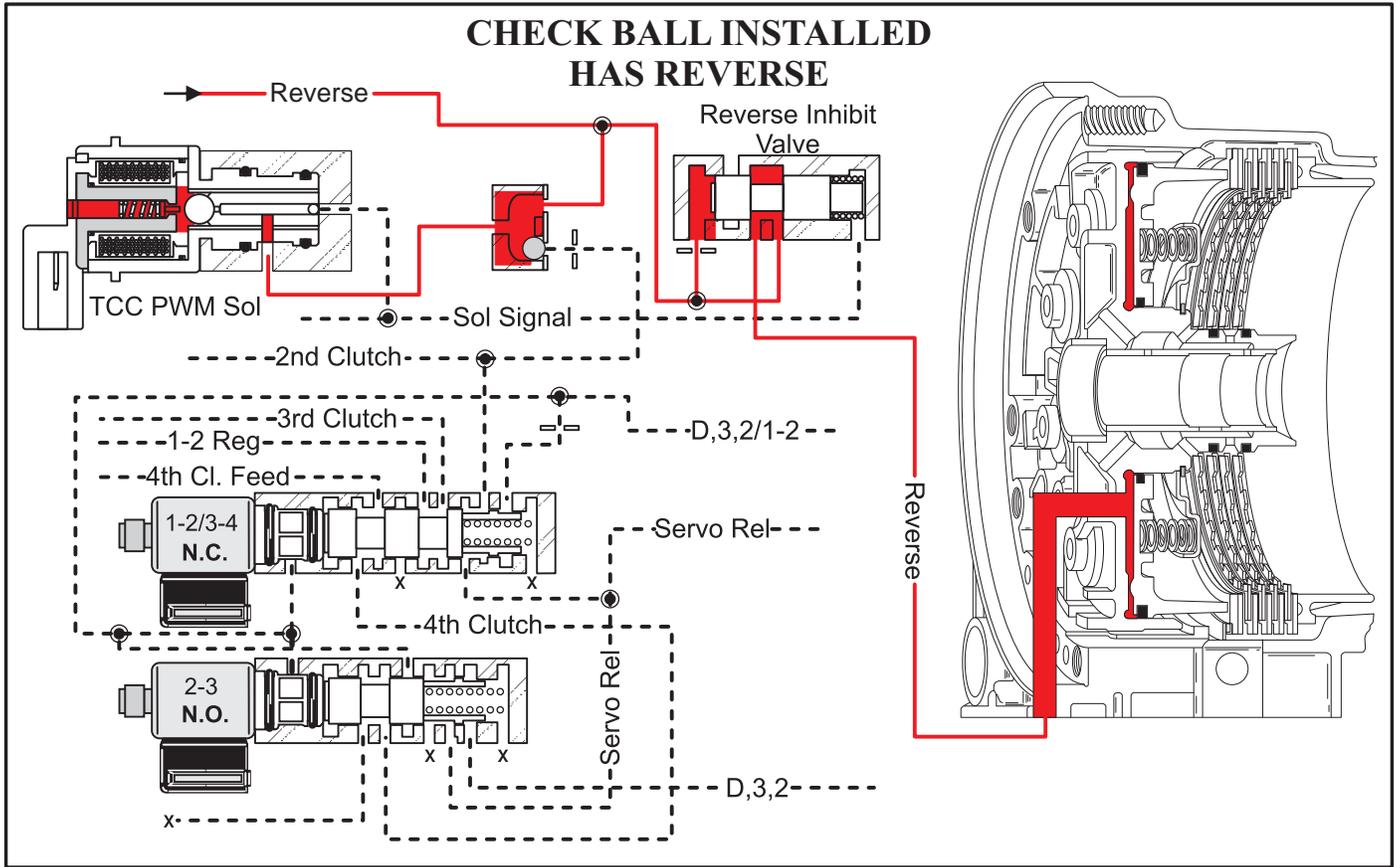
Figure 3 shows the ball properly installed in the adapter housing. Note the ball seats against the separator plate and forces oil into the reverse clutch circuit, through the reverse inhibit valve then applying the reverse clutch, while at the same time blocking oil from entering the 2nd clutch circuit.

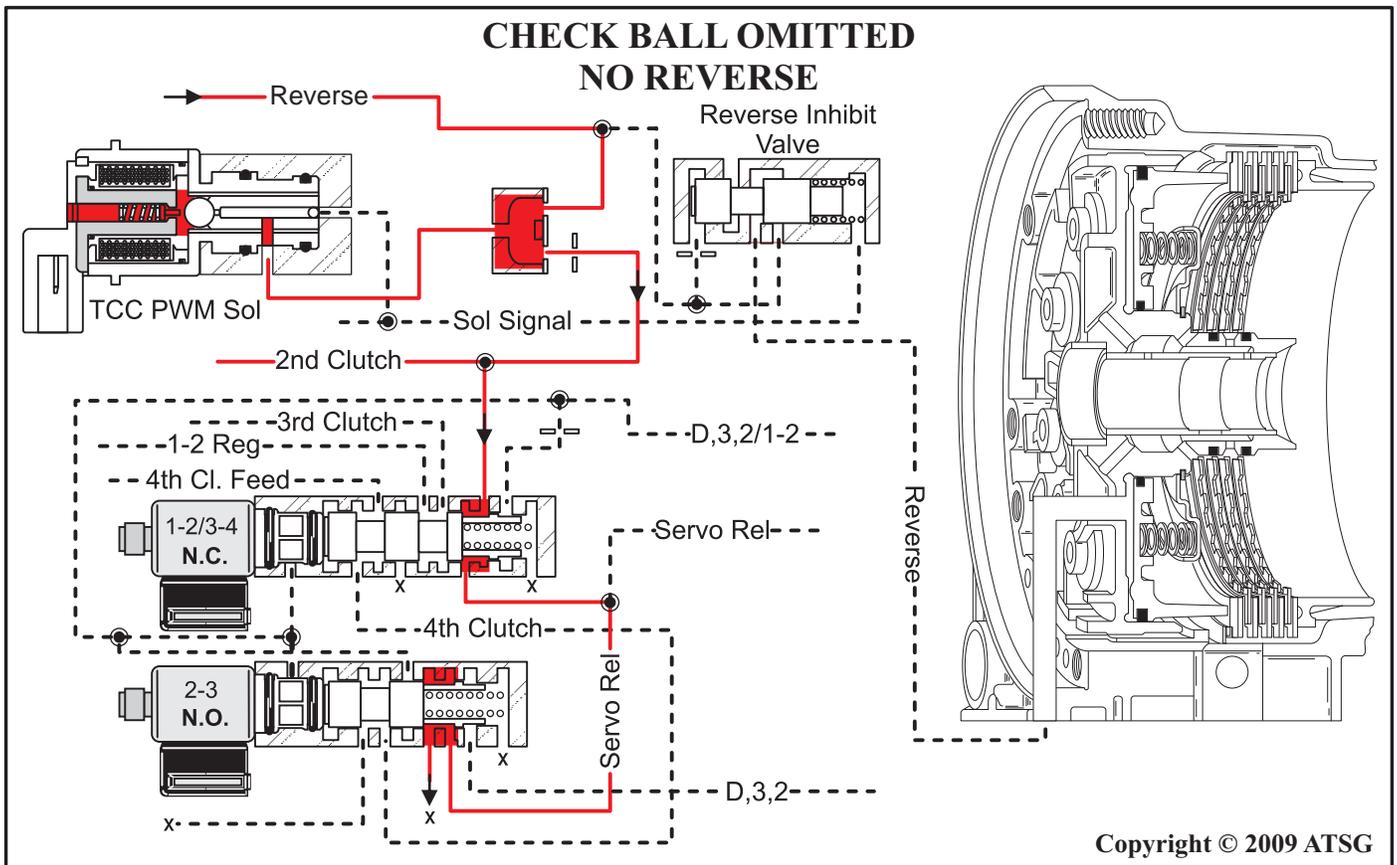
Figure 4 shows a missing check ball in the housing. With no check ball to seat against the plate, reverse oil pressure passes into the 2nd clutch circuit. Oil pressure flows through the 1-2/3-4 shift valve and exhausts at the 2-3 shift valve giving the neutral condition.

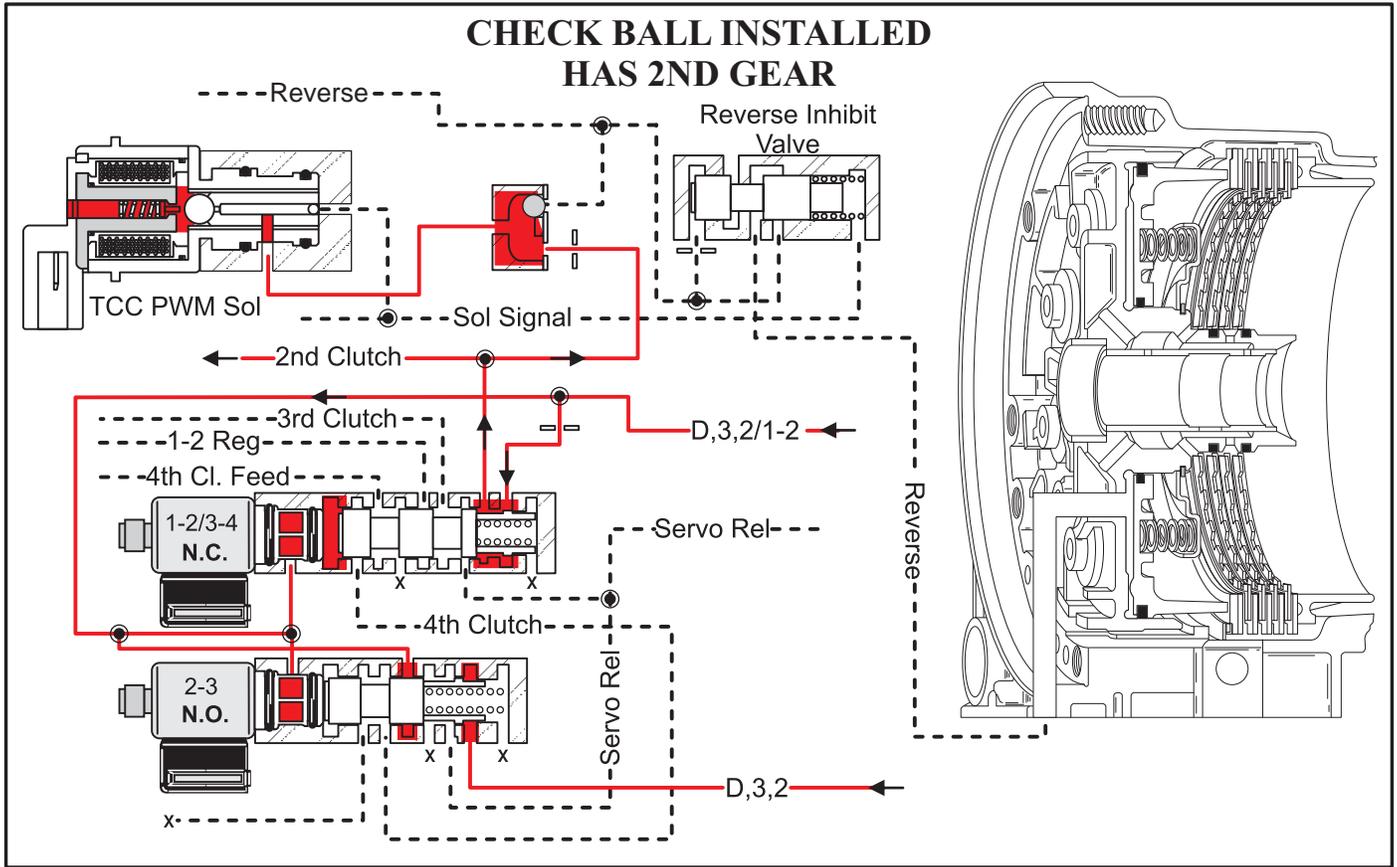
Figure 5 shows the ball properly installed in 2nd gear. Note the ball seats against the plate, and blocks oil from entering the reverse clutch circuit.

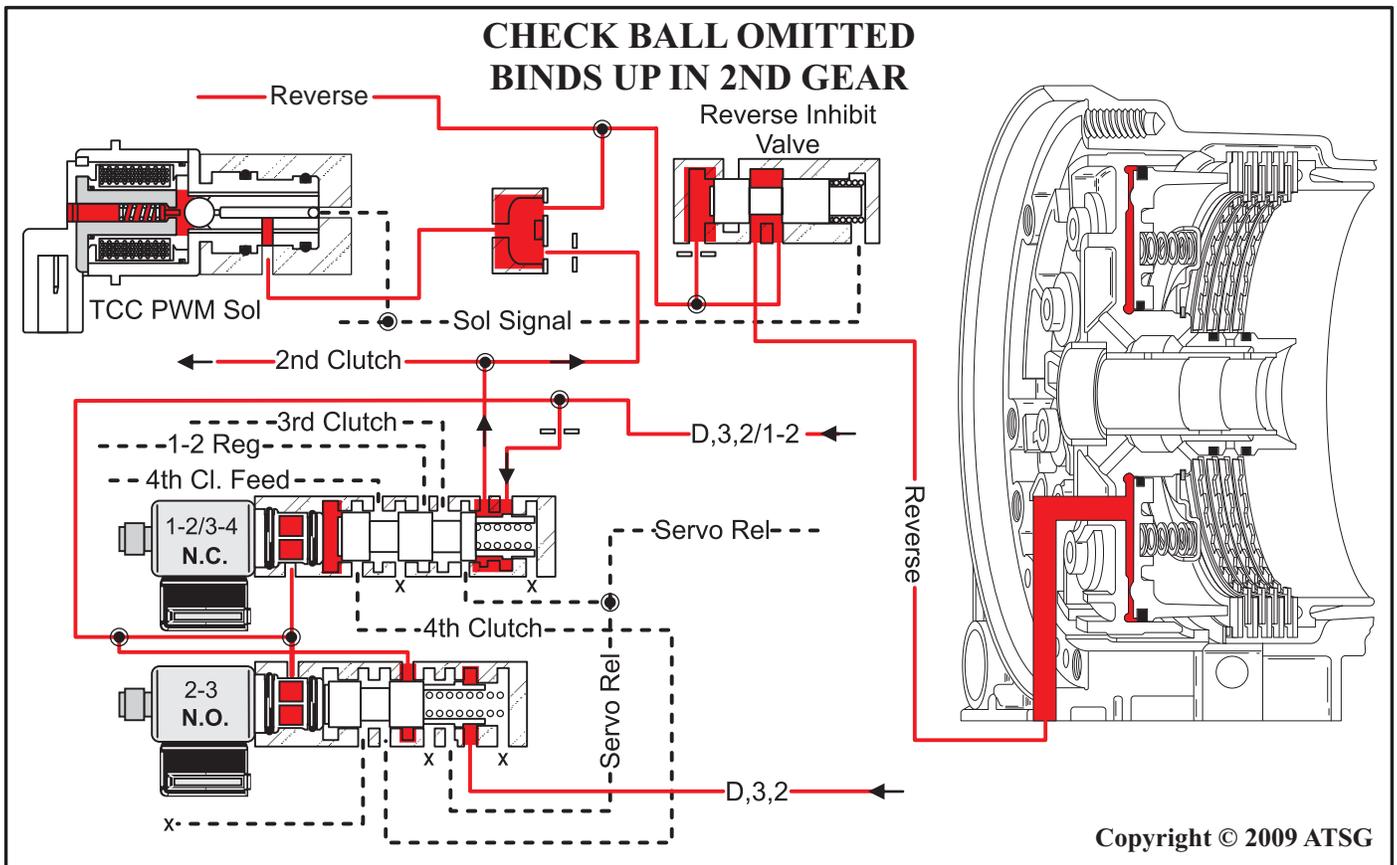
Figure 6 shows the ball missing. Oil pressure is allowed to enter the reverse clutch circuit causing the reverse clutch and 2nd clutch to apply together which causes the bind up condition on the shift.
