# Technical Service Information

## FORD AX4S N-D DELAY/BANG 1999 & UP MODELS

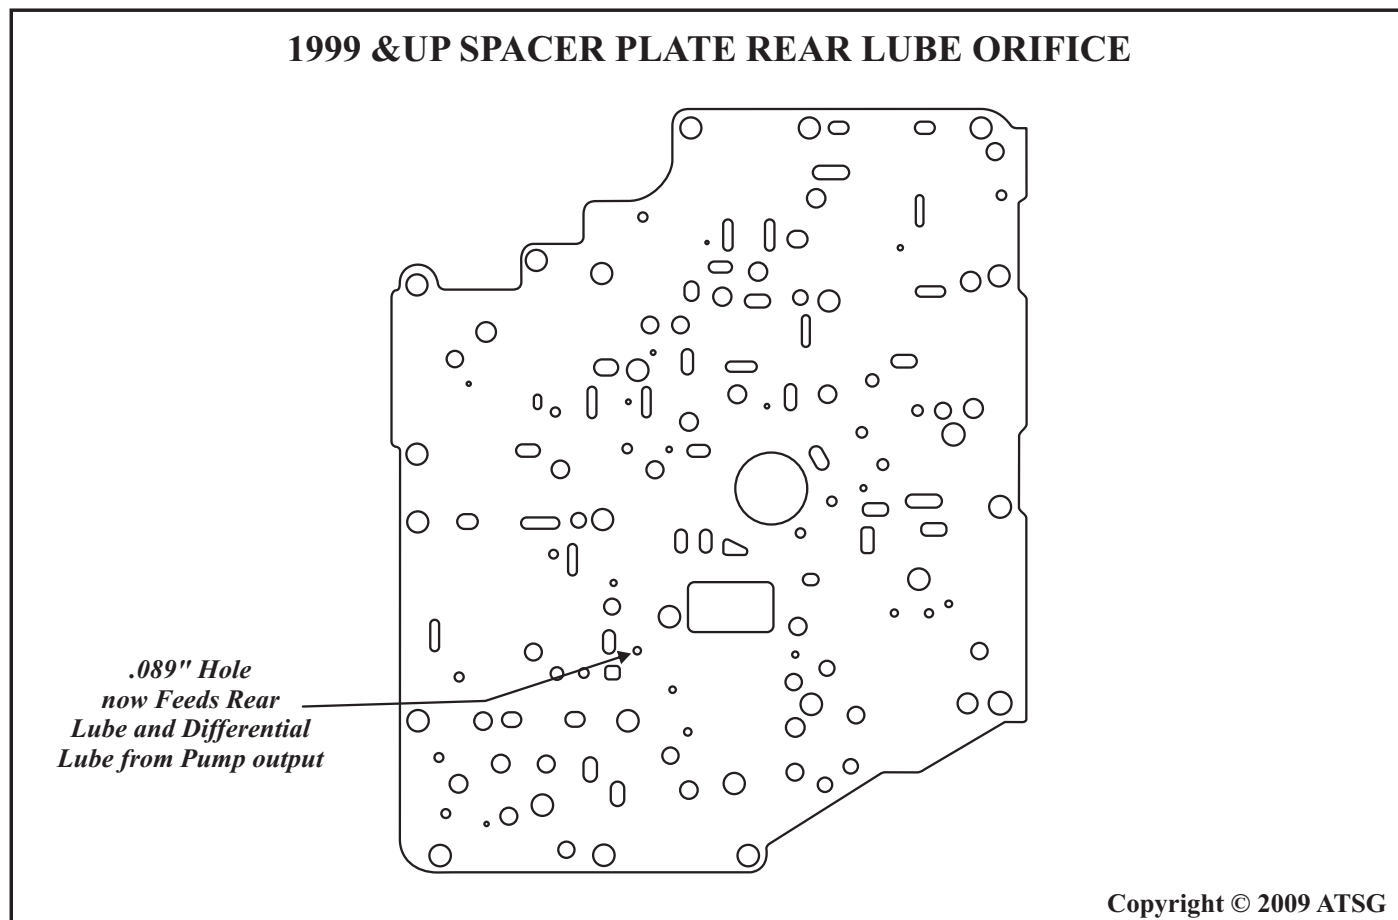
Figure 1

**CAUSE:** The cause may be, a leak in the lube circuit, which is now fed directly from pump output, through an .089" orifice in the main spacer plate, as shown in Figure 1. This leak may be from a broken o-ring on the lube pipe where it fits in the case or a crack in the braised area where it feeds the support, or a damaged "orange" lube seal in the support (see Figures 2 and 3). A leak in the lube circuit may cause a low overall line pressure condition, when the PCM notices that forward has not been engaged, it will elevate line pressure causing the bang when forward is finally engaged.

**CORRECTION:** To correct this condition, ensure that the lube pipe o-ring and the braised area of the pipe are in good condition, also make sure that the "orange" seal in the support is in good condition.

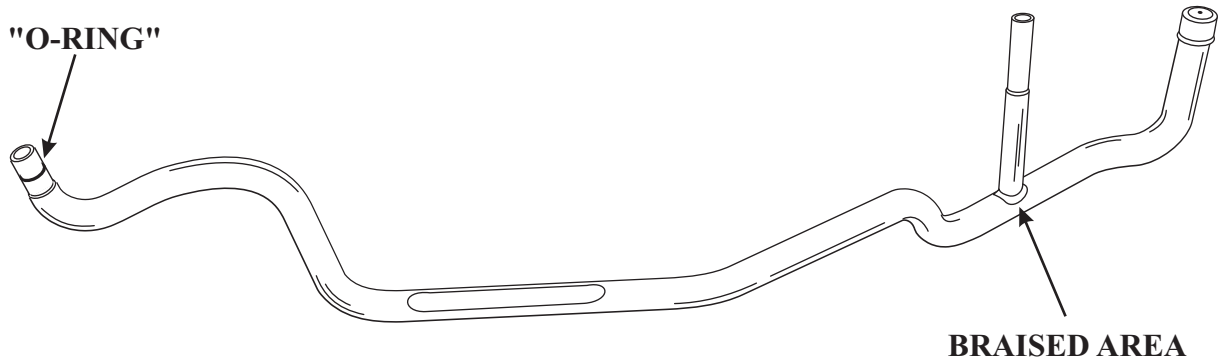
Figure 2

## REAR / DIFFERENTIAL LUBE PIPE

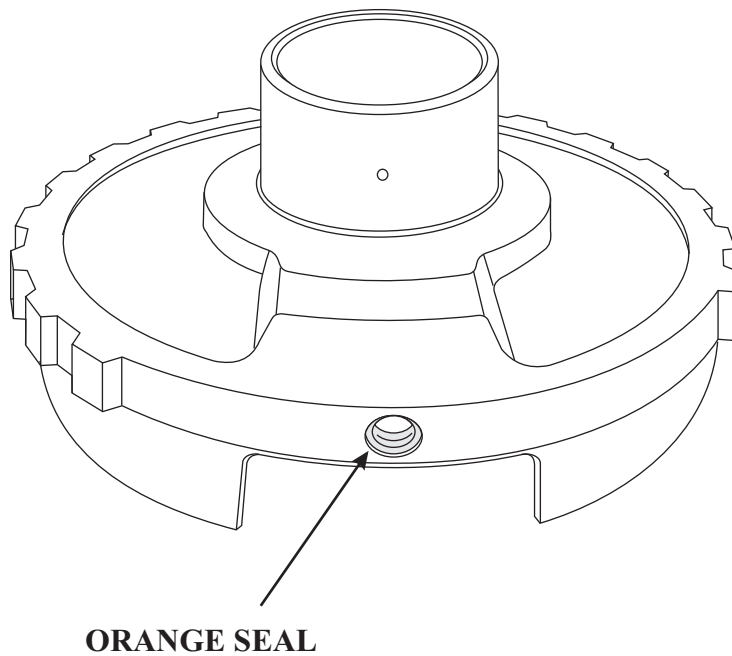
Figure 3

## SUPPORT
