Technical Service Information

GM 6L80 SLIPS IN FORWARD DTC P2728

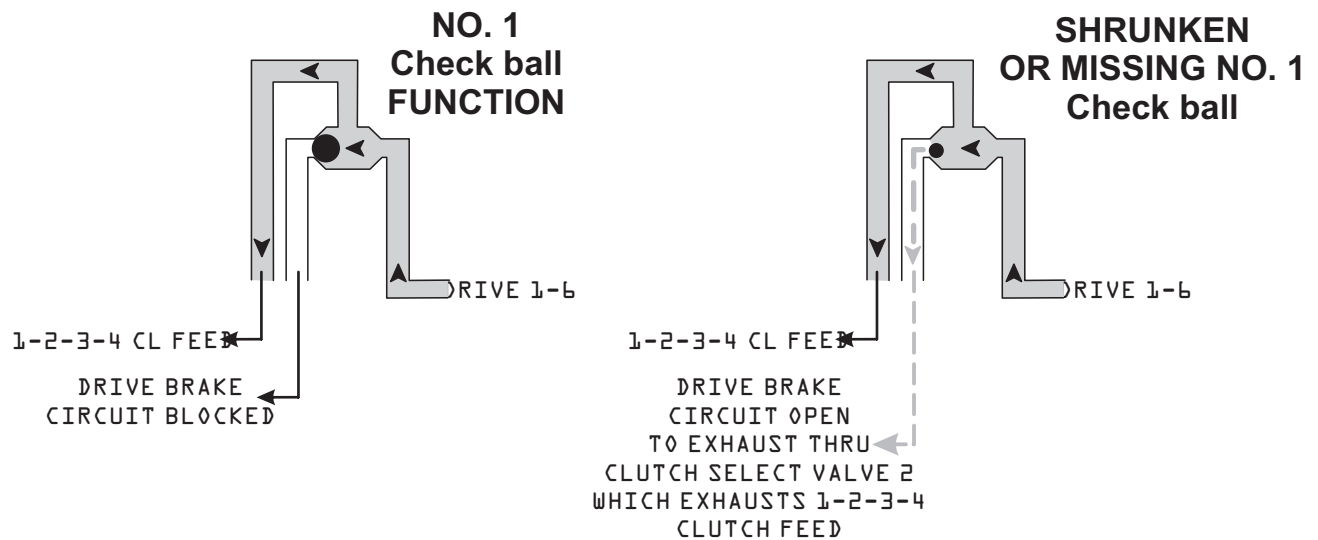
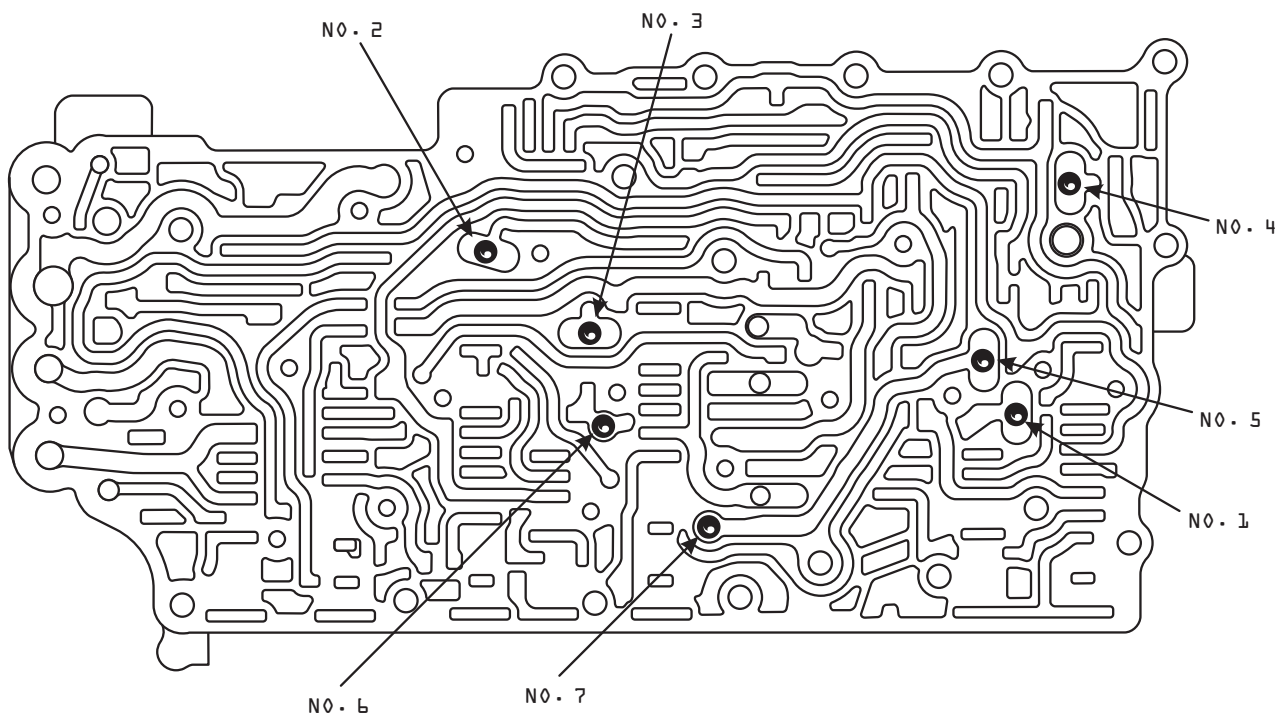
Figure 1

CAUSE: The cause may be a shrunken or missing number 1 nylon check ball. Refer to figure 1 for the location of the check ball in the upper valve body assembly. The number one check ball is located in the upper valve body, as shown in Figure 1. When the transmission is operating in drive 1st, 2nd, 3rd, 4th, 5th or 6th gear, drive 1-6 fluid seats the check ball against the drive braking passage and enters the 2-6 clutch/1-2-3-4 clutch feed circuit to apply the 1-2-3-4 clutch. When the check ball shrinks or disintegrates, 1-2-3-4 Clutch pressure will pass thru the ball seat to an exhaust provided by Clutch Select Valve 2. See figure 1 for partial schematic. **Note:** The DTC's listed above are performance codes related to the solenoid that controls the 1-2-3-4 Clutch application, a missing check ball can cause these codes to set, do not assume the TCM/Solenoid assembly is faulty, it could be a simple check ball!

6L80 NUMBER 1 CHECK BALL LOCATION AND FUNCTION IN 1ST GEAR

CORRECTION: Replace the nylon check balls with 1/4" torlon check balls available in most aftermarket Torqueflight kits, including 42-48RE. These check balls are made out of more durable material.
