4L60/65/70E

PUMP & INPUT SHAFT USAGE

Technical Service Information

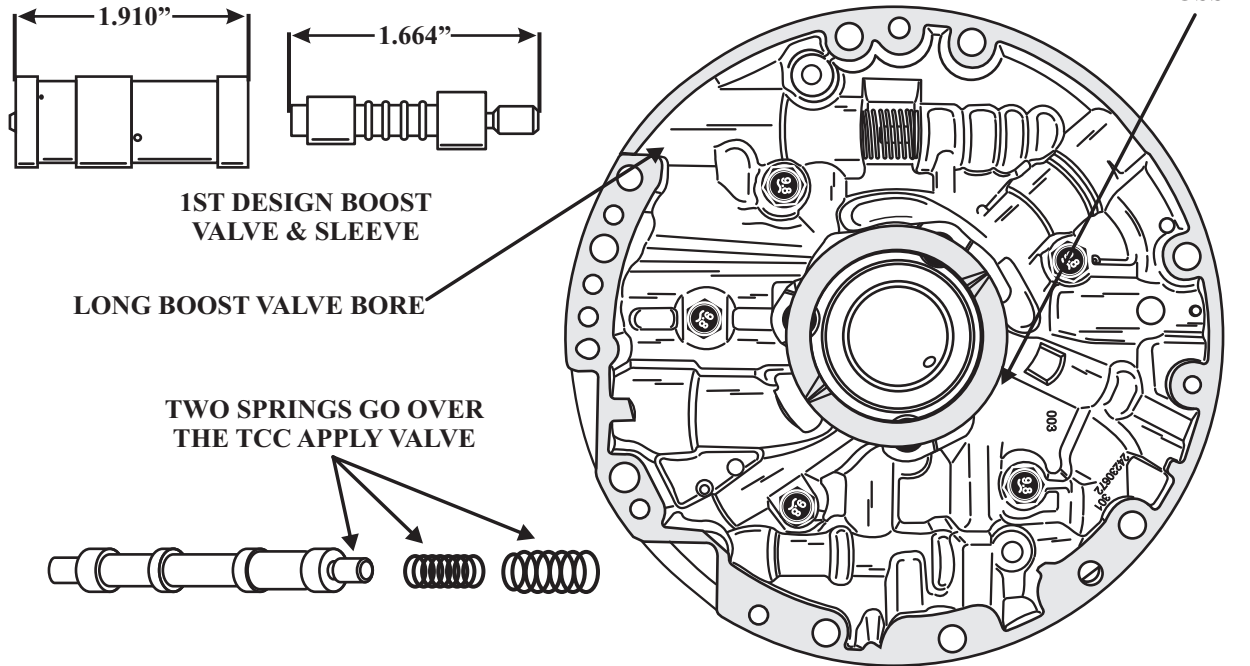
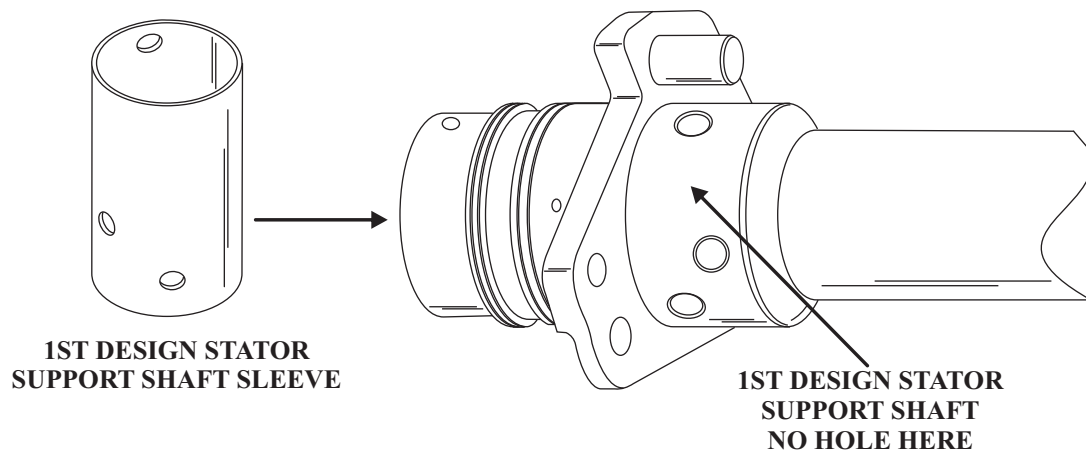
Figure 1

(1) In model years 1997 to early 2005, the 4L60E series transmissions utilized a pump cover with no provisions for an ISS, the input shaft sealing ring grooves had not changed and there was no speed sensor rotor. The pump cover used the 1st design internal stator shaft sleeve and the 1st design boost valve which is 1.664" with a boost valve sleeve of 1.910" in length as well as two springs that went on the TCC apply valve, (Refer to Figure 1).

INPUT SHAFT WITH RING LANDS
NOT RELOCATED AND NO SPEED ROTOR

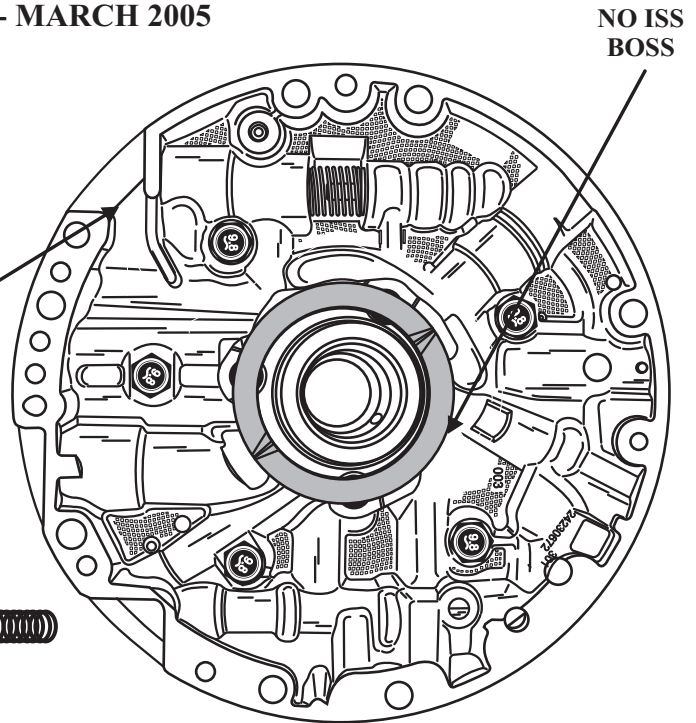
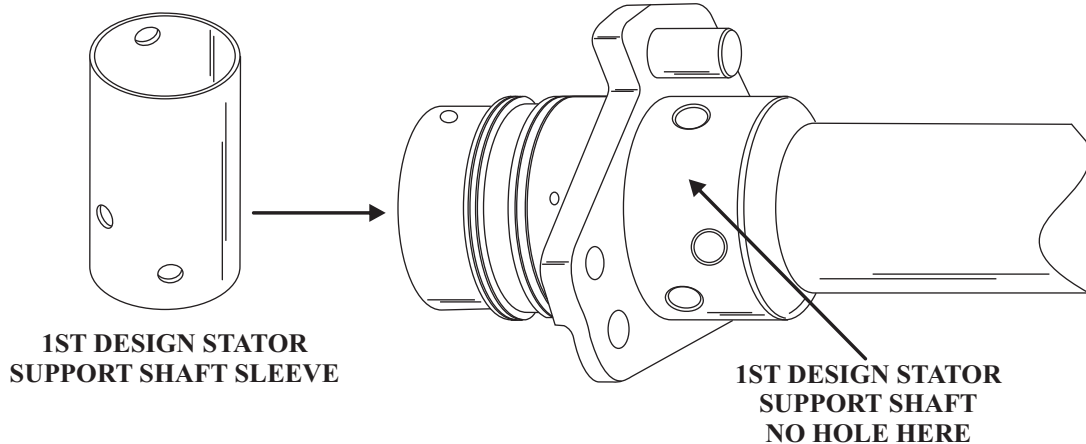
Figure 2

(2) Effective February 1st, 2005, the oil pump cover now uses a new design TCC valve with a single spring, (Refer to Figure 2).

(3) Effective March 7th, 2005, the oil pump cover now uses a more compact boost valve and sleeve. The snap ring groove location for the boost sleeve is now situated 2.57" from the bottom of the bore compared to 2.68" for the previous design. The bore length for the boost sleeve and snap ring has been reduced by approximately 0.110", also seen in Figure 2.

2ND DESIGN BOOST
VALVE & SLEEVE

THE BOOST VALVE BORE
HAS BEEN SHORTENED .106"

ONE SPRING GOES INTO
THE TCC APPLY VALVE

INPUT SHAFT WITH RING LANDS
NOT RELOCATED AND NO SPEED ROTOR

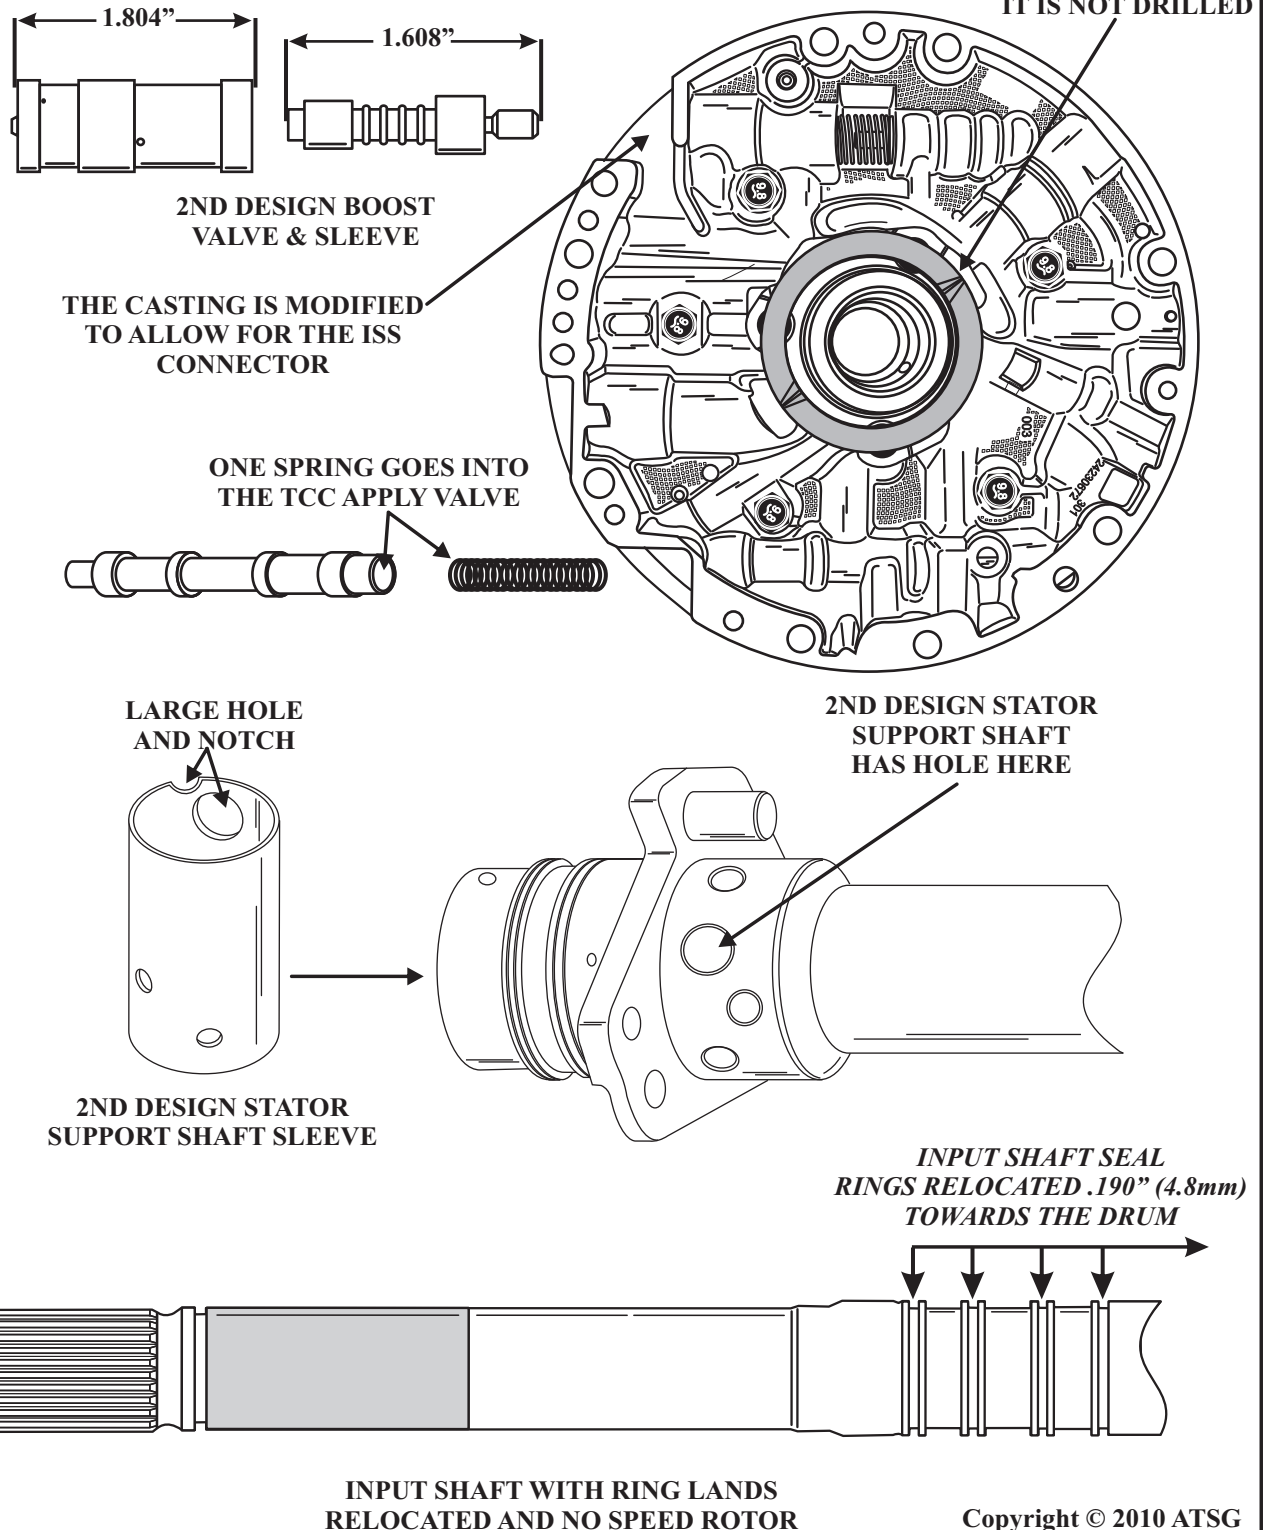
Figure 3

(4) After July 16th, 2005, the pump cover casting was modified in order to situate the ISS connector. This modification removed metal directly below the PR valve and boost sleeve bore and extended a cast wall inward. The internal TCC release passage was also modified at this time. The ISS mounting holes are not yet machined into the oil pump cover, (Refer to Figure 3).

At the same time, the turbine shaft oil seal ring grooves were moved inboard towards the rear of the unit approximately 0.190"(in.) to produce an area with which to manufacture 15 rotor teeth, this can also be seen in Figure 3.

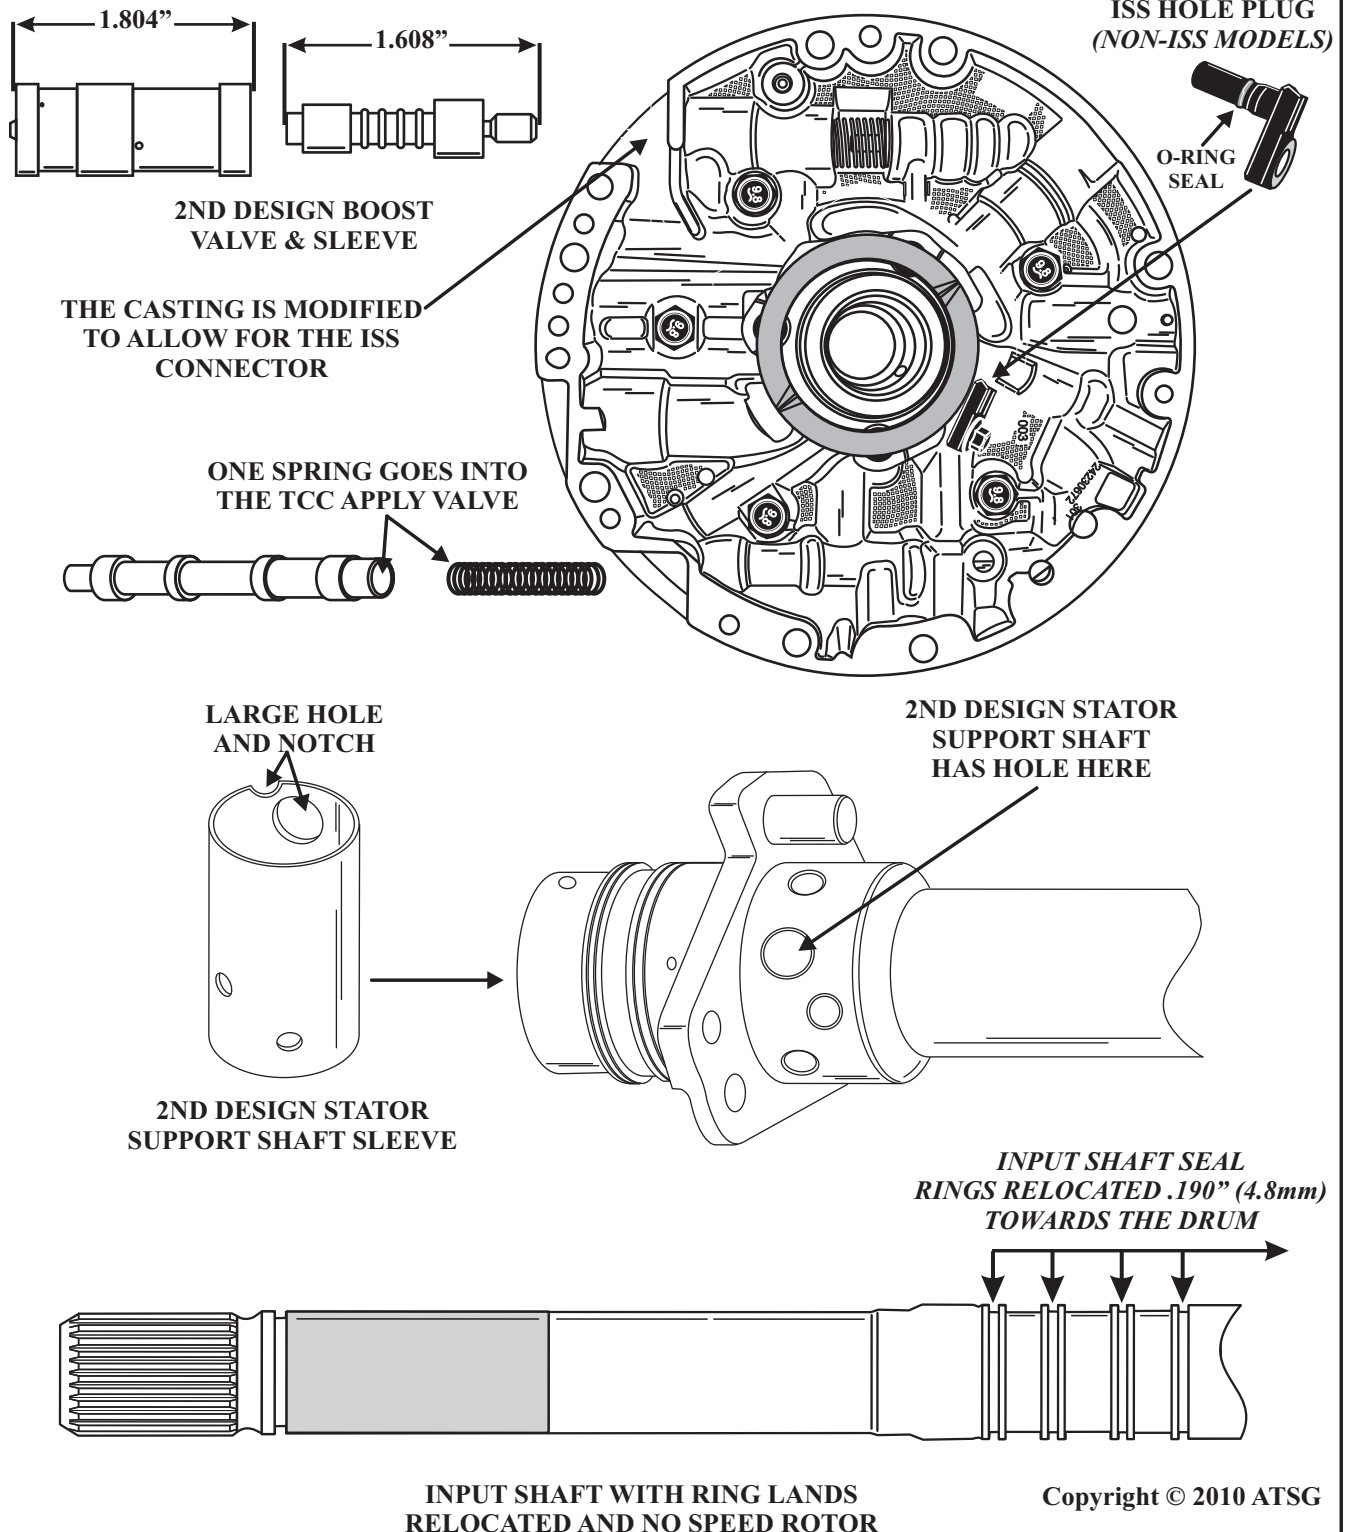
Figure 4

continued: (4) Late in 2005 and early in the 2006 model year, some pre ISS models may still not have the ISS mounting holes machined into the cover. This will be evident as a smooth un-machined surface without the ISS mounting holes. For non ISS models, an ISS hole plug will be used in place of the ISS assembly, (Refer to Figure 4).

On Non-ISS models that have a functional ISS hole in the pump cover, the rubber plug with an o-ring seal must be installed. Failure to do so will result in no converter charge and the vehicle will not move.

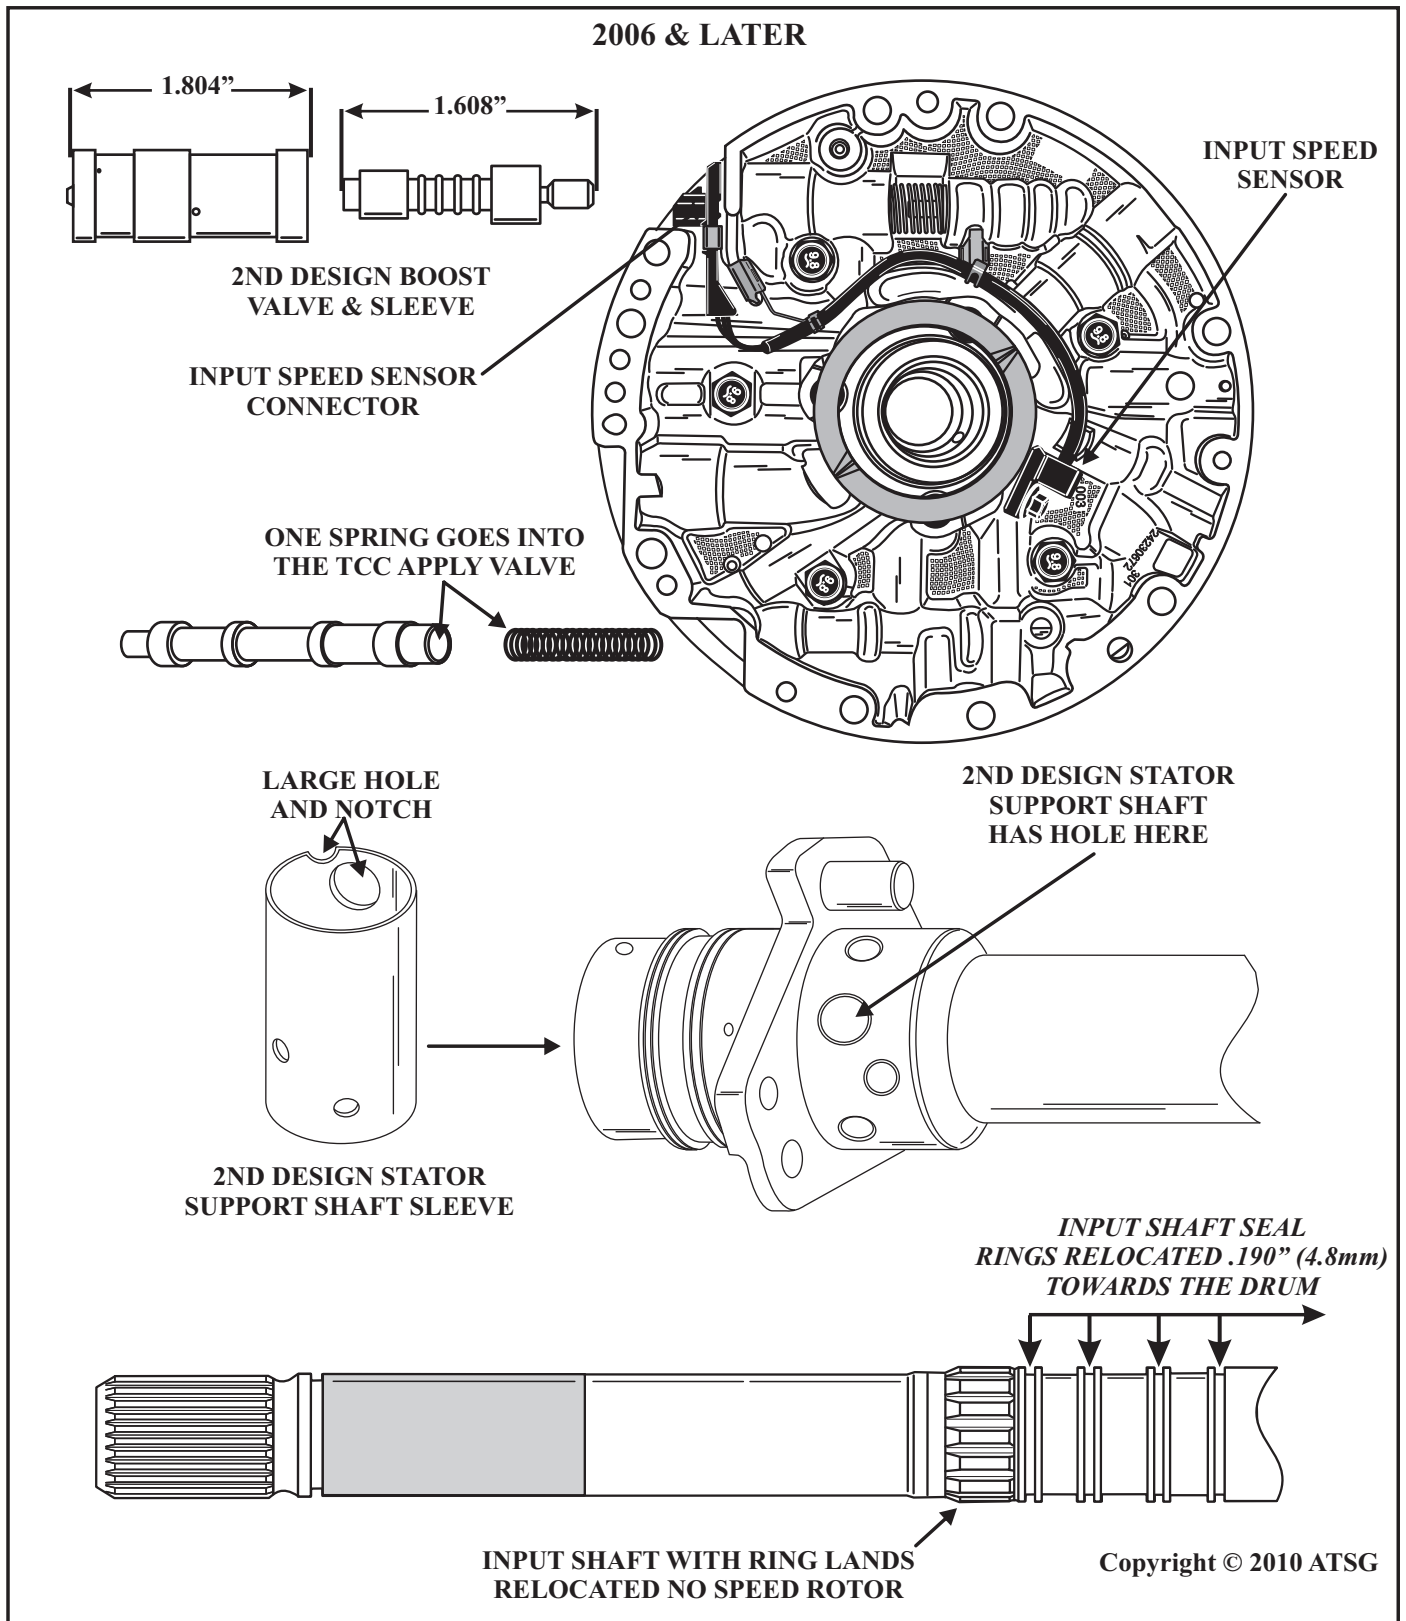
Figure 5

As ISS models were introduced, later in the 2006 model year, the machining took place and the input speed sensor (ISS) was added, (Refer to Figure 5), the presence of the ISS also necessitated a new internal wire harness to accommodate the ISS and software changes to the PCM provided code capability for ISS malfunctions.

If an input shaft is used without the speed rotor, and the pump cover has an ISS, codes P0716 or P0717 will be stored which could cause TCC slip and gear ratio calculation errors.
