Technical Service Information

HONDA/ACURA BAXA/B7XA FAMILY TIE UP IN REVERSE WHEN HOT

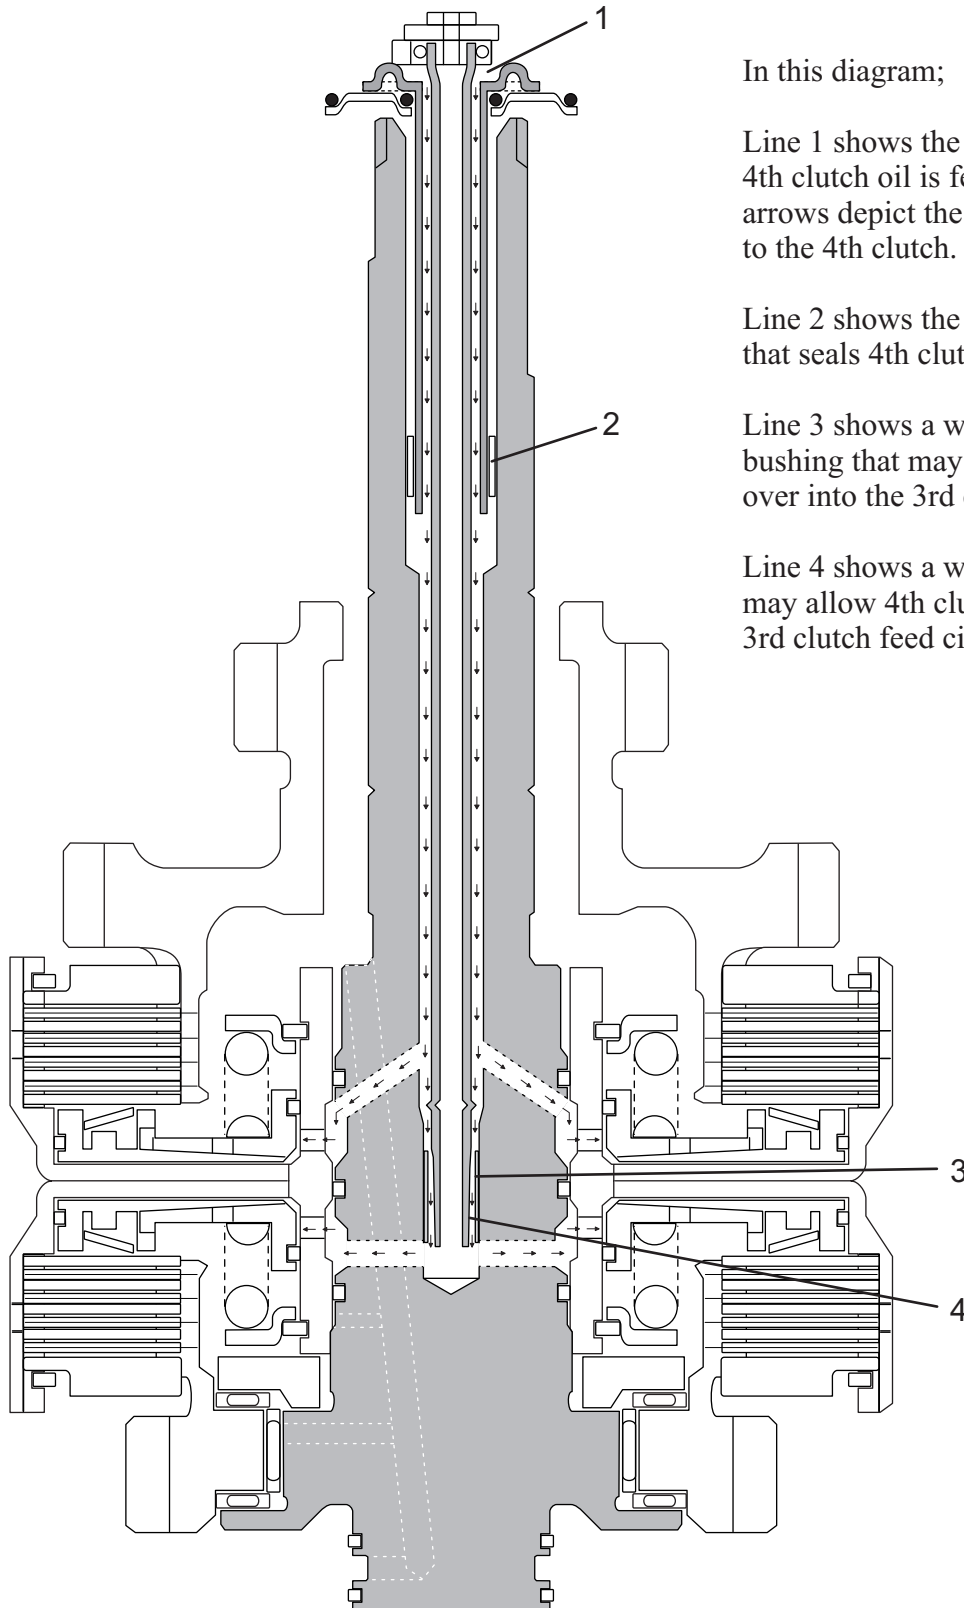
Figure 2

CAUSE: One cause may be a worn bushing in the main shaft, or a worn 3rd clutch feed tube in the back cover allowing 4th clutch oil to cross over into the 3rd clutch circuit partially applying the 3rd clutch and causing the tie-up.

HONDA/ACURA BAXA/B7XA FAMILY PARTIAL CUTAWAY CROSS LEAK AREAS

Line 3 shows a worn 3rd clutch feed tube bushing that may allow 4th clutch oil to cross over into the 3rd clutch feed circuit.

Line 4 shows a worn 3rd clutch feed tube that may allow 4th clutch oil to cross over into the 3rd clutch feed circuit.

If any pressure is present on the 3rd clutch tap when the selector is placed in the reverse position, it will be necessary to remove the transmission from the vehicle and disassemble so the mainshaft can be replaced. It will be necessary to also inspect the tubes located in the transaxle rear cover. If any wear is present on the 3rd or 4th clutch feed tubes, the rear cover will need to be replaced since the tubes are not serviced separately. Refer to figure 3 for illustration of the mainshaft and the location of the 3rd and 4th clutch feed tubes in the transaxle rear cover.

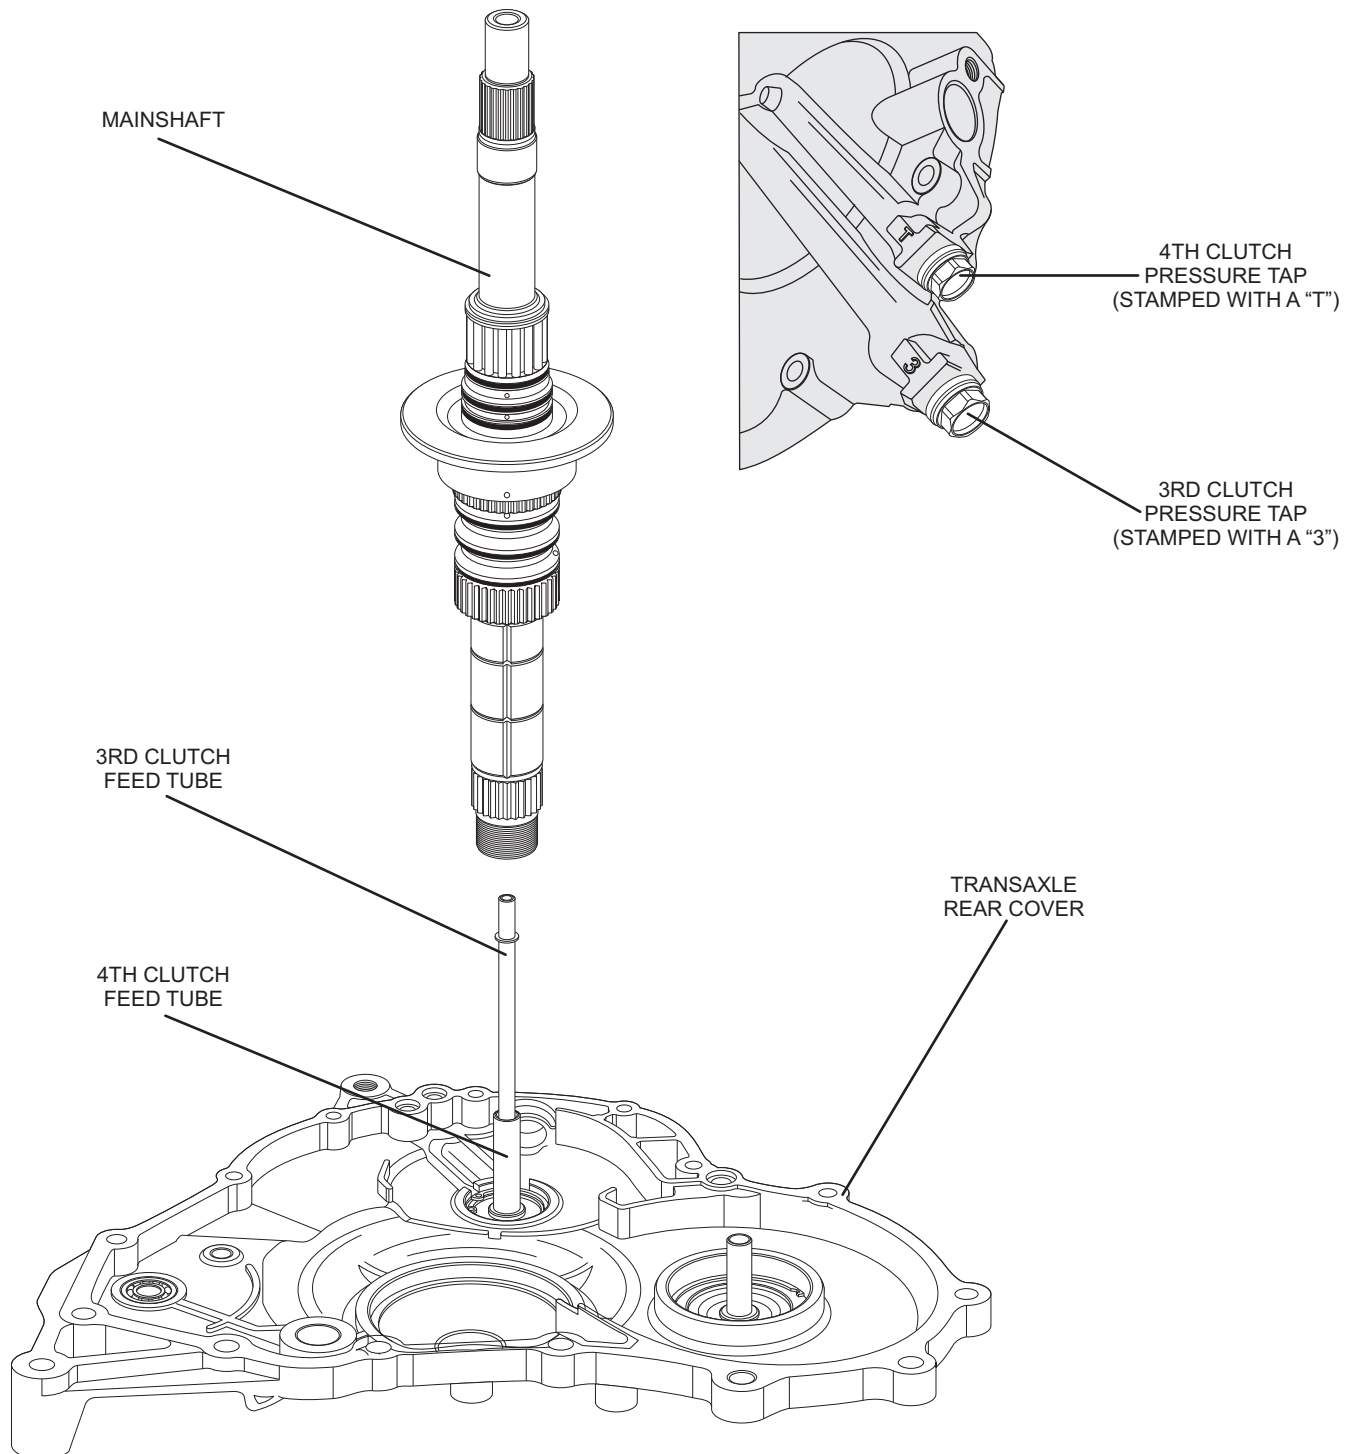
Figure 3

HONDA/ACURA BAXA/B7XA FAMILY REAR COVER/MAINSHAFT ILLUSTRATION AND PRESSURE TAP LOCATIONS

CORRECTION: The best way to check for this condition is to conduct a pressure test on the 3rd clutch pressure tap when the vehicle is “HOT” and the selector is placed into reverse. Refer to figure 3 for pressure tap locations on the transaxle rear cover.
