SUBARU PHASE II P0741 TORQUE CONVERTER SLIP

COMPLAINT: Before or after overhaul, 1998 and up Subaru vehicles equipped with the Phase II Four Speed transmission may exhibit a Diagnostic Trouble Code P0741 Torque Converter Slip.

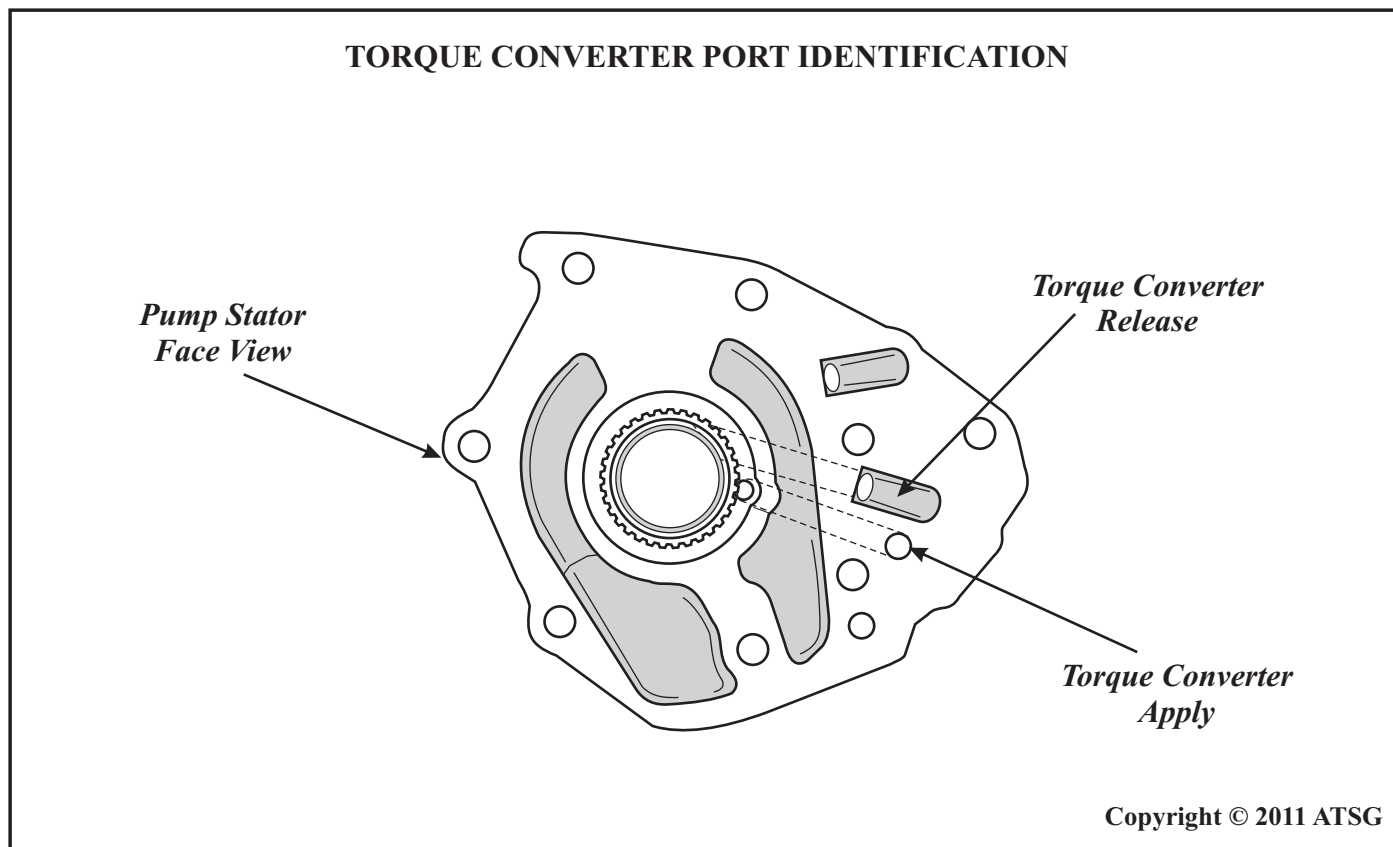
CORRECTION: Refer to Figure 1 to identify the Torque Converter release port and the Torque Converter apply port in the face side of the Stator assembly. See Figure 2 for an illustration of the Torque Converter Apply Circuit and how the TCC Apply pressure can be lost with the worn stator bushings. Refer to Figure 3 and assemble the Turbine shaft into the Stator shaft. Locate the Torque Converter release port on the face view of the stator and close it off with your finger. Apply 80-100 psi of air pressure to the center of the turbine shaft, and ensure no leakage past the bushing that is illustrated in Figure 3. **Note: This is the only sealing surface separating Torque Converter Off and Torque Converter Apply.**

At the time of this printing there are no bushings available from aftermarket suppliers. It may be necessary to replace the stator to repair this condition.

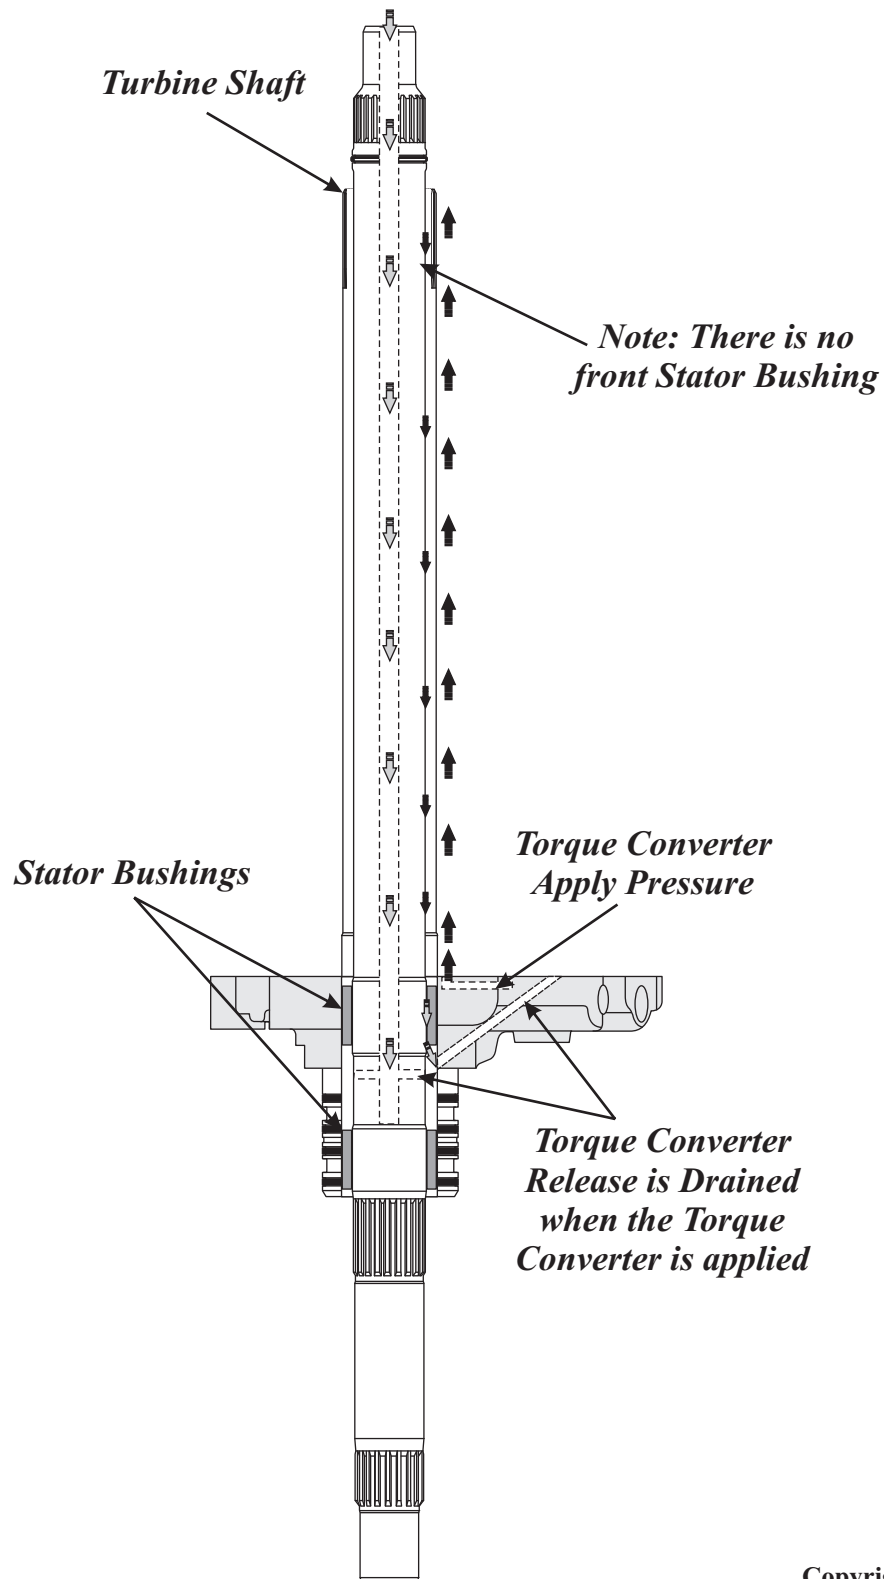
Figure 2

CAUSE: The cause may be, worn stator bushings allowing a pressure loss in the Torque Converter apply circuit.

TORQUE CONVERTER APPLIED

Note: Torque Converter Apply Pressure will be lost to the already exhausting Torque Converter release circuit, when the stator bushings are worn.

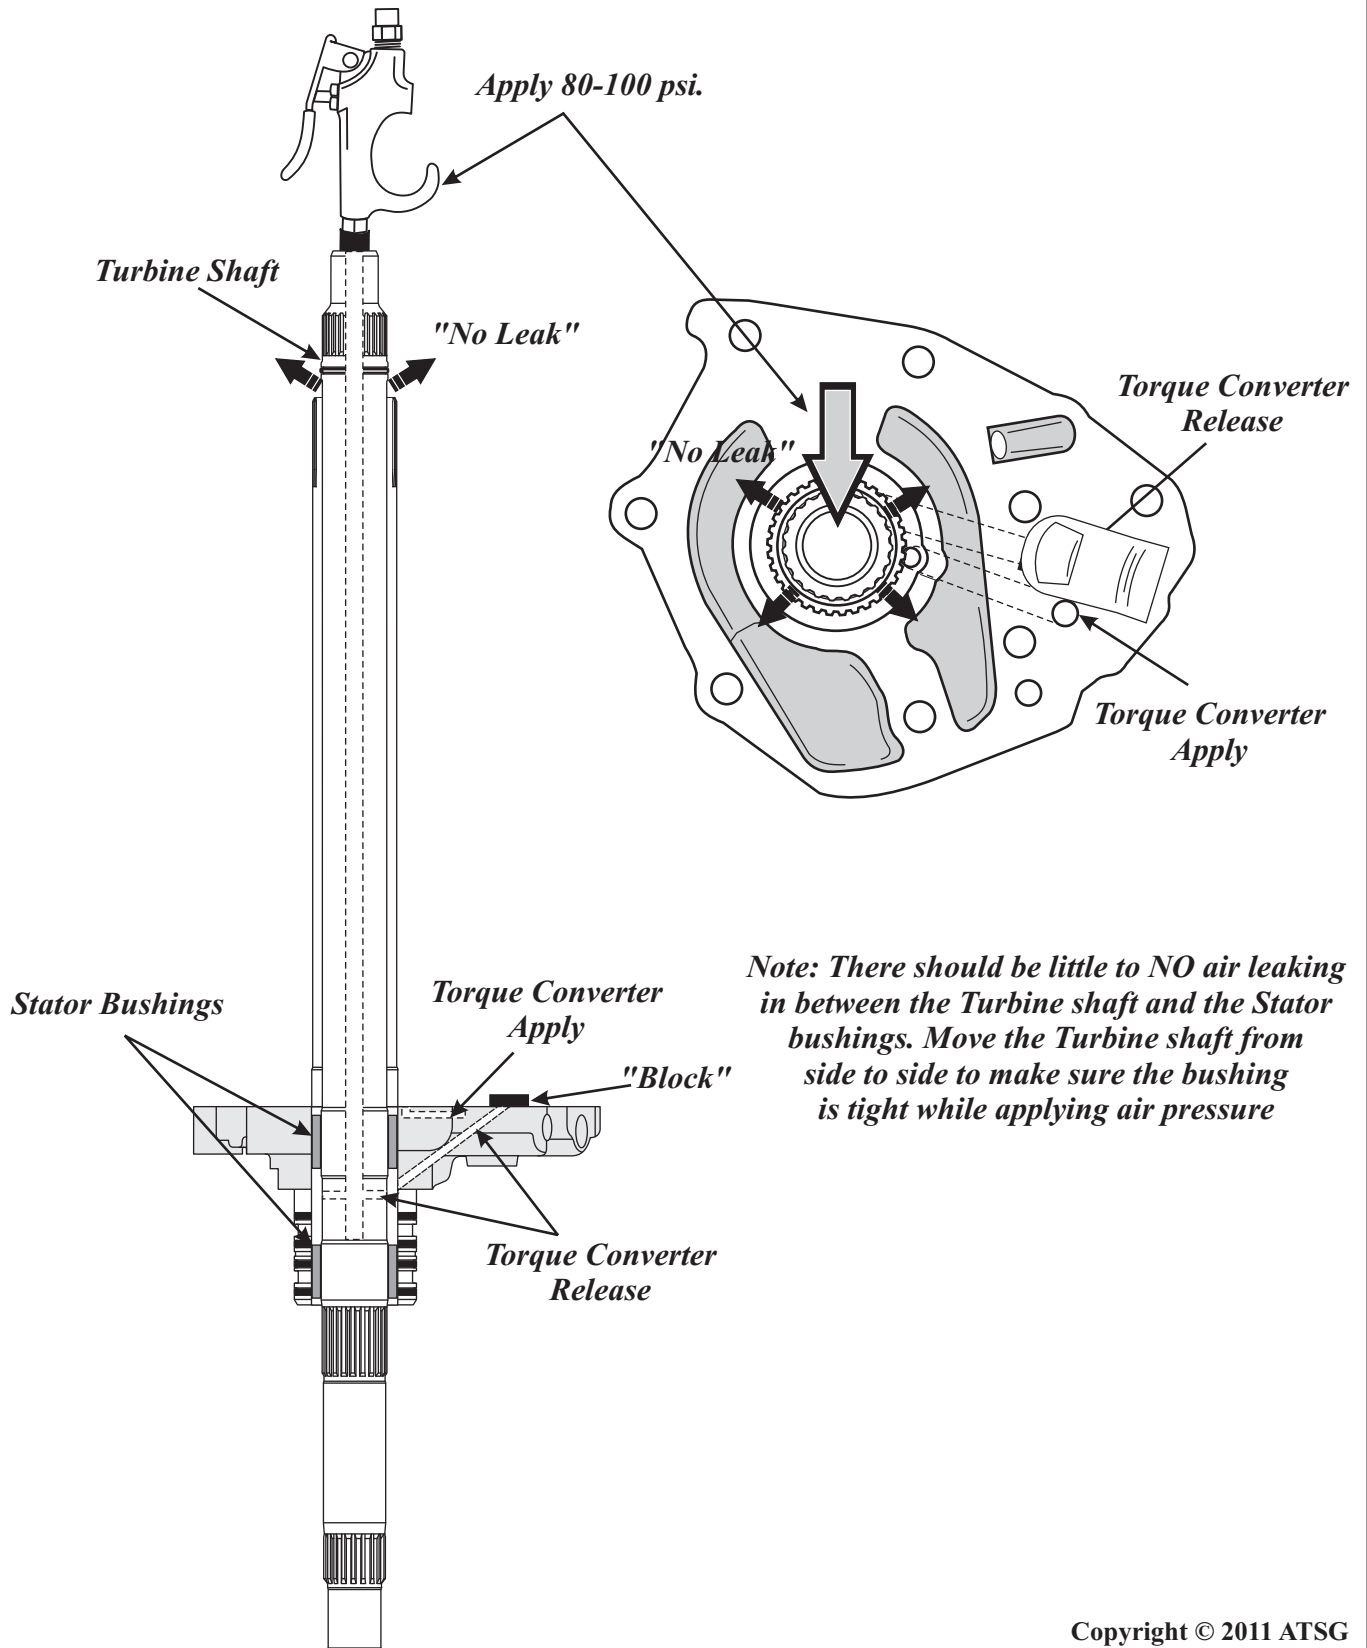
Figure 3

STATOR BUSHING AIR CHECK
