Technical Service Information

FORD/MAZDA CD4E PERSISTENT GEAR RATIO ERRORS 2001 & UP

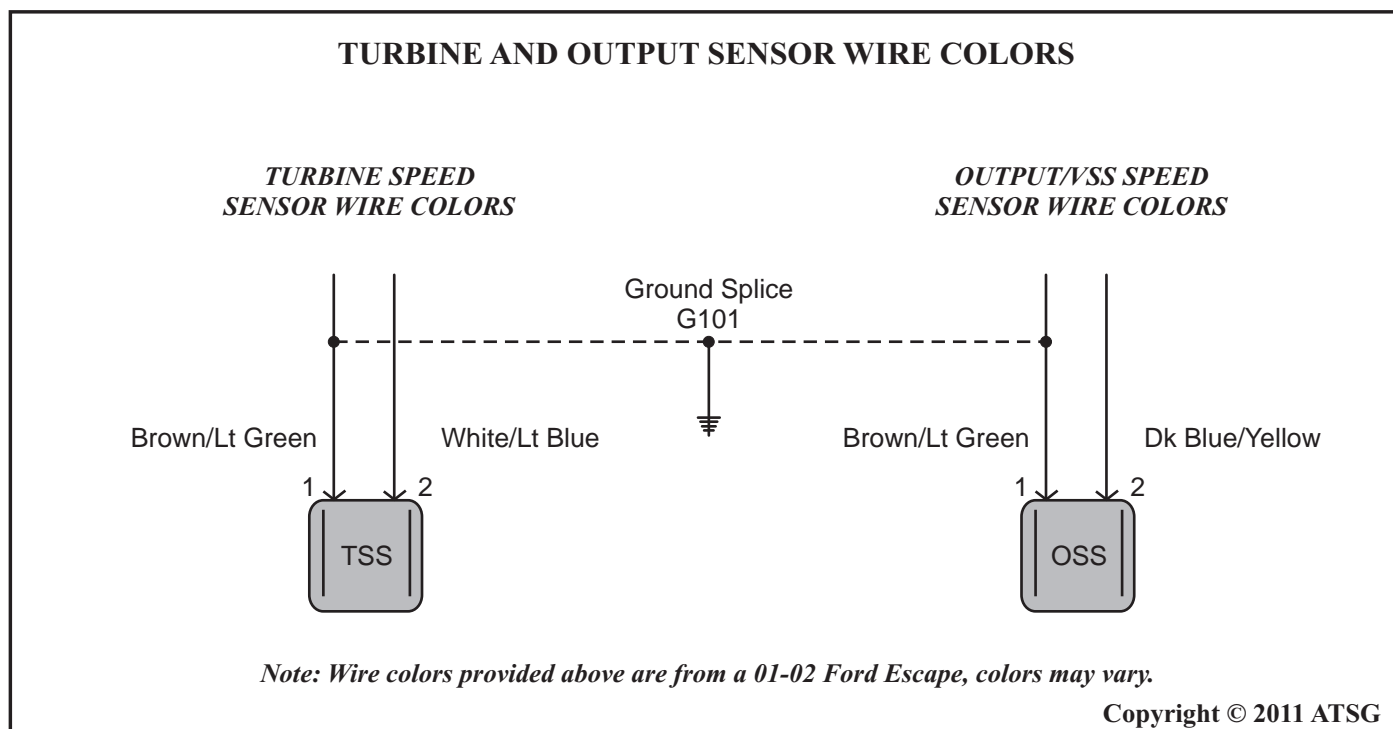
CAUSE: The cause may be that during installation of the transmission, the Turbine Speed Sensor harness connector was connected to the Output/Vehicle Speed Sensor, and the Output/Vehicle speed sensor harness connector was connected to the Turbine Speed Sensor, as the connectors are identical and the harnesses are long enough to cross-connect. The previous design VSS was on the opposite side of the trans which made it impossible to cross-connect. The new design OSS/VSS arrived in 2001 and up models.

CORRECTION: Refer to Figure 1 for a sample wiring schematic showing the wire colors for these two sensors. Figure 2 shows the location of the previous design and new design Vehicle Speed Sensor locations. Refer to Figure 3 for a close up of the TSS and VSS and their connectors. Verify that the correct harness is connected to the correct sensor.
