Technical Service Information

VT20/25-E DELAYED FORWARD ENGAGEMENT

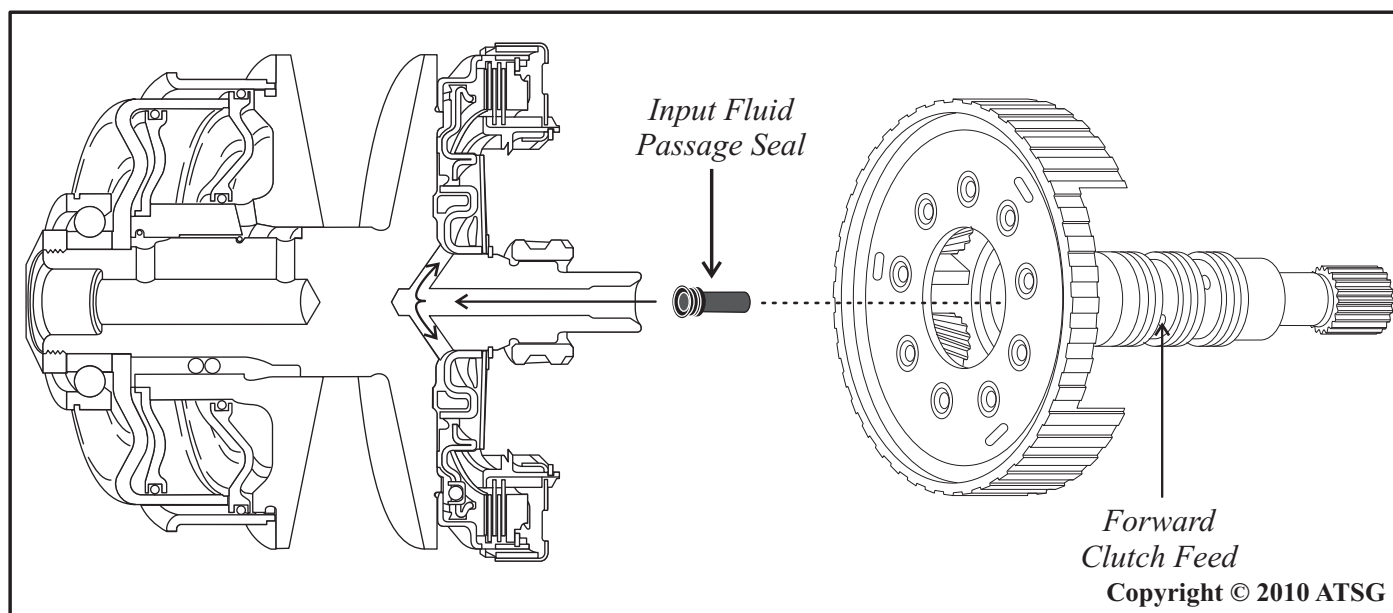
Figure 1

COMPLAINT: Before and after repairs, a slight delayed engagement into drive occurs when cold and becomes worse as fluid temperature increases.

CAUSE: Pressed into the Input Shaft Assembly is an Input Fluid Passage Seal (Figure 1) that loses its sealing capabilities and often times goes overlooked during repairs.

CORRECTION: Replace the Input Fluid Passage Seal. At the time of printing, this seal is included in a Precision kit.
