## JEEP & DODGE TRUCKS

### TPS CODE P0123 STORED

**COMPLAINT:** The vehicle comes in with a complaint of no upshift or a loss of fourth gear with no TCC application. Code retrieval results in code P0123 being stored indicating the TPS signal voltage is too high. The scan tool data list parameter for the TPS signal voltage displays 5 volts at closed throttle, yet when the TPS signal voltage is checked at the TPS signal wire with a voltmeter, the closed throttle voltage is normal.

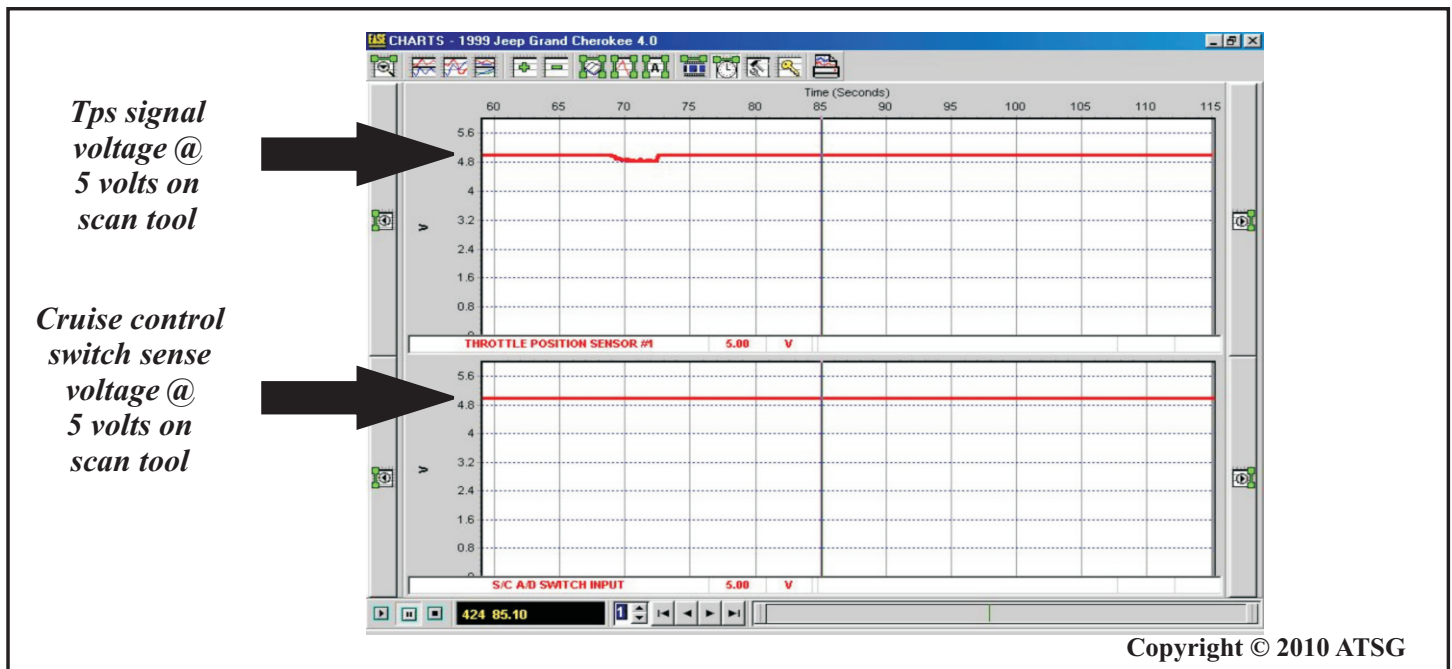
Figure 2

Using an EASE scan tool in the graphing mode (Figure 2), a screen capture was taken of both the TPS and Cruise Control Switch Sense voltage revealing that as far as the computer is concerned, both are pegged at approximately 5 volts. Figure 3 shows a different scan tool displaying the TPS signal voltage being pegged at 5 volts yet with an actual meter on the TPS signal wire, a normal 1.161 volts at closed throttle is seen. This indicates that the companion sensor could be shorted to power preventing the internal capacitor from discharging. Checking the Cruise Control Sense wire at the PCM with a volt meter reveals that 12 volts are present confirming a short to power (Figure 4).

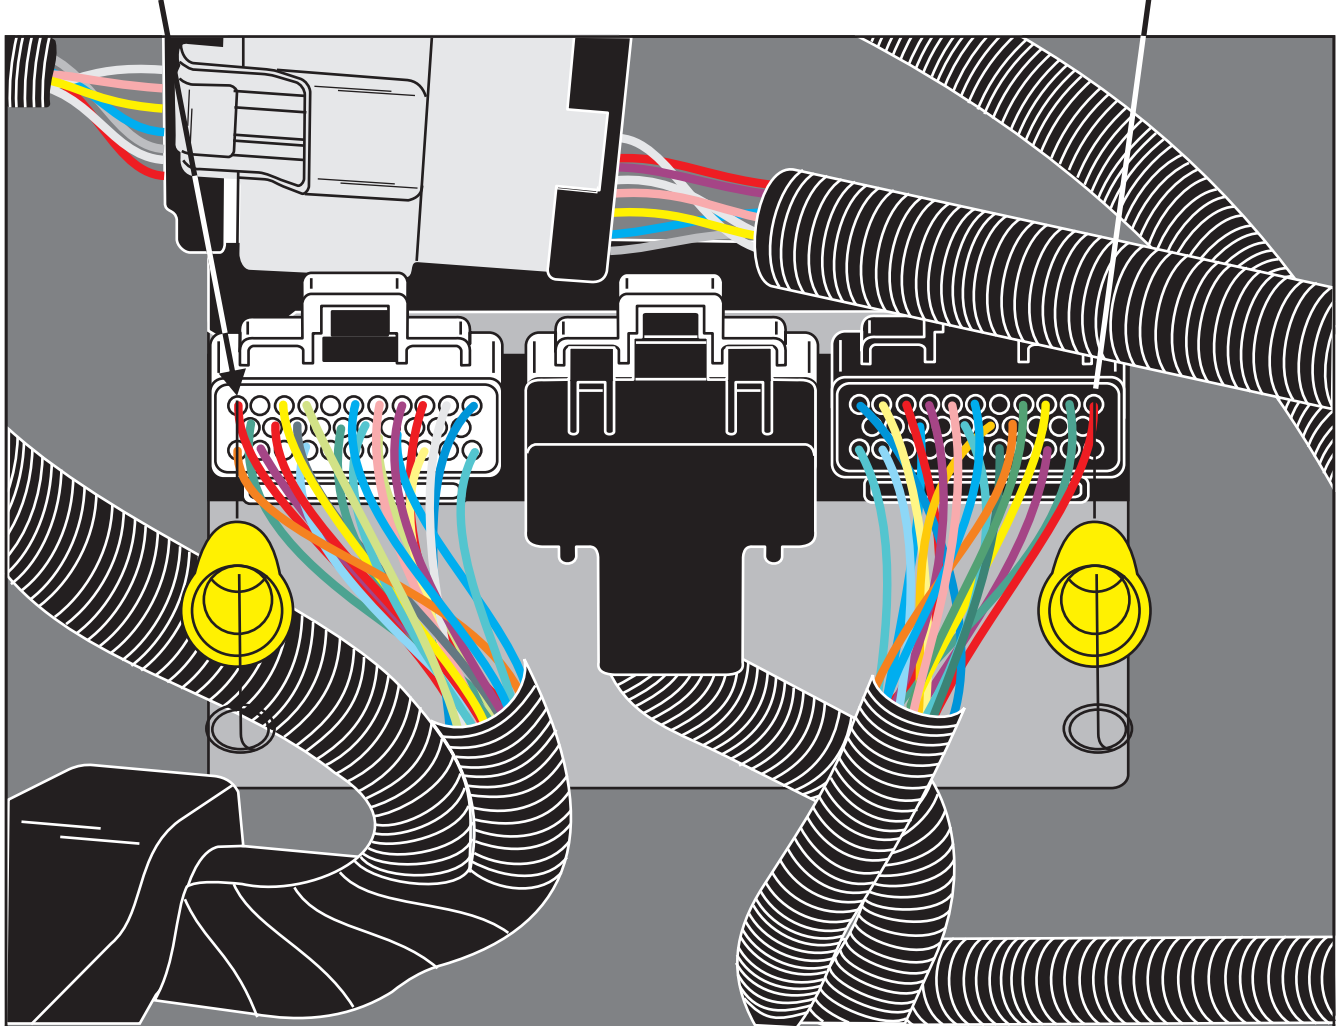
**CRUISE CONTROL SENSE WIRE**  
**@ THE C3 CONNECTOR**  
**TERMINAL 32**  
*(Reads 12 volts at all times  
with a DVOM)*

**TPS SIGNAL WIRE**  
**@ THE C1 CONNECTOR**  
**TERMINAL 23**  
*(Reads correct voltage  
with a DVOM)*

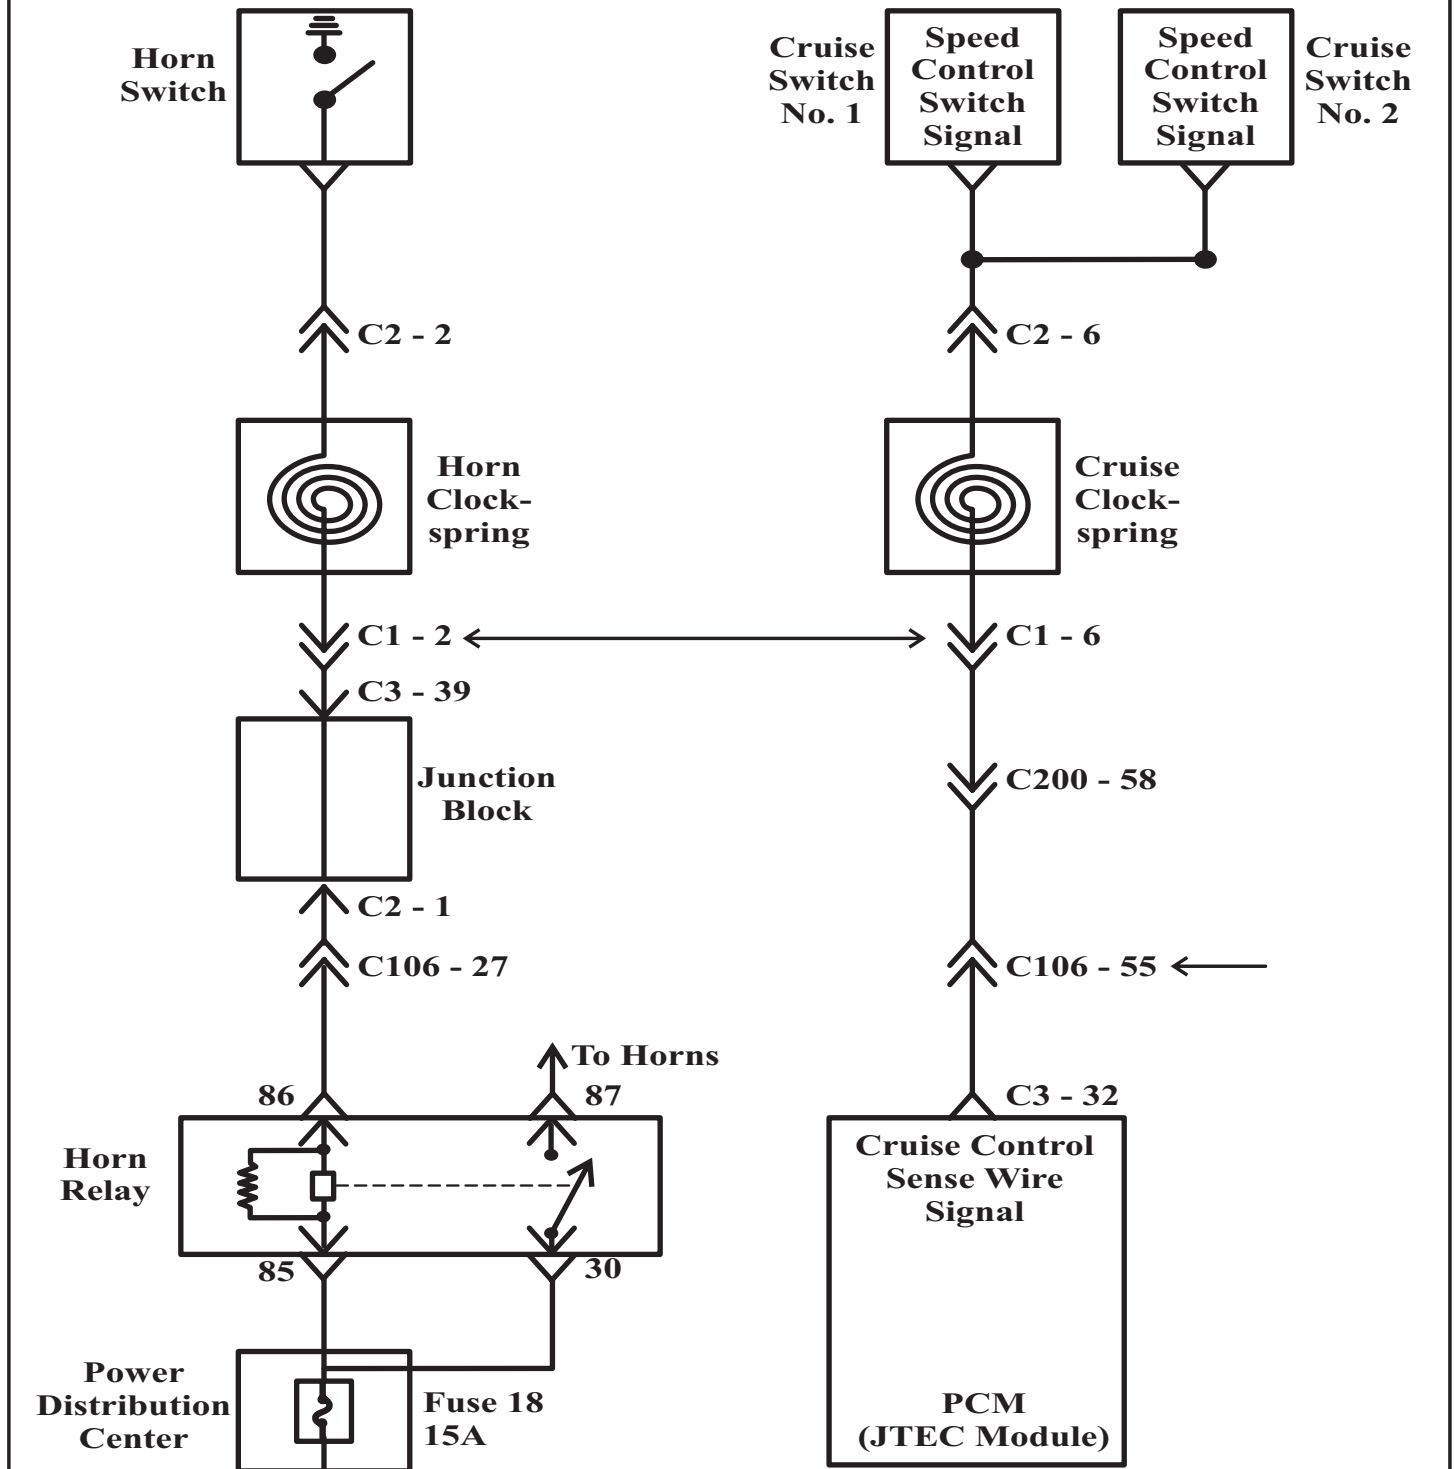
Figure 5

One common reason for this condition is the horn's 12 volt clockspring circuit shorting to the Cruise Control Switch Sense wire circuit. Since the cruise switch sense and the TPS signal share the same internal capacitor, the voltages on both are driven high yet only 5 volts are seen in the scan tool display. The reason for this is that the computer was never programmed to see more than 5 volts on these circuits.

Looking at the wiring in Figure 5, there are several connectors that could allow a short to power from the horn's circuit into the cruise control circuit (C1, C200 and C106). With the C1 connector being located under the steering column, it was the easiest to unplug and when it was, the 12 volts at the Cruise Control Switch Sense circuit disappeared and the TPS Signal voltage went back to normal on the scan tool.
