TOYOTA A140/A240/A340/A540 SERIES TRANSMISSIONS REPEATED TROUBLE CODE DTC P0770

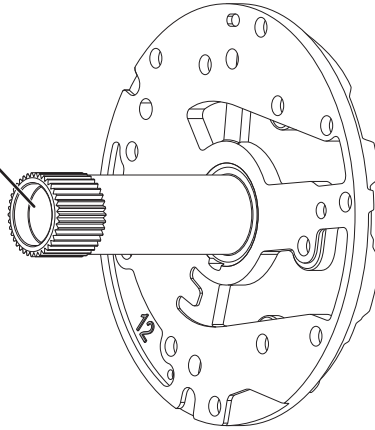
Refer to Figure 1 for diagram of front stator bushing location. Look at the partial cutaway diagram as shown in Figure 2. The diagram depicts how converter apply oil pressure passes between the bushing and turbine shaft and exhausts along with converter release pressure.

FRONT STATOR
BUSHING LOCATION

CORRECTION: Install a new front stator bushing.

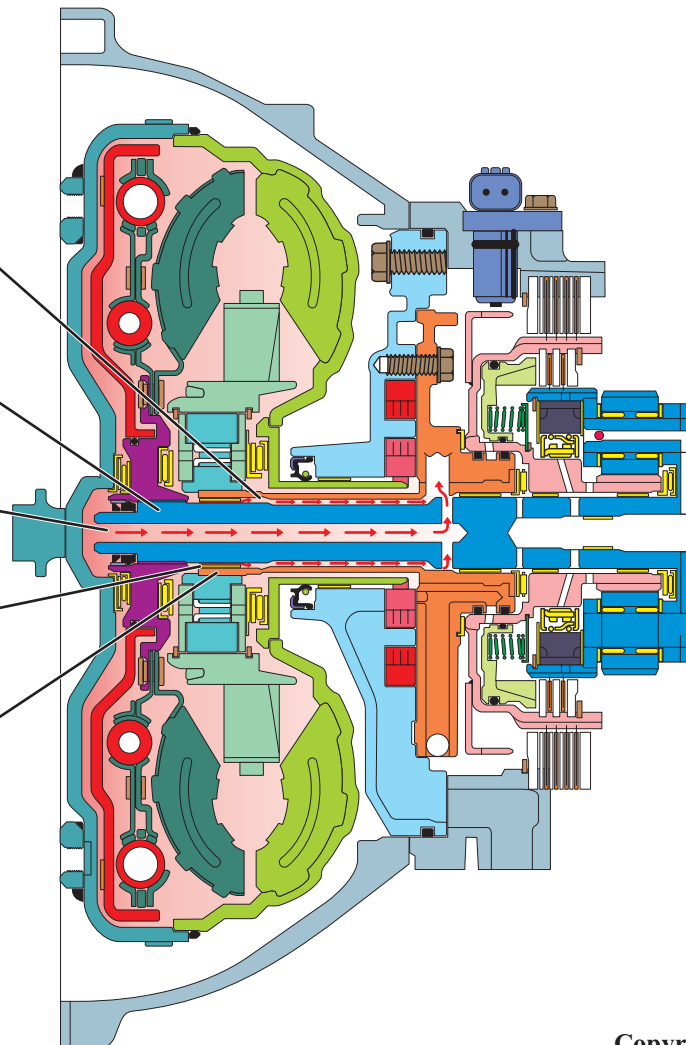
Figure 2

CAUSE: One cause may be a worn front stator bushing. The front stator bushing in the Toyota A140/A240/A340/A540 transmission separates converter apply oil pressure and converter release oil pressure. When the front stator bushing is worn and TCC is applied, torque converter apply oil pressure will be able to pass between the bushing and the turbine shaft into the converter release passage and will exhaust through the stator causing a drop in converter apply pressure such that the converter clutch may no longer have the ability to hold adequately. The PCM detects the slip and stores the DTC P0770.

CONVERTER APPLY
PRESSURE LEAKING
PAST BUSHING
