## 1996 & LATER JEEP & DODGE TRUCKS WITH RE TRANSMISSIONS AND GAS ENGINES GOVERNOR PRESSURE SENSOR VOLTAGE CODES

**COMPLAINT:** Any 1996 and later Dodge or Jeep trucks using an RE series RWD transmission behind gasoline engines may exhibit a chronic "governor pressure sensor volts to high" code P1763 causing the PCM to place the transmission into 3rd gear failsafe. This may be accompanied with a customer complaint of a loss of engine power. The internal wiring harness, solenoids and sensor may have already been replaced in an attempt to resolve the code.

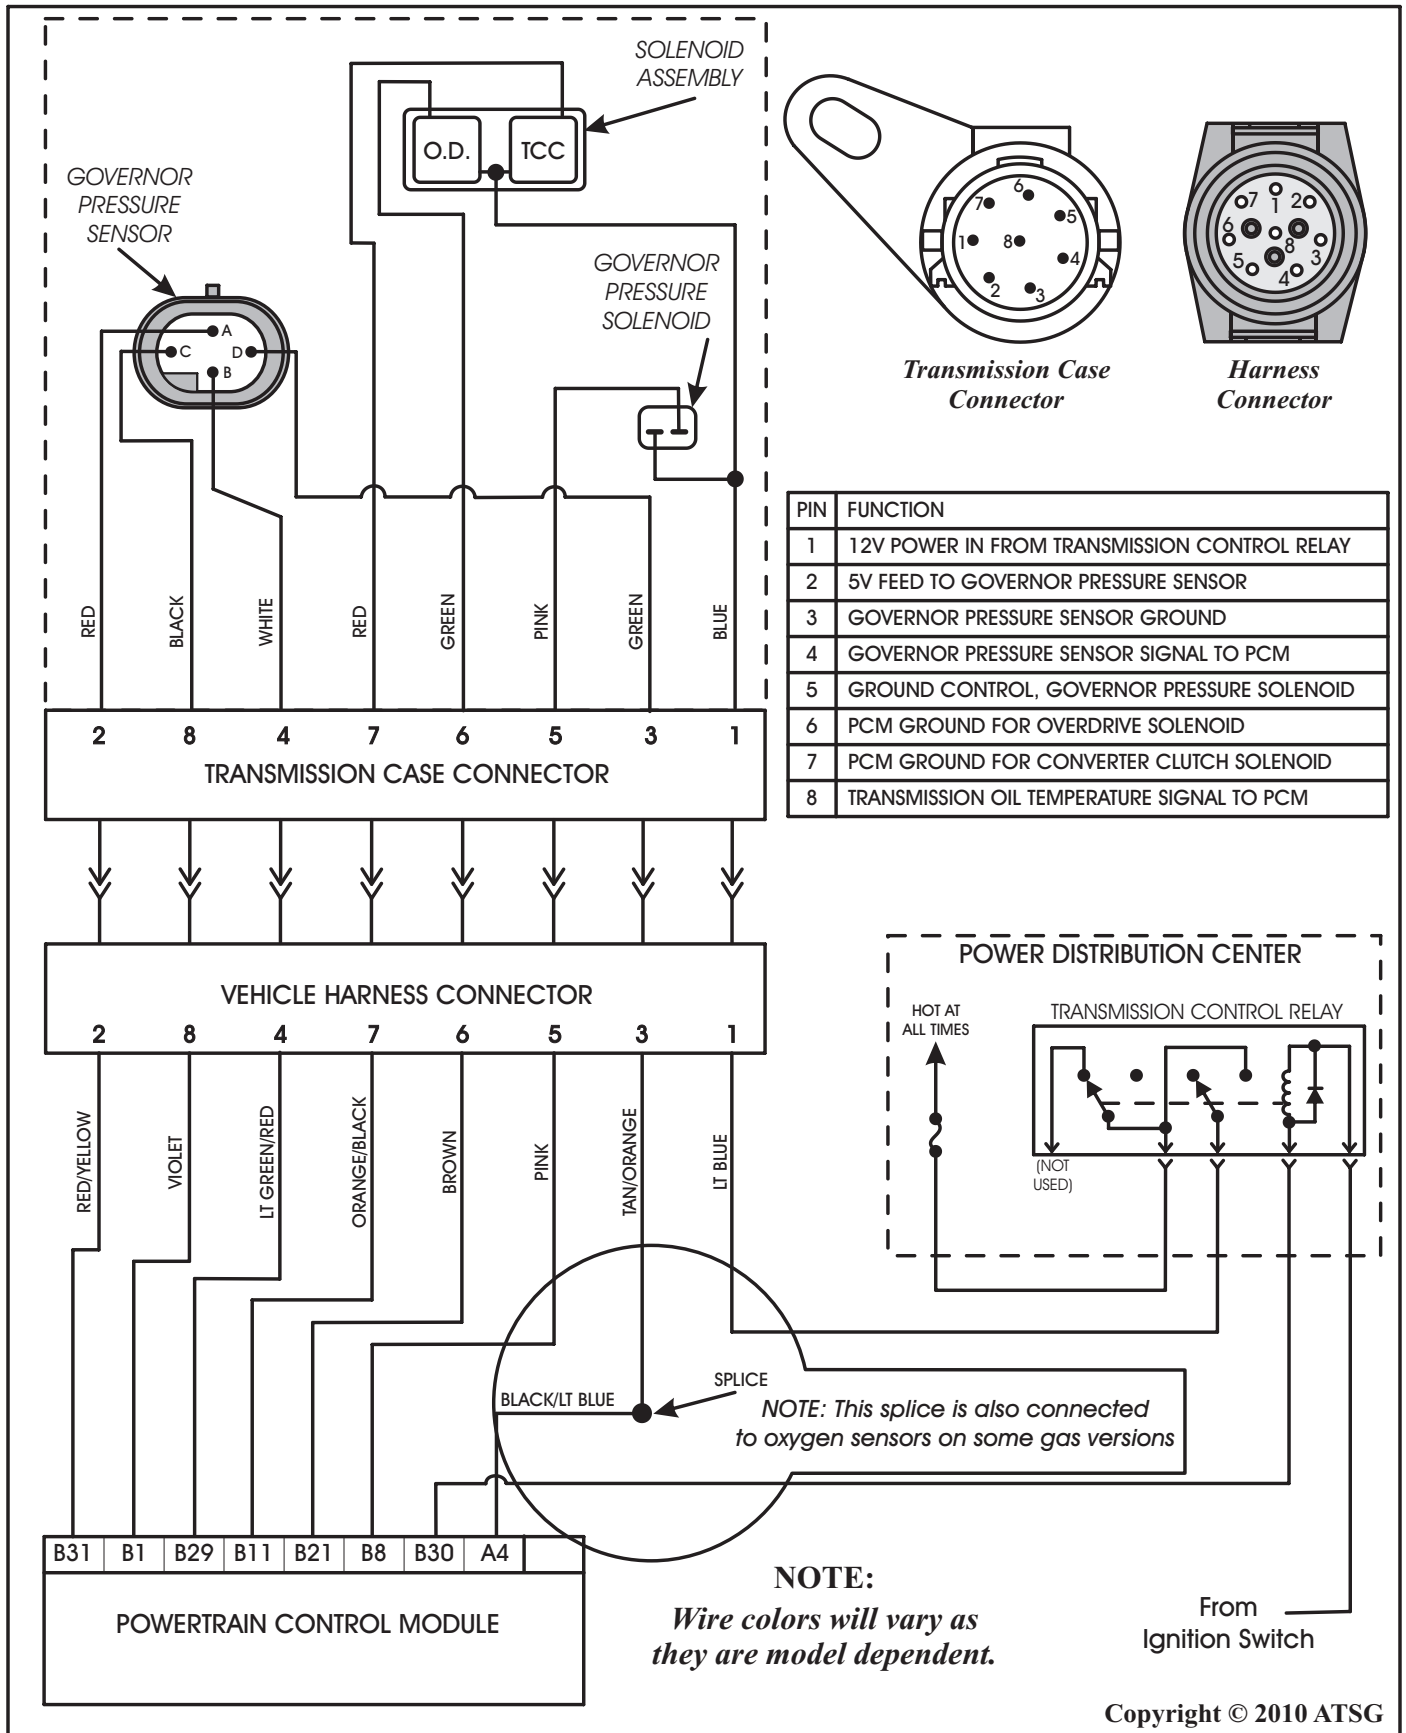
Figure 1

1. One cause could be that the ground circuit for the governor pressure sensor has been compromised (See Figures 1 and 2).
  - a. Faulty governor pressure sensor
  - b. Faulty battery temperature sensor
  - c. Faulty heated oxygen sensor(s)
  - d. Faulty wiring, splices, other shared sensors or the PCM
2. Another cause could be that line pressure is running above factory specification. This could be the result of a valve body modification or a valve body malfunction, or the solenoid block is warped and leaking which allows solenoid oil to push on the tip of the transducer.
3. A malfunctioning alternator producing voltage spikes or high charging voltage would be another consideration.

1. Since the governor pressure sensor ground circuit is shared with a variety of other sensors including the battery temperature sensor and the heated oxygen sensor, other codes may be present with P1763 such as a P1492 "Battery Temperature Sensor Volts To High." A P1762 Governor Sensor Offset volts or drift too low or too high, or a P1757 Governor pressure above 3 psi at 0 MPH may also be present. But of all the above possibilities listed in cause number 1, malfunctioning heated oxygen sensors are the most common cause for compromising the shared ground path for the governor pressure sensor. A quick check can be made by simply clearing the code and unplug both the upstream and downstream sensors and take the truck for a road test. If the code does not return then run the vehicle with the sensors plugged in one at a time to determine which oxygen sensor is causing the code and replace the sensor. If this quick test proves that the heated oxygen sensors are not the cause of any governor pressure sensor codes, a specific wiring schematic for the vehicle being worked on will need to be acquired and each and every sensor sharing the governor sensor's ground path will need to be inspected.

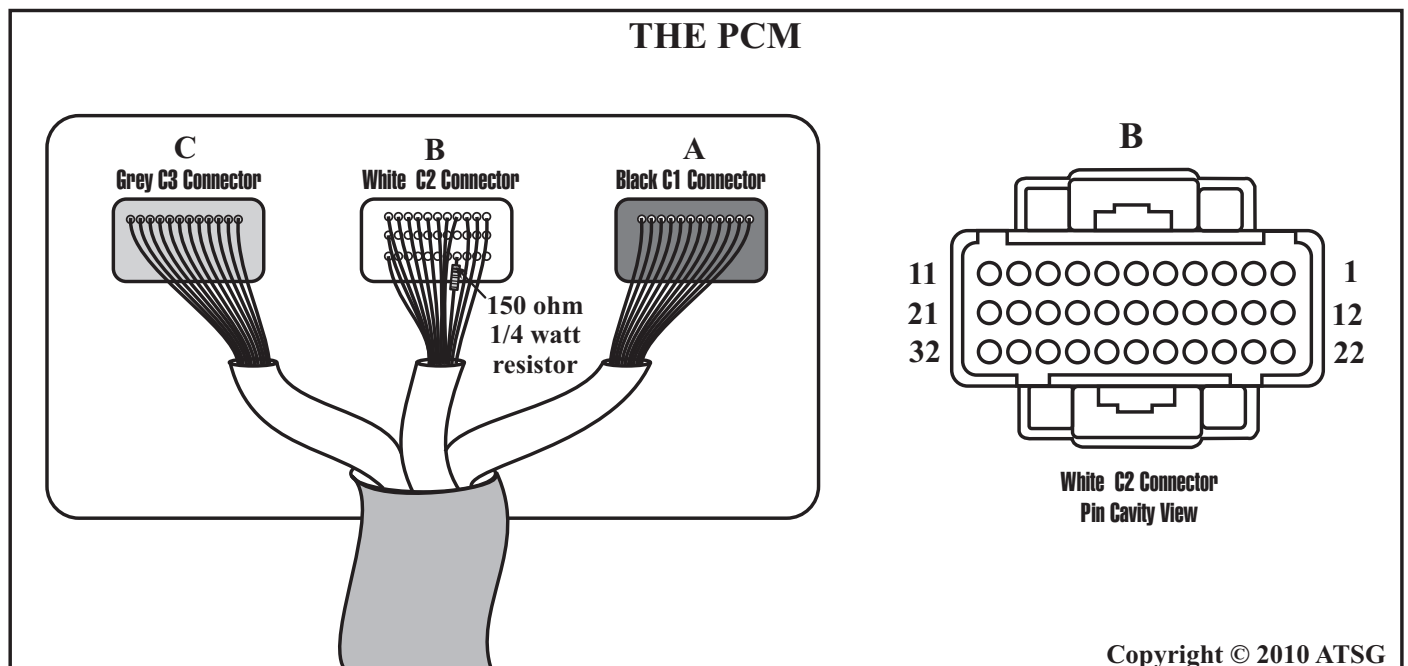
Figure 3

Sometimes you may find that a 150 ohm 1/4 watt resistor has been installed into the wiring harness near PCM "B-C2" white connector terminal 29 as seen in figure 3. This resistor acts as a voltage divider and has proven to work well.

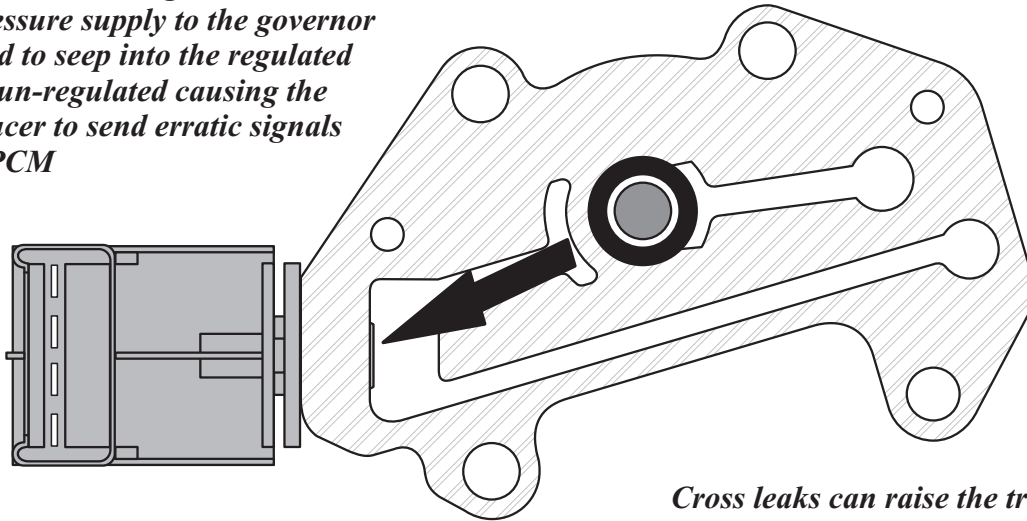
Figure 4

If the solenoid block is suspected to be warped, (Refer to Figure 4), verify the voltage on the transducer signal wire is higher at a stop in drive than it should be which is 0.6 volts. Plug a known good set of internal electrical components into the vehicle wire harness connector and now see if the transducer signal voltage is 0.6, if it is, the solenoid block is leaking.

### WARPED SOLENOID BLOCK

*A distorted mounting block will allow line pressure supply to the governor solenoid to seep into the regulated circuit un-regulated causing the transducer to send erratic signals to the PCM*

*Cross leaks can raise the transducer's signal voltage causing governor offset pressure and wrong gear starts.*

**CORRECTION:** One fix can be to use Superior's A K500-618-L shift correction package which includes a new governor pressure control valve. This valve allows operating pressure to be raised for heavy-duty use without fear of setting code 1763.
