Technical Service Information

MERCEDES BENZ 722.6 BOGS DOWN IN THIRD GEAR

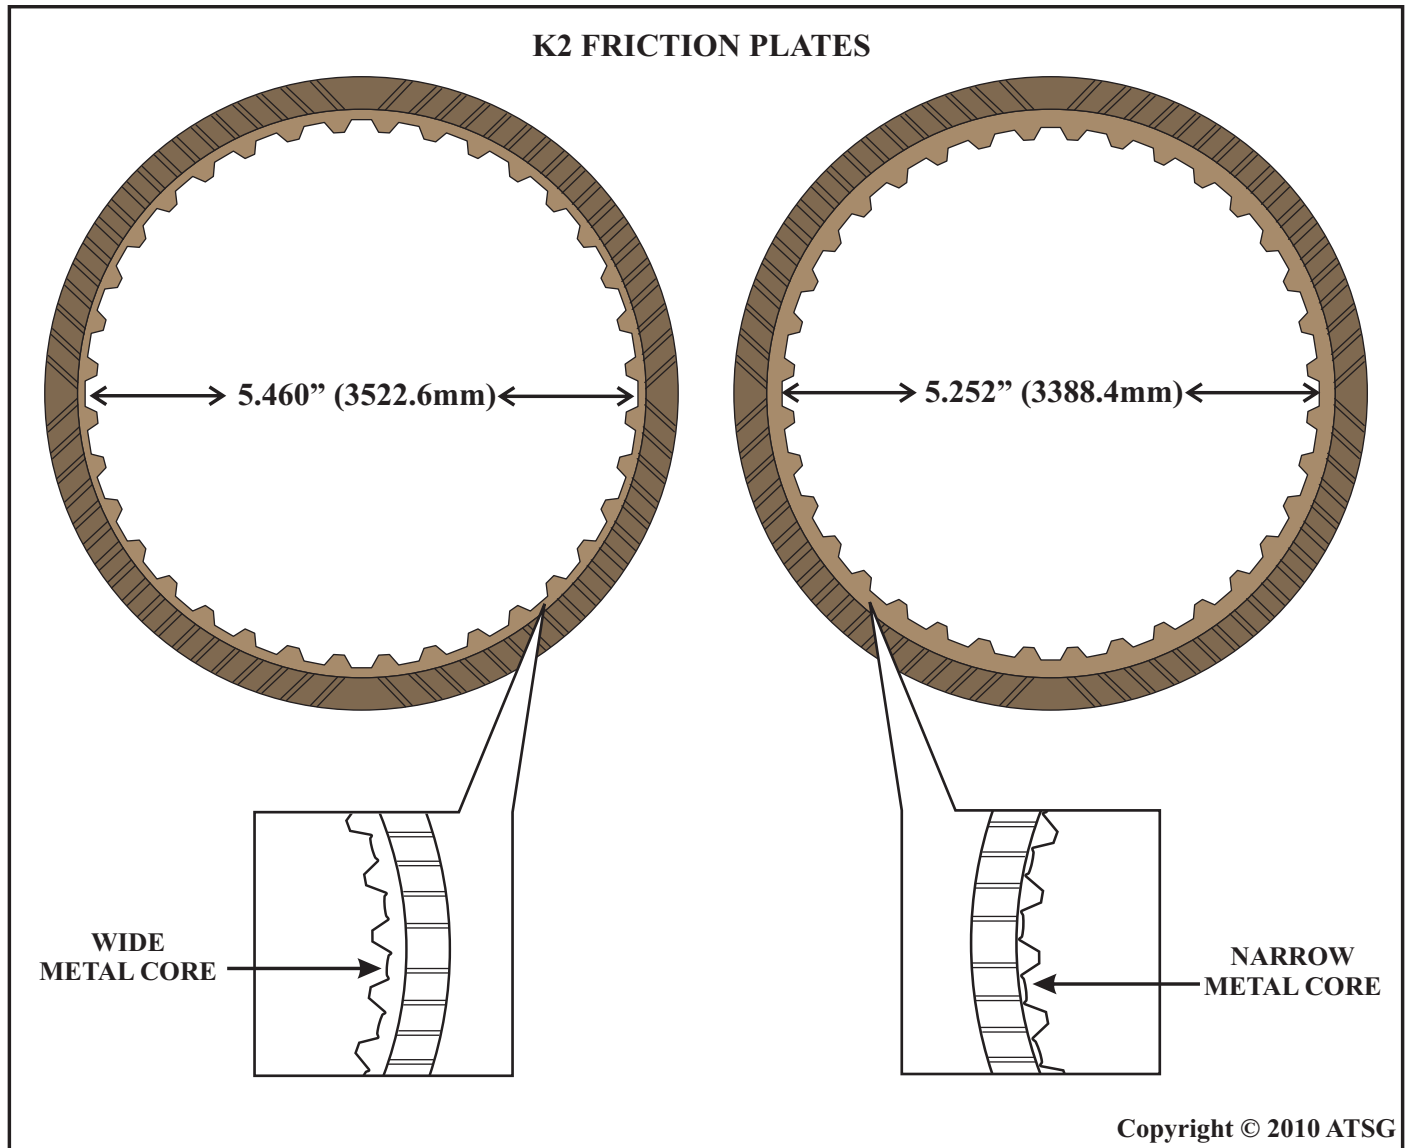
Figure 1

CAUSE: There are two different inside diameters for the K2 friction plates, (See Figure 1), the outside diameter and tooth configuration are the same for both and they both have 36 internal teeth. There are two different diameters for the rear carrier hubs to accommodate the difference in the K2 friction plates, (Refer to Figure 2), these differences are dependant on engine size.

CORRECTION: The smaller diameter carrier is easily identified because it is a three pinion design, the larger diameter carrier is a four pinion design.
Insure that there is a proper fit between the K2 friction plate teeth and the splines of the carrier hub.

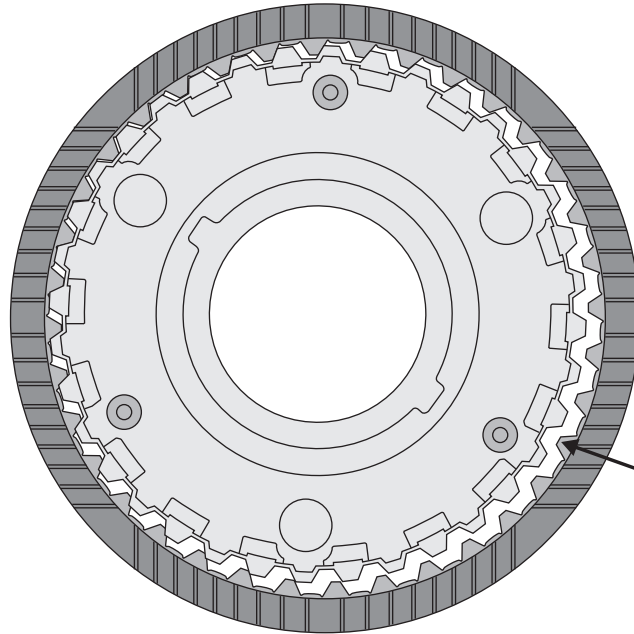
INCORRECT

When the transmission was removed and disassembled, the technician finds the that the K2 friction plates have cut through the aluminum the rear carrier hub.

When the larger inside diameter frictions are installed on the smaller diameter carrier, the teeth of the K2 friction plates will spin around on the aluminum carrier hub and cut in to it. Figure 3 illustrates the correct and incorrect tooth to spline fit of the K2 friction plates to the carrier hub splines.

FRICITION PLATES
TEETH DO NOT FIT
SPLINES ON CARRIER

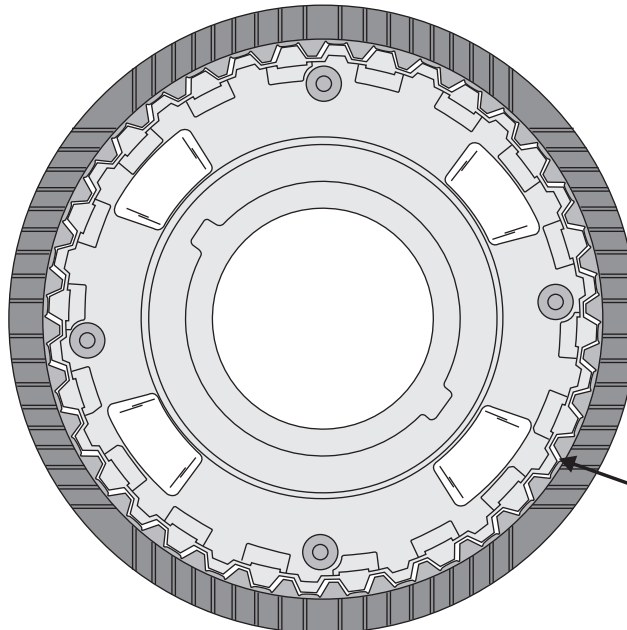
CORRECT

FRICITION PLATES
TEETH FIT SPLINES
ON CARRIER
