## NISSAN/INFINITI RE4F04B NO UP-SHIFT DTC P0720 MAY BE STORED

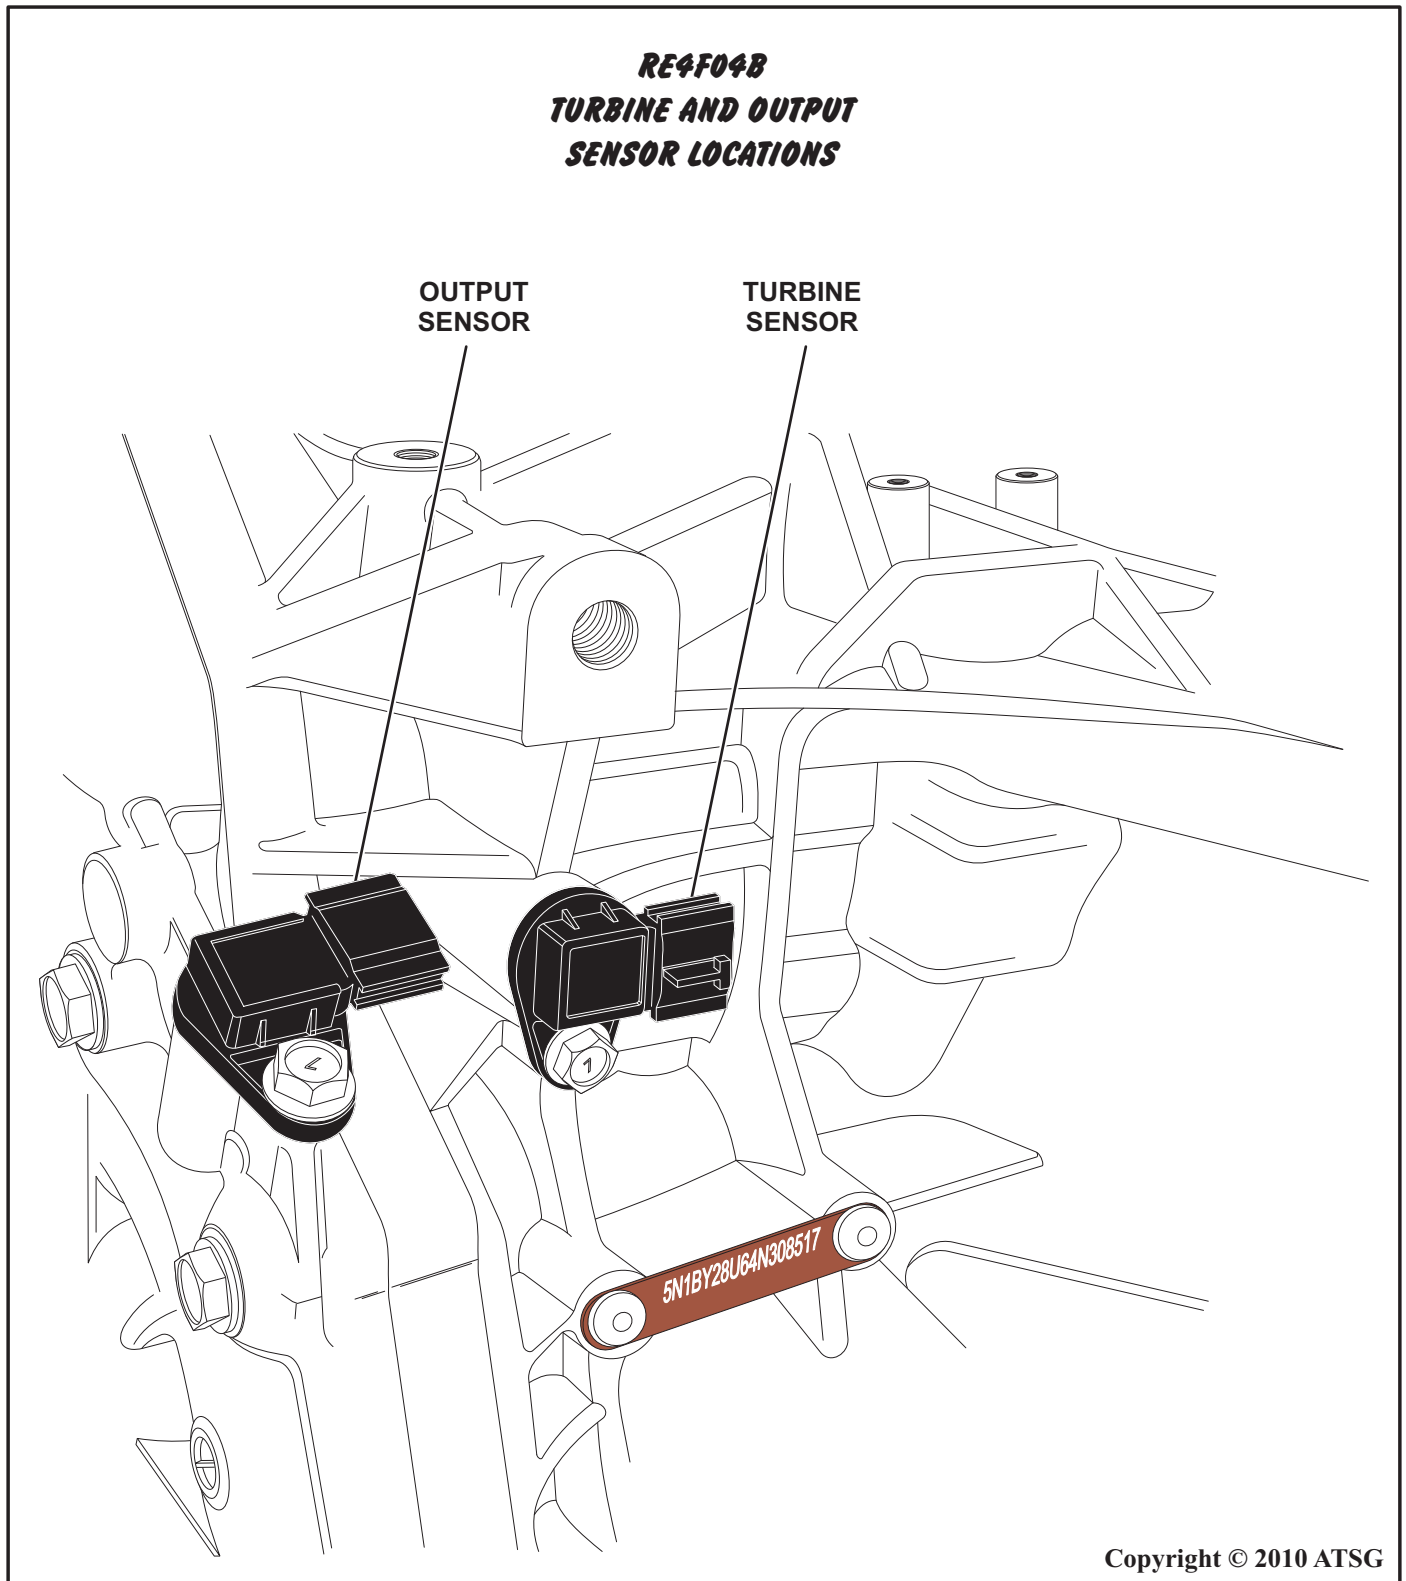
**CAUSE:** One cause may be the connectors for the output sensor and turbine sensor cross-connected. Some late model Nissan/Infiniti models with the RE4F04B transmission utilize a turbine sensor as well as an output sensor. The turbine sensor and the output sensor are both Hall Effect type sensors and are located on the back of the transmission near the driver side axle. Refer to Figure 1 for output and turbine sensor locations.

If the output sensor connector is incorrectly plugged into the turbine sensor, the Transmission Computer (TCM) will not detect any output rpm when taking off, thereby causing DTC P0720 to be stored with a no up-shift condition.

**CORRECTION:** When installing the transmission make certain to connect the sensors correctly. Refer to the wiring diagrams provided in Figure 3 for wire color reference.

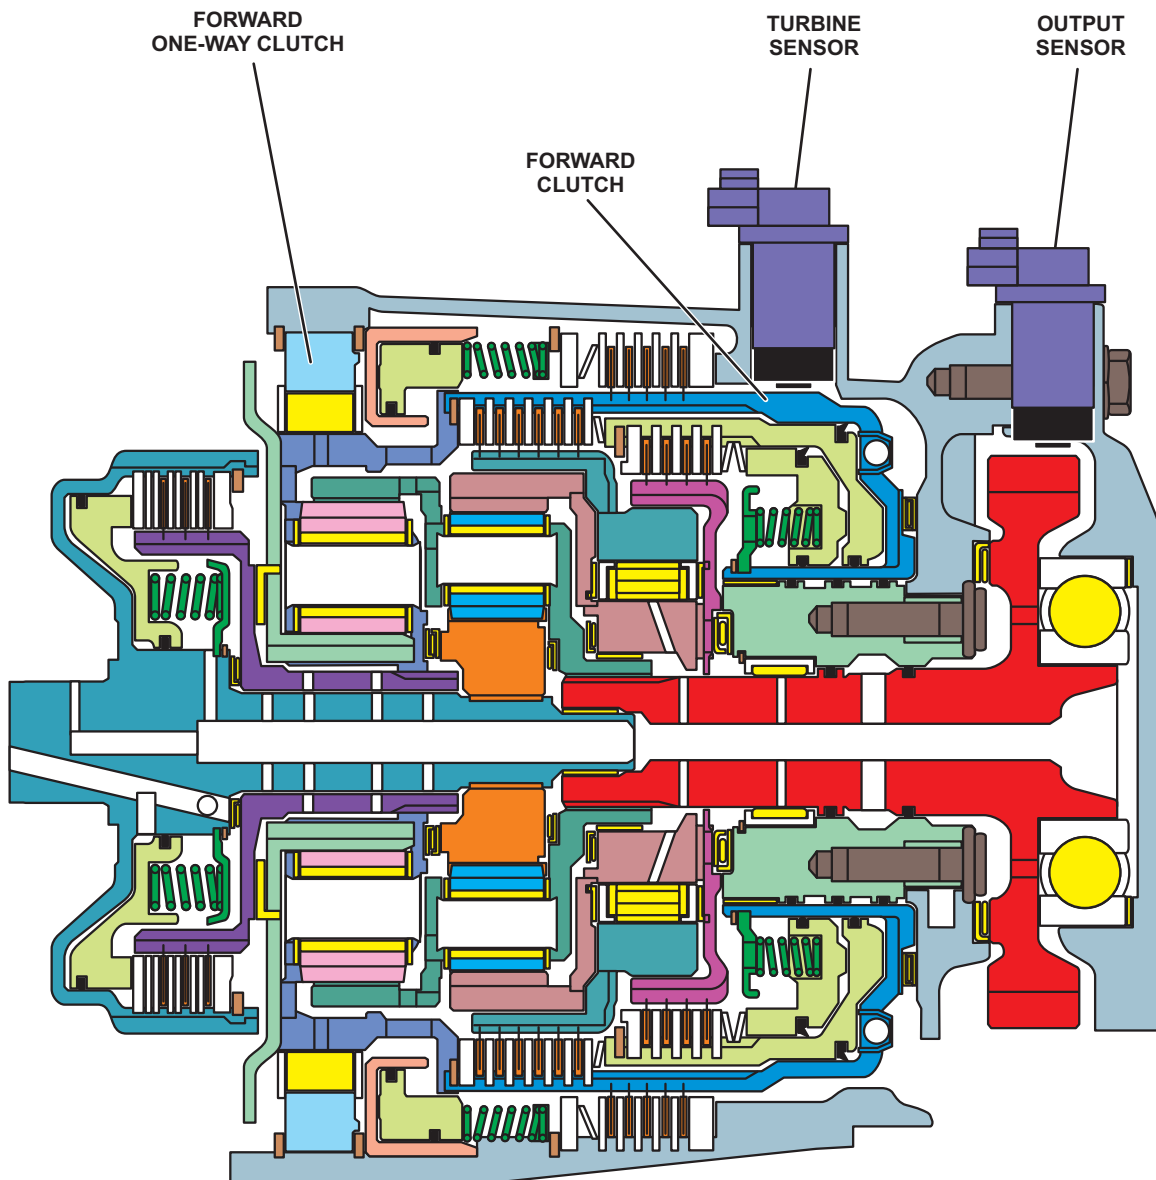
Figure 2

The reason the TCM detects no output rpm is because there is no turbine sensor reading when the transmission is in 1st gear. Refer to the partial cut-away view of the RE4F04B in Figure 2. The output sensor obtains its reading from the output gear while the turbine sensor obtains its reading from the forward clutch drum. In first gear the forward clutch drum is held stationary by the action of the low one-way clutch.
