## BMW/JAGUAR ZF5HP24 REPEAT “A” CLUTCH DRUM FAILURE

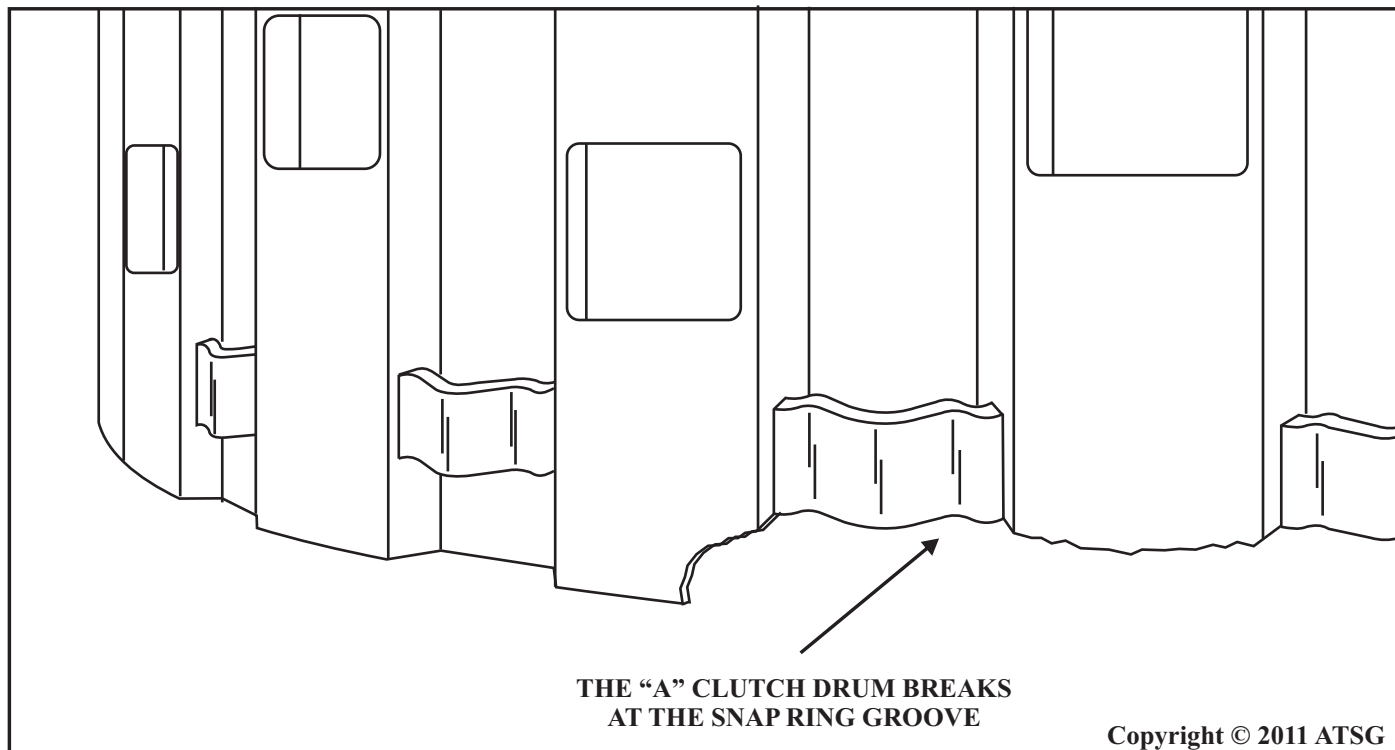
Figure 1

Upon disassembly of the transmission the “A” Clutch drum is found to be broken at the clutch pack retaining snap ring (Refer to Figure 1) and the snap ring has come out of the drum.

**CAUSE:** The drum is breaking in the snap ring area due to *un-commanded* pressure spikes. There is an updated pressure regulator valve (See Figure 2) which could help the situation as long as the valve bore is not worn. The pressure spikes can still occur and are caused by wear in the pressure regulator valve bore in the lower front valve body, Refer to Figure 3.

**CORRECTION:** Using the part numbers found under Service Information, replace the pressure regulator valve and the lower front valve body.
