98 & UP DODGE TRUCK 46RE FAMILY INTERMITTENT NO UP-SHIFT AND SPEEDO PROBLEMS

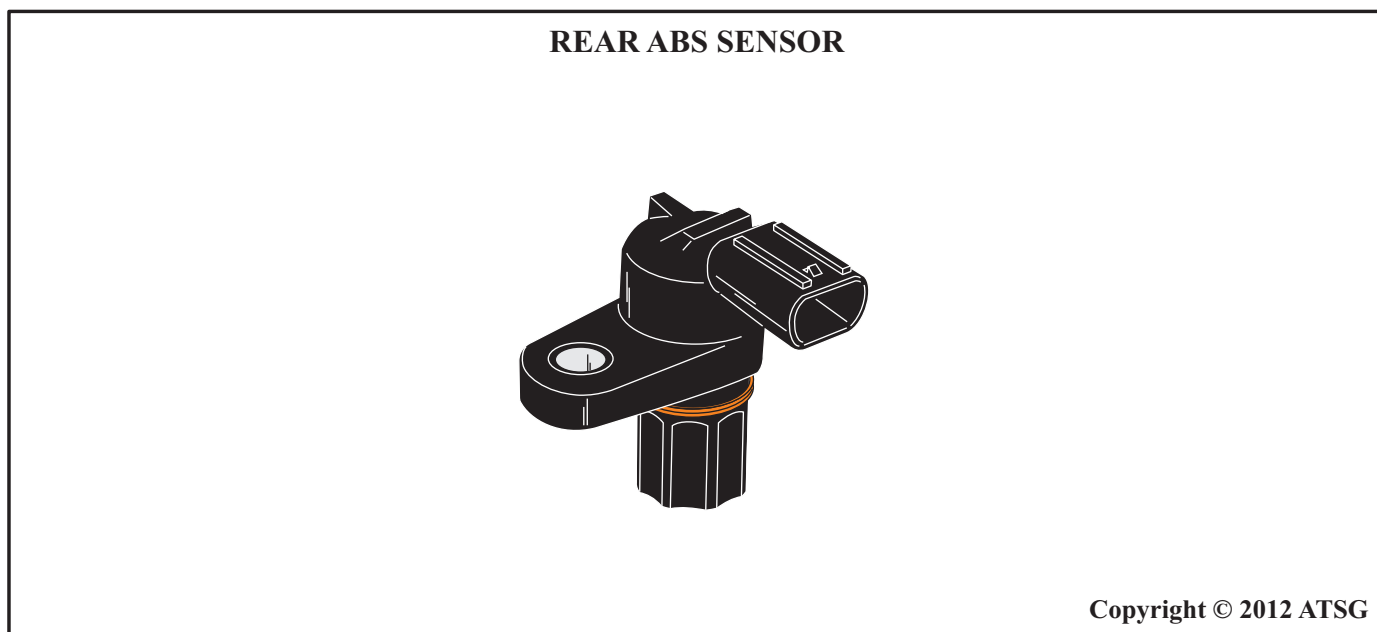
Figure 1

CAUSE: The cause may be, a faulty Rear ABS sensor located on the differential housing, not producing any speedometer input to the PCM/Speedometer. To Verify, monitor Vehicle Speed, Output speed and Desired Governor pressure input on the scan tool. Notice, that when there is no speedometer operation, there will be a desired Governor pressure reading of "0" even when the vehicle is moving at 20-30 mph. **Note:** Desired Governor pressure (what the PCM wants to see on the Governor Pressure Sensor-"Actual Governor psi") is based on the Output Speed Sensor reading compared to the Vehicle Speed Sensor. If either the OSS or VSS malfunction the PCM may choose the one that is **not** operating to base the Desired Governor pressure on, which in turn can cause a "0" Desired Governor Pressure reading and a no up-shift condition.

CORRECTION: To correct this condition, replace the Rear ABS sensor, shown in Figure 1, which is located in the differential housing shown in Figure 2.

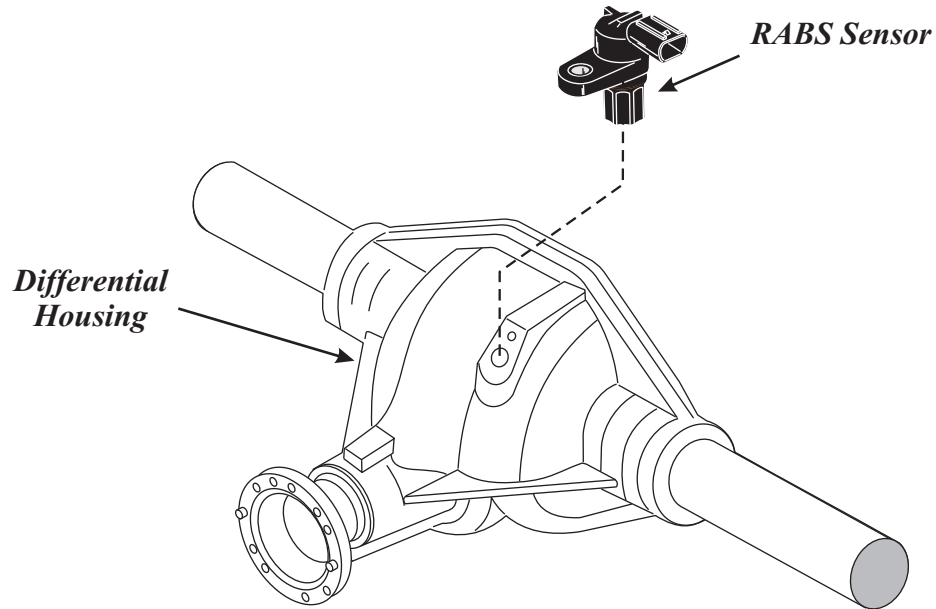
Figure 2

REAR ABS SENSOR LOCATION ON REAR DIFFERENTIAL
