45RFE/545RFE/68RFE

DELAYED ENGAGEMENTS AFTER COOLER FILTER REPLACEMENT

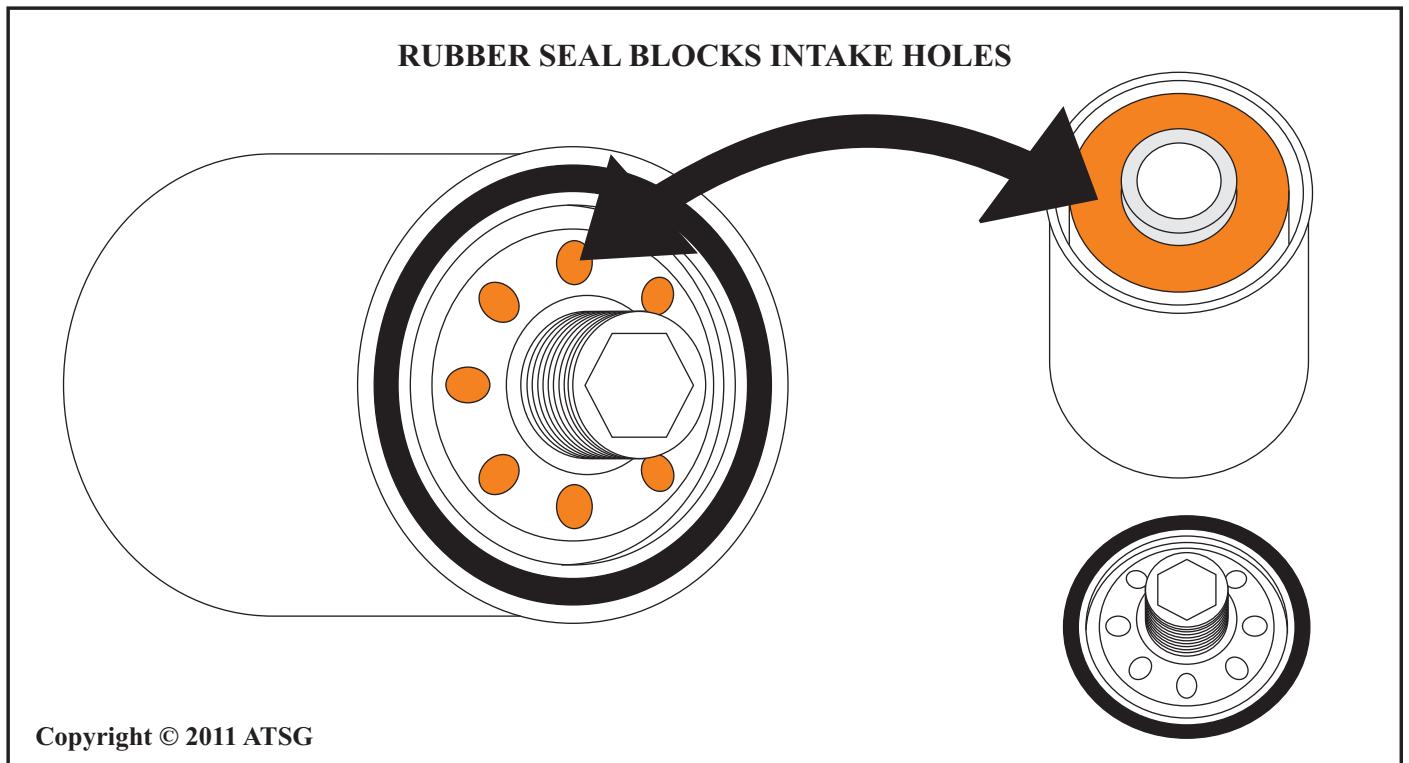
Figure 1

CAUSE: A cooler filter that restricts flow may have been installed, Figure 1.

NOTE: *Never use an O.E. cooler filter that has a part number of 04799662AB.*
