## **HONDA/ACURA MGHA FAMILY COUNTER SHAFT SPEED SENSOR BREAKAGE**

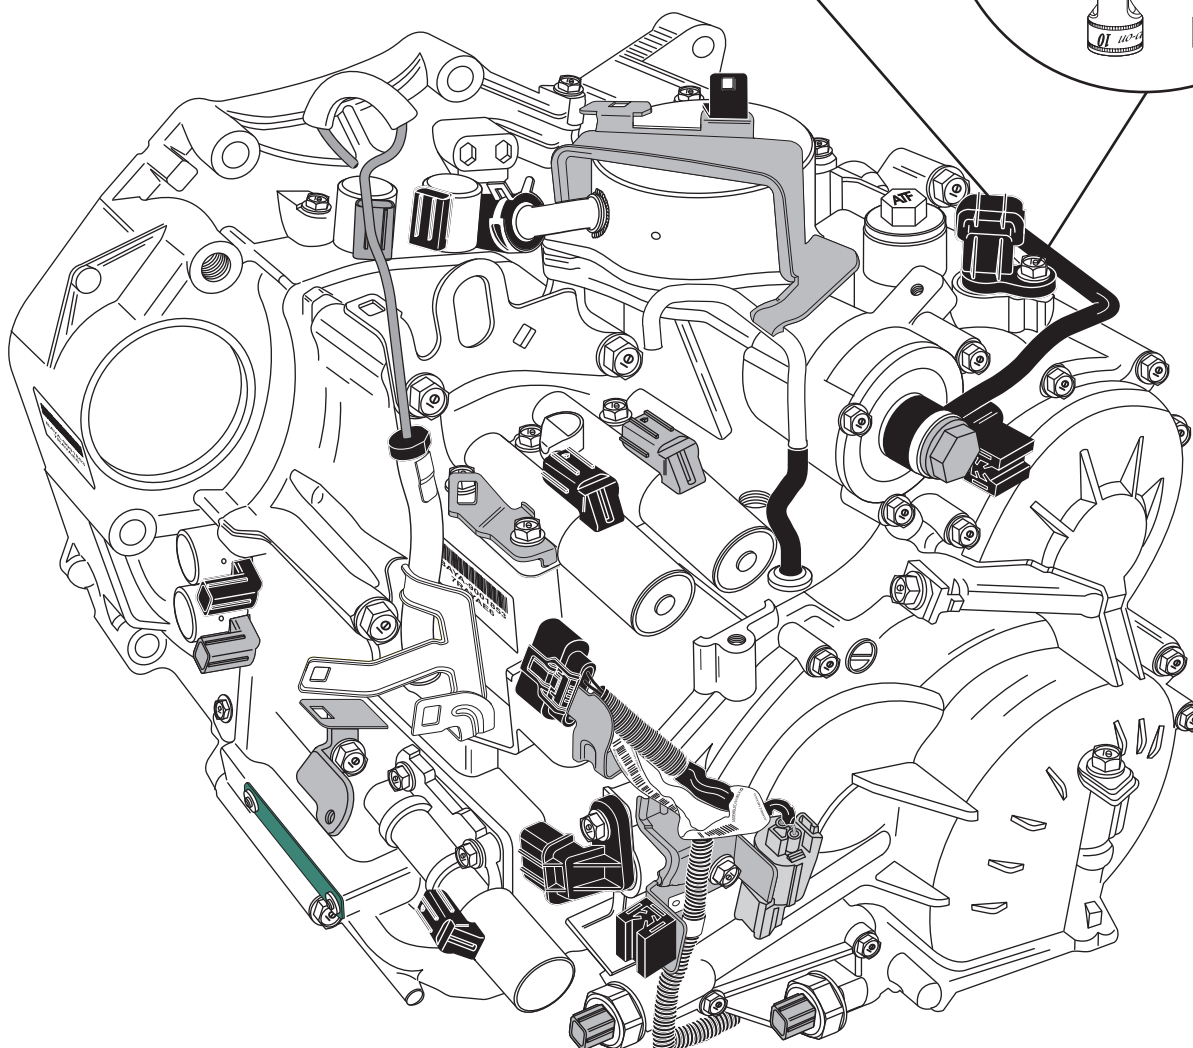
**CAUSE:** The cracked or broken Output Shaft (Counter Shaft) Speed Sensor is normally damaged during removal of the transmission from the vehicle for repair. The reason this occurs is because there is very little clearance between the body of the speed sensor and the speed sensor retaining bolt. The lack of clearance makes it very easy and likely to break the speed sensor by making contact with the body of the sensor with the extension and or socket used to remove the sensor retaining bolt.

*Output Shaft (Counter Shaft)  
Speed Sensor*

**CORRECTION:** It has been found that using a Snap-On® shallow 3/8 inch drive Flank Drive® universal socket allows enough clearance for safe removal from the transmission. The universal swivel base allows the technician enough clearance to keep from cracking/breaking the sensor and also provides enough leverage to allow for easy loosening of the retaining bolt. Refer to the diagram in Figure 1 for the location of the Output Shaft (Counter Shaft) Speed Sensor.

Use the universal swivel  
socket to safely and effectively  
remove the speed sensor  
retaining bolt
