## DODGE/CHRYSLER 62TE MULTIPLE GEAR RATIO ERRORS AFTER OVERHAUL

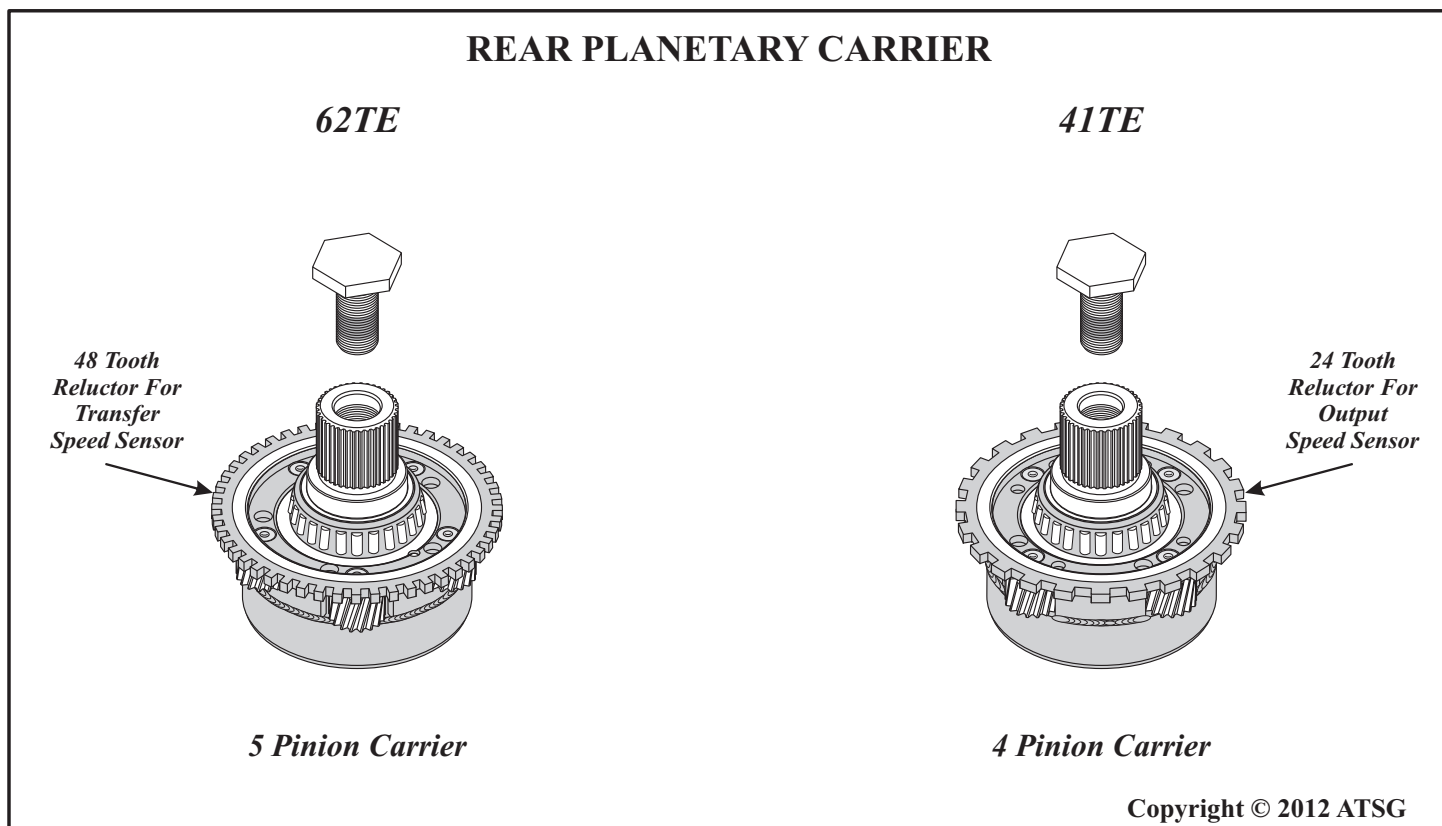
**CAUSE:** The cause may be, that during transmission overhaul, the planetary geartrain had to be replaced, and during that process, a 41TE rear planetary carrier was used by mistake. See Figure 1 and notice that there is a tooth count difference between the two carriers in the area of the park gear/reluctor. The 41TE uses the teeth for park as well as a reluctor for the Output Speed Sensor. The 62TE uses the teeth only for a reluctor the Transfer Speed Sensor. Another possibility, that creates the same trouble codes, is that during transmission re-installation, the Transfer Speed Sensor connector and the Output Speed Sensor were swapped, as they are the same type connector and they are right next to each other as shown in Figure 2.

**CORRECTION:** To correct this condition, ensure that the correct planetary carrier is used, and if that is right, refer to Figure 2 and verify that the Transfer Speed Sensor and Output Shaft Speed sensors are properly connected. Figure 2 provides common wire colors for the two sensors, although the wire colors may vary with different models.

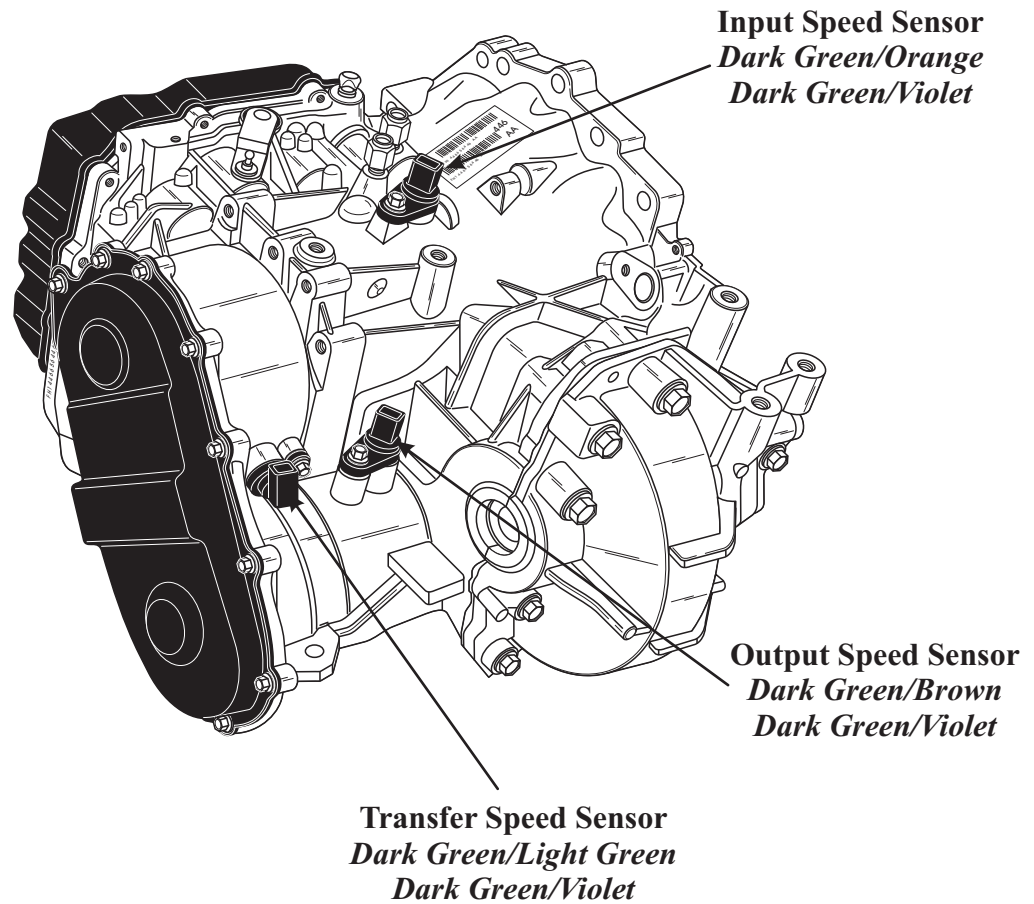
Figure 2

## 62TE SPEED SENSOR LOCATIONS
