Technical Service Information

CHRYSLER/DODGE 62TE

1-2 OR 2-3 NEUTRAL

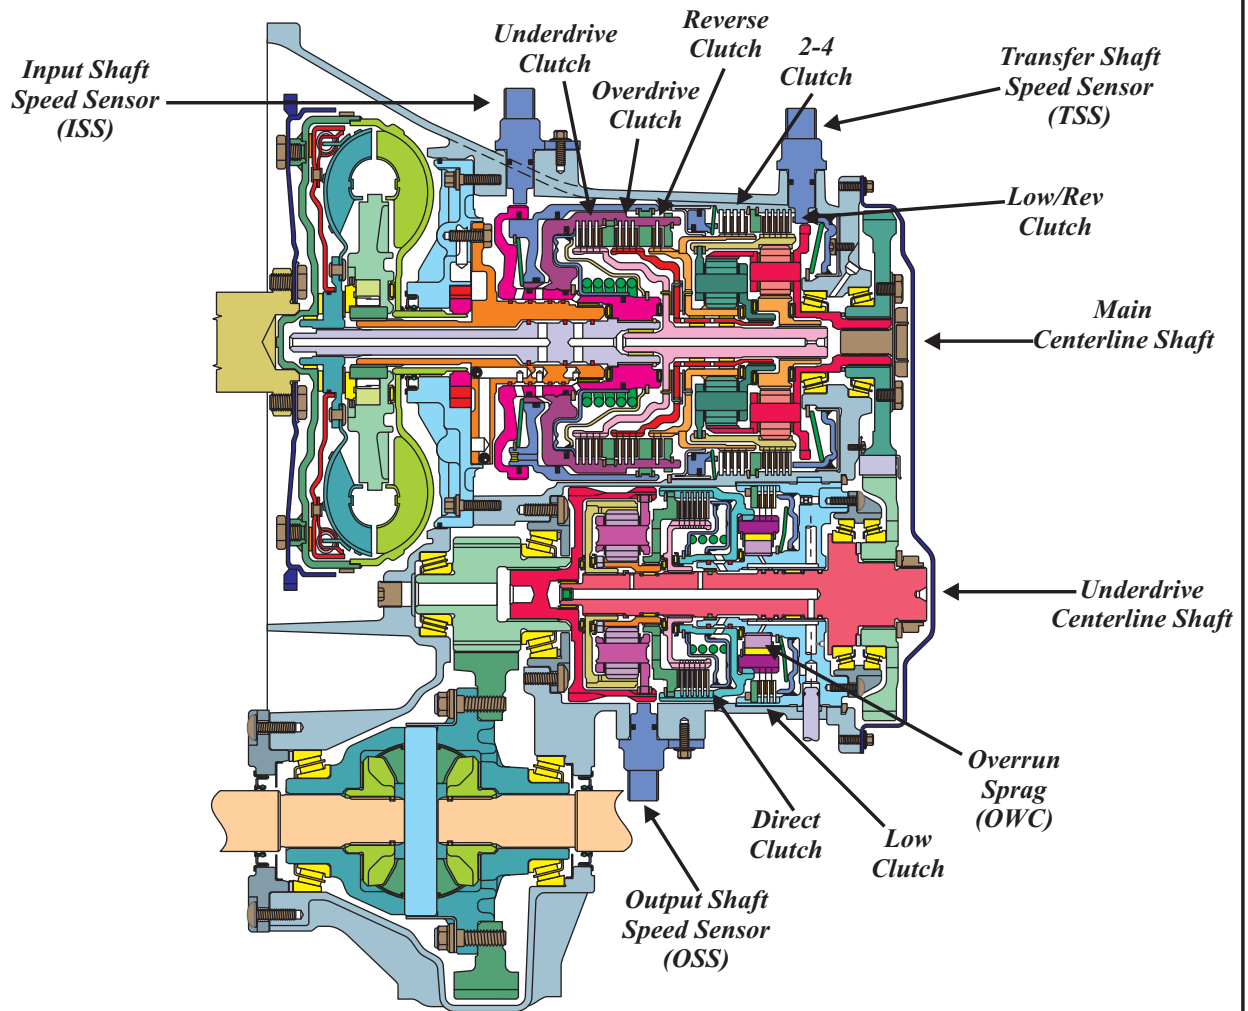
Figure 1

1. For a Neutral on a 1-2 upshift, worn sealing ring lands on the Low Clutch housing causing a severe pressure loss to the Direct Clutch. Refer to Figures 1 and 2 for a component and solenoid application chart and note that during the 1-2 upshift, the Direct Clutch comes on and causes the pinion shaft to turn 1:1. See Figure 3 for a location of the Direct Clutch sealing rings and Piston.
2. For a Neutral on a 2-3 upshift, during the overhaul process, the feed pipe for the 2-4 clutch was put in backwards causing a severe leak in the 2-4 Clutch. Refer to Figures 1 and 2 for a component and solenoid application chart and note that during the 2-3 upshift the 2-4 Clutch is applied, a severe leak will cause a neutral on the 2-3 and a neutral when in limp mode as well. See Figure 4 for a location of the 2-4 feed pipe.
