G.M. 4L60/65/70E P0894 TCC SLIP

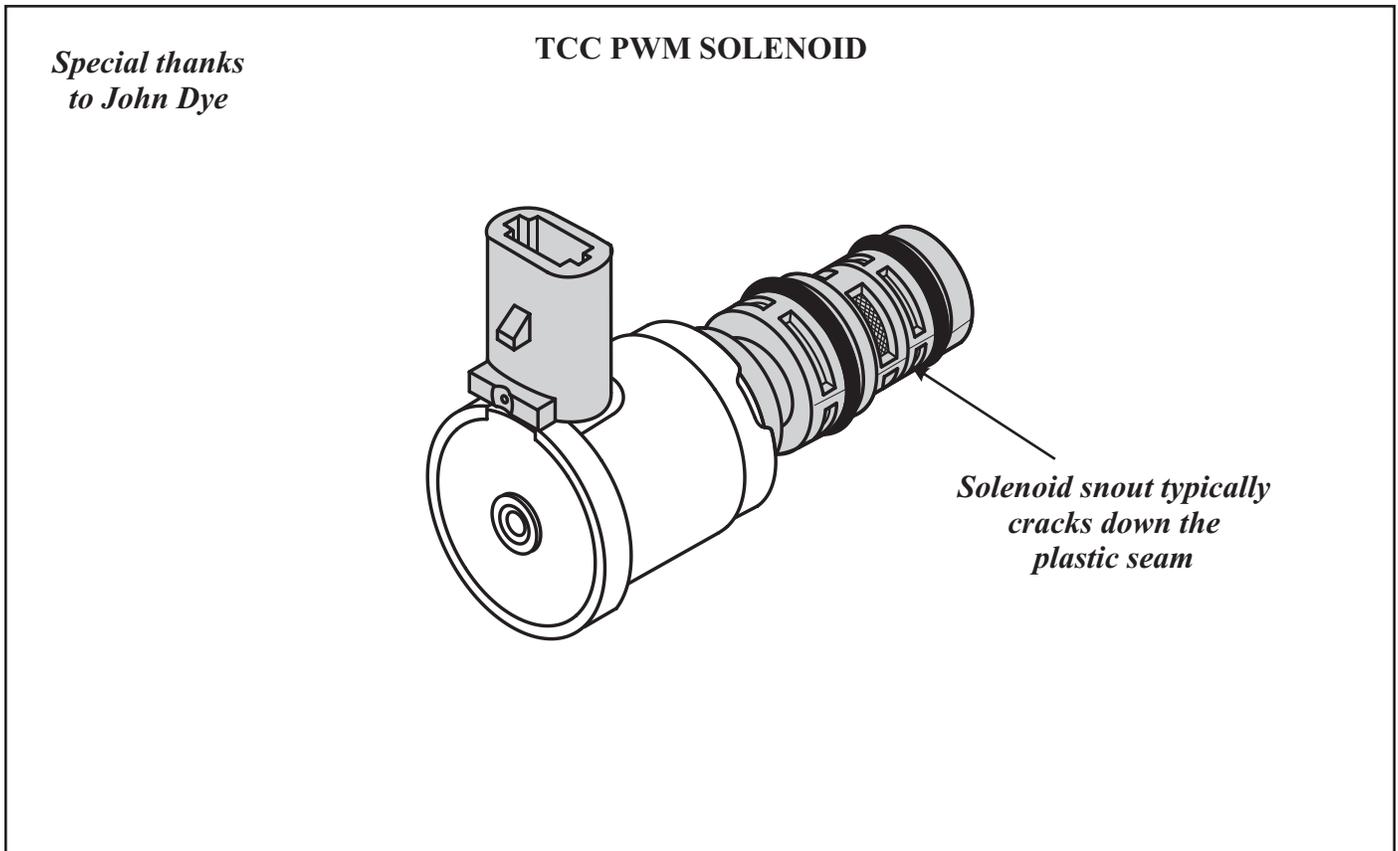
Figure 1

CAUSE: The cause may be, that during the rebuild process, the TCC PWM solenoid was not replaced, as the symptom mimicked that of a worn out TCC regulator bore, as shown in Figure 2. A closer inspection of the solenoid snout, as shown in Figure 1, shows that a hairline crack caused a loss of solenoid pressure acting on the TCC regulator valve causing the Torque

CORRECTION: Replace the TCC PWM solenoid.

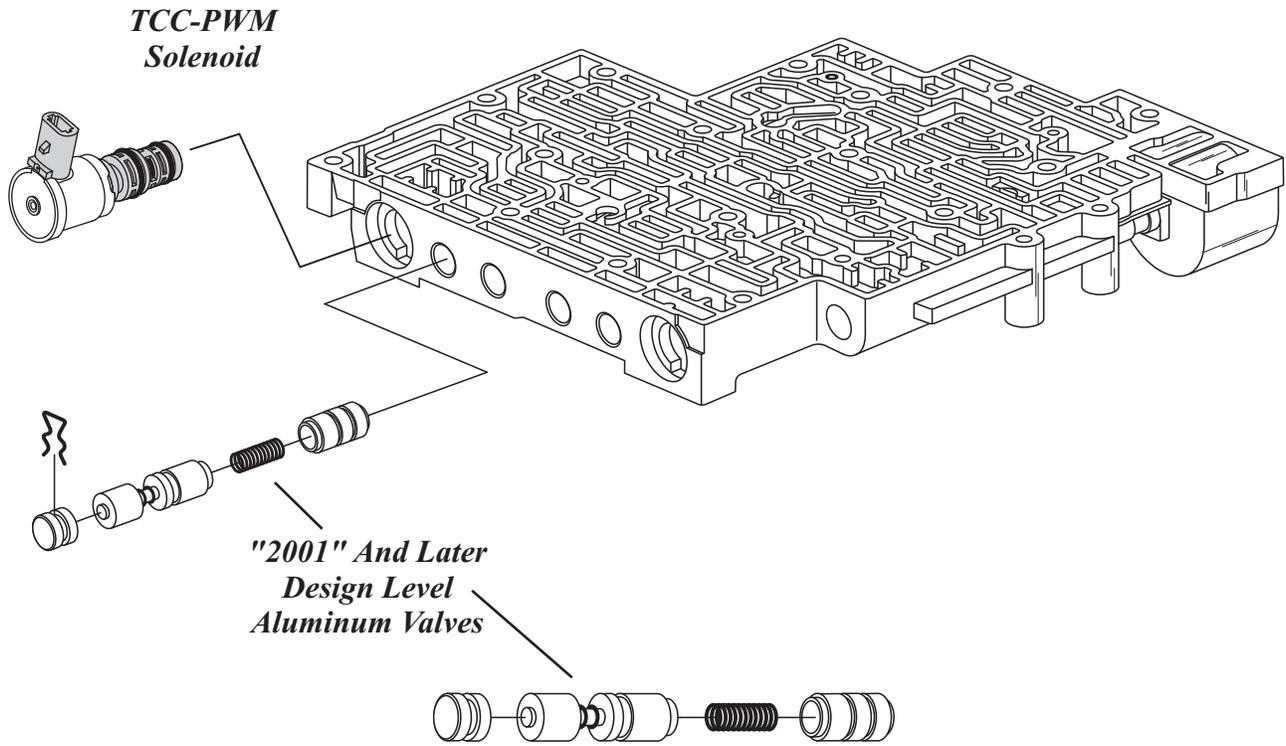
Figure 2

CONVERTER CLUTCH REGULATOR VALVE LINE-UP
