AUDI/PORCHE/SAAB/VOLVO/VW

AISIN 09G, 09D, TF80, AW 55-50SN WITH VARIOUS SHIFT COMPLAINTS

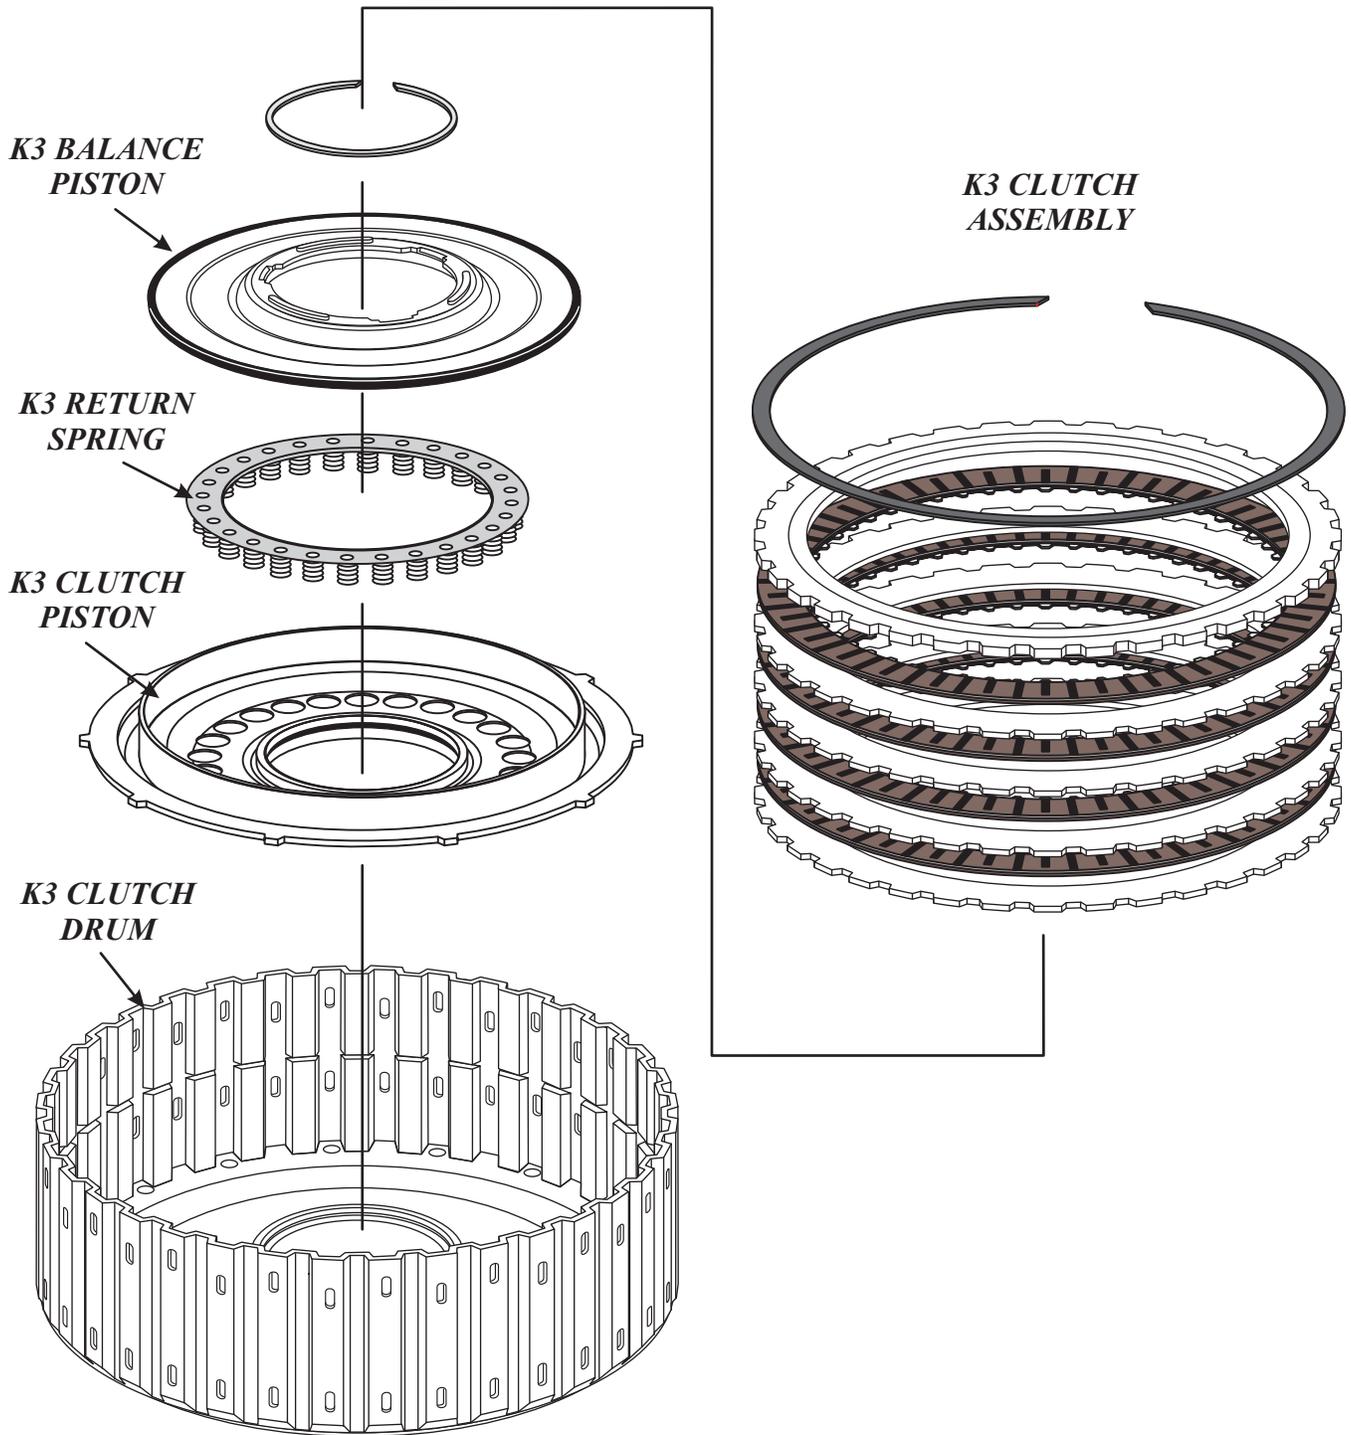
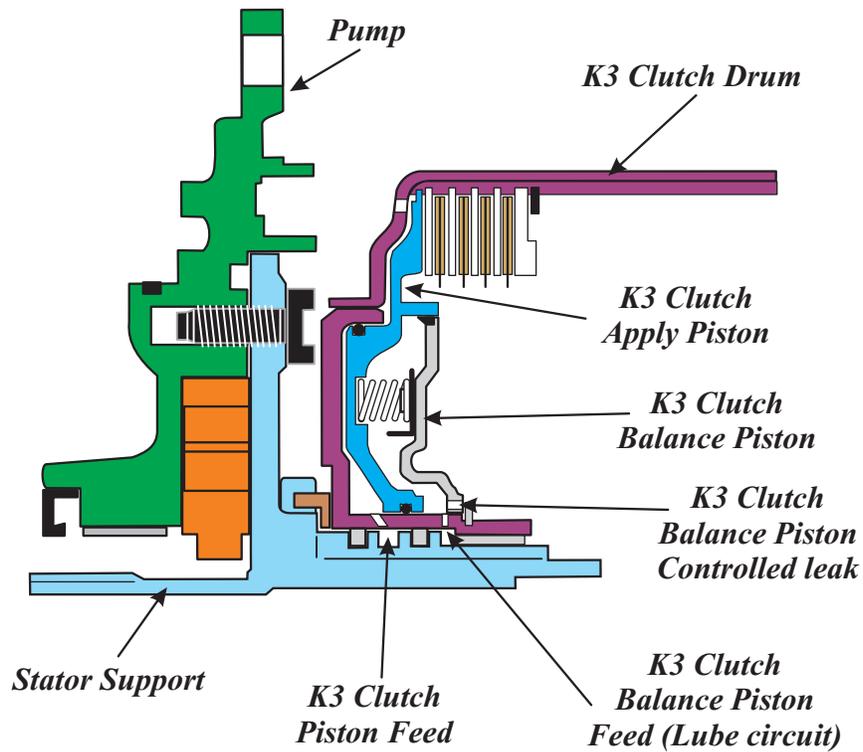
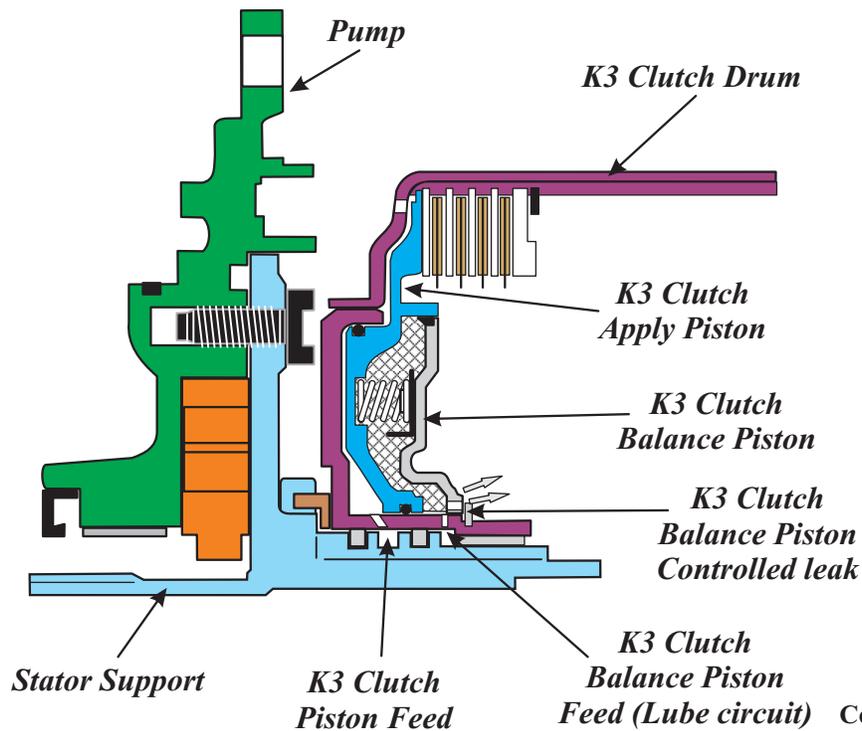
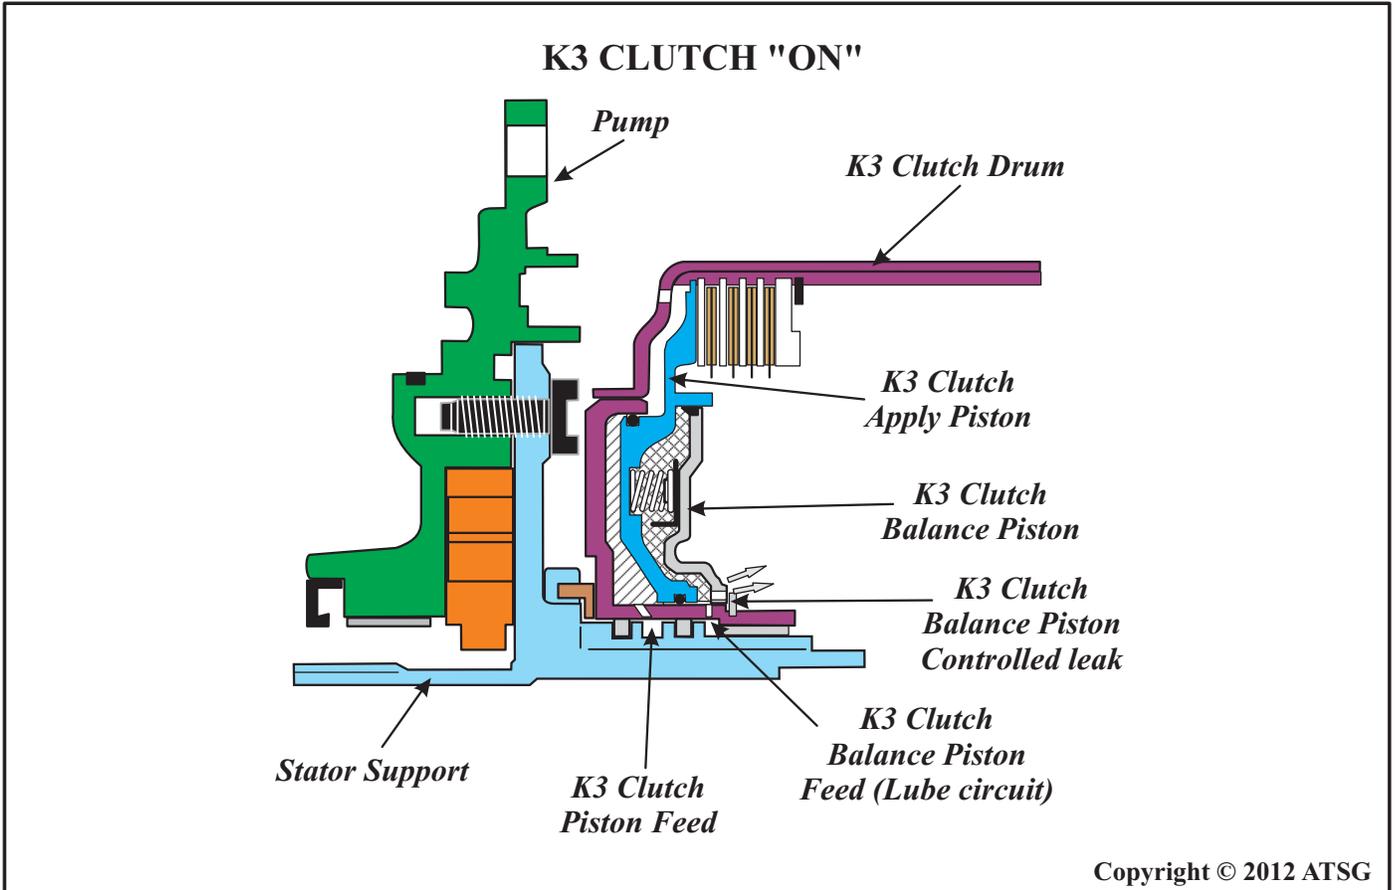
CAUSE: The cause may be a loss of lube pressure due to worn pressure regulator valve bores (primary/secondary), worn bushings, excessive end play and/or failed bonded balance pistons. The K1, K2 and K3 clutch assemblies are equipped with these bonded counter balance pistons. Using K3 as an example from an 09G transmission (figures 1 and 2), the balance piston function is to hold "counter" or "back" pressure on the K3 apply piston. The balance piston is fed from the lube circuit, and its purpose is to provide a small amount of pressure to assist the release of the K3 clutch. It also acts as an accumulator during application of the K3 clutch (figures 3 and 4). The bonded piston has three notches where the retaining snap ring is located allowing a controlled leak of this pressure, and when the bonded rubber is worn this will allow a larger volume of pressure loss which can cause the harsh applications. The K1 can cause a harsh N-D and 5-4 shift, the K2 can cause a harsh 3-4 shift and the K3 can cause a harsh 2-3, 3-5 and N-R shift.

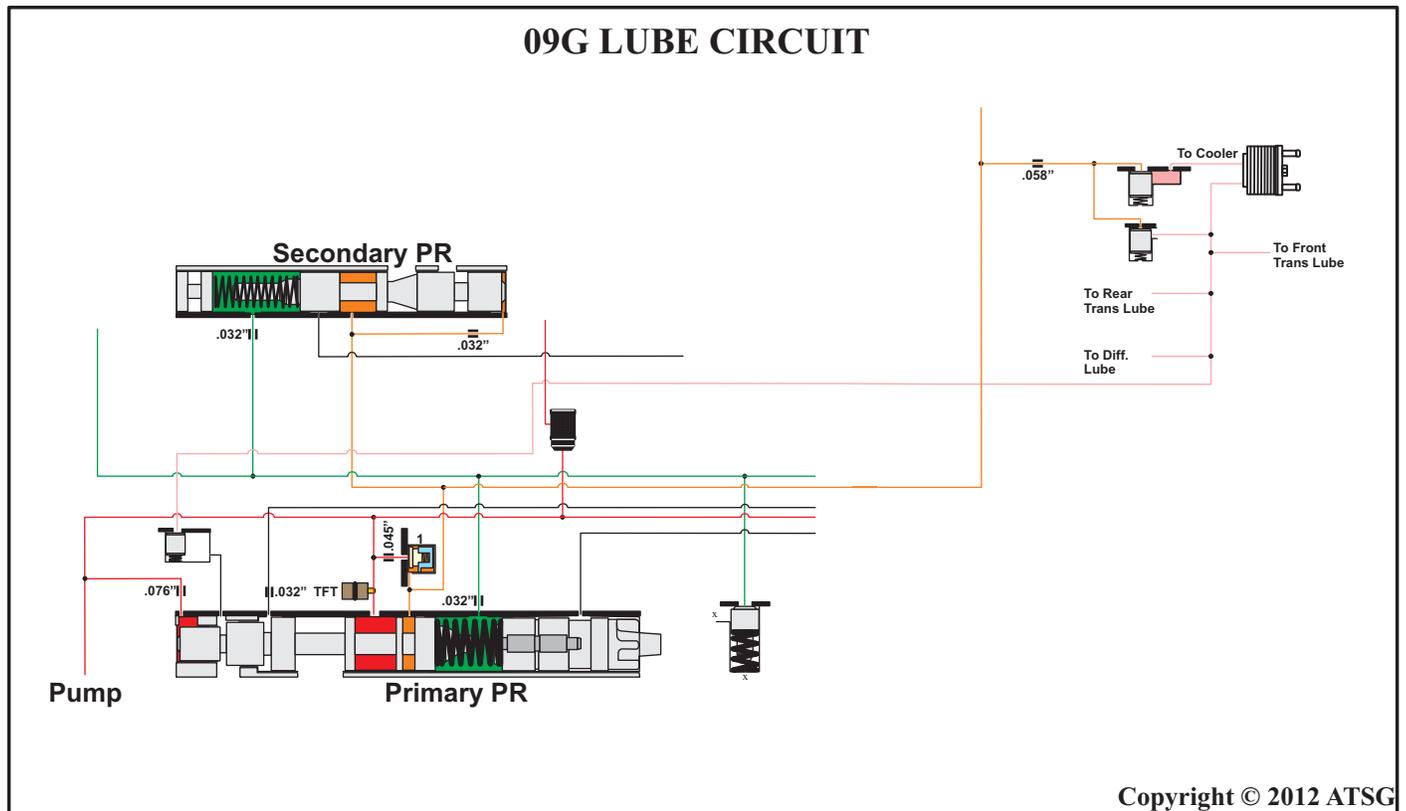
Figure 5

CORRECTION: Most Aisin Seiki transmissions utilize a primary and secondary pressure regulator valve from which lube originates and has its pressure control. Should either one of these valves wear into the bore it can drop lube pressure (figure 5).

Check lube pressure with a pressure gauge. There should be approximately 6 to 10 psi of lube during operating temperature. If pressure runs close to zero psi, these regulator valve bores will need to be inspected. Bushing wear and loose end play can also cause a loss of lube pressure in addition to failed counter balance bonded pistons. All of which will need to be either repaired or replaced restoring circuit integrity.
