## NISSAN RE4F04B HARSH 1-2 UPSHIFT AND OR P0745 DTC.

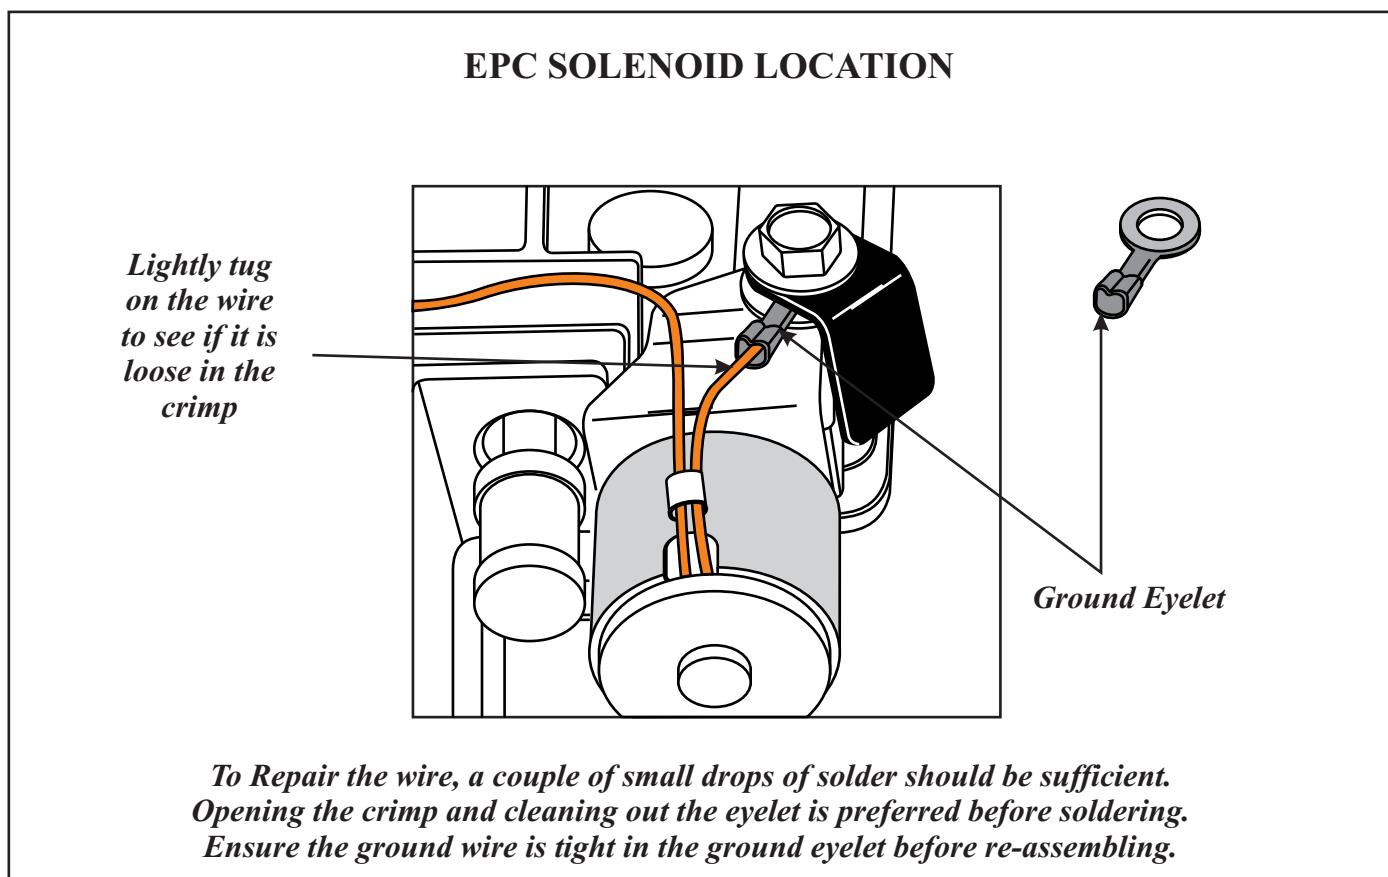
**COMPLAINT:** The cause may be, the ground wire for the EPC solenoid, as shown in Figure ,1 is loose in the eyelet under the valve body bolt that secures it, creating a poor ground, which in turn causes high pressure as well as the P0745 DTC.

**CORRECTION:** To correct this condition, refer to Figure 1 and lightly tug on the ground wire to the EPC solenoid. The wire should not move in the crimp. If the wire is a little loose, open the crimp clean the inside of the eyelet with a wire brush, re-crimp the wire back in the eyelet, then put a couple of drops of solder over the wire to secure it to the ground eyelet.
