DODGE/JEEP 45/545RFE DRIVE LINE “PING” COMING OUT OR INTO PARK

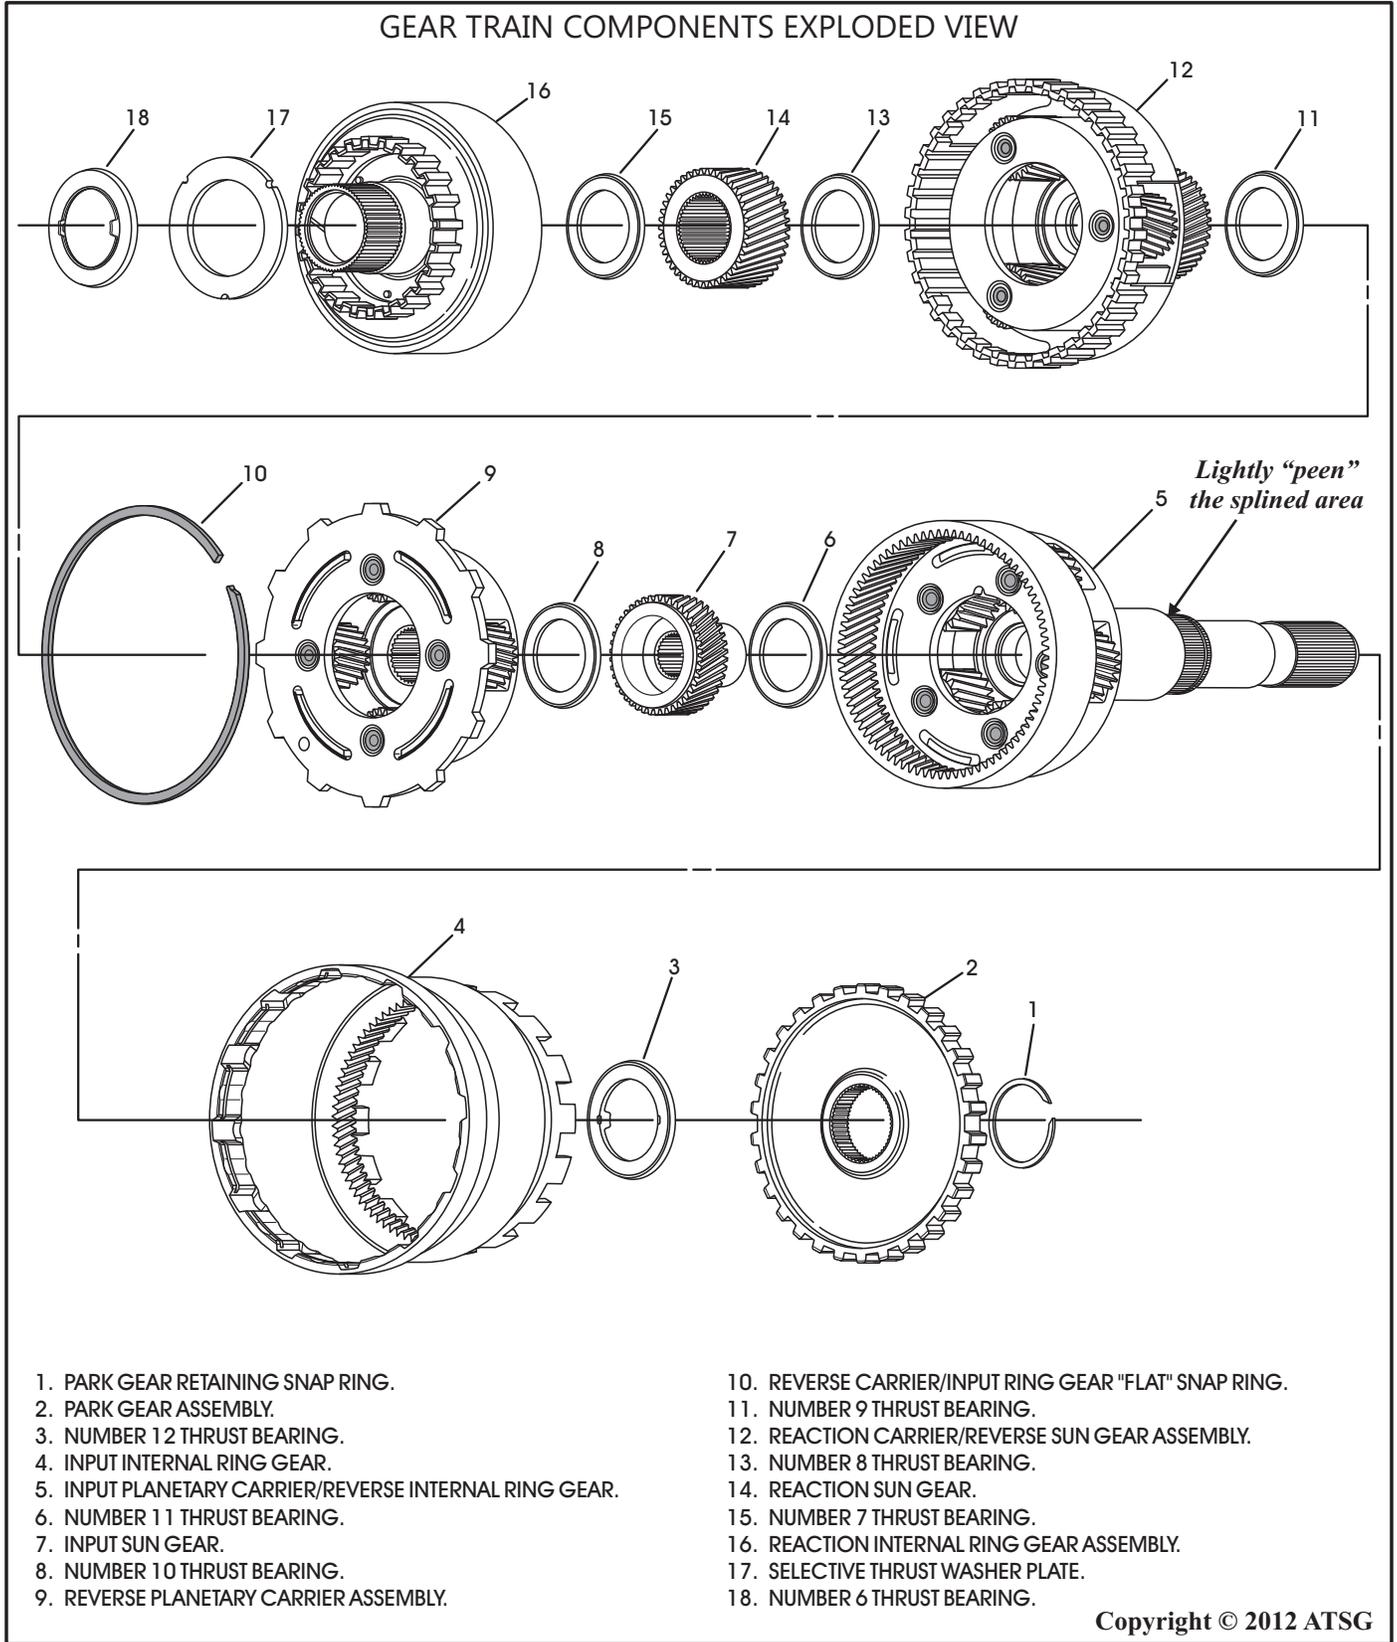
CAUSE: The cause may be, that the splined area on the output shaft, or the Park Gear, shown in Figure 2 may be worn, allowing the park gear to make a sound like a bell.

CORRECTION: To correct this condition, a center punch can be used in the splined area, as shown in Figure 2, to “peen” the splined area. When this is done, the Park gear will have to be tapped into place as it will be snug in the splined area, then the snap ring can be installed. **Caution:** Do not over peen the splined area or the park gear will be difficult to remove!
