FORD 5R55W/S FLARED 2-3 SHIFT OR NO 3RD UNDER HARD THROTTLE

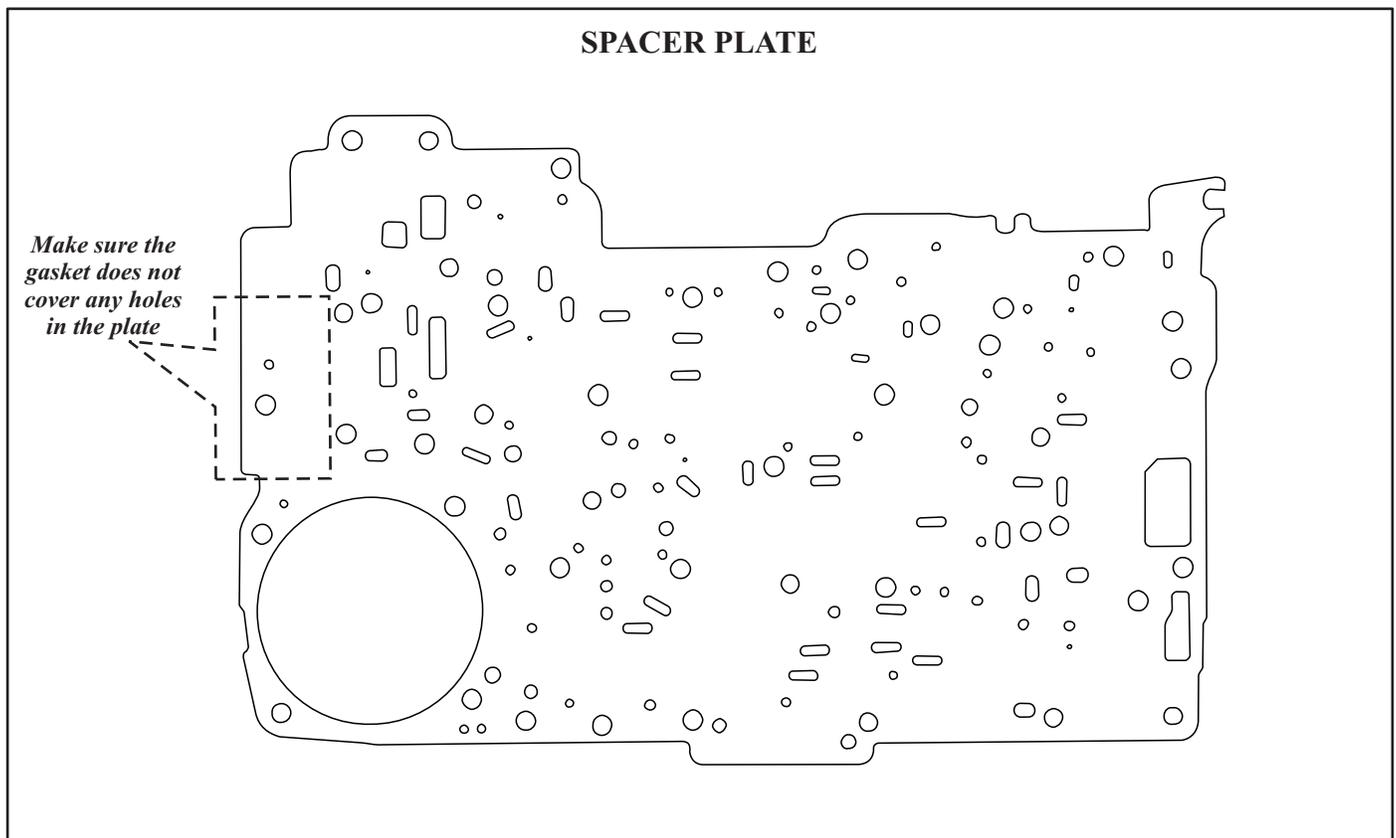
Figure 1

COMPLAINT: After overhaul, vehicles equipped with the 5R55W/S transmission may exhibit a 2-3 up-shift flare and or a condition , under hard acceleration, of a 2nd to 4th up-shift skipping over 3rd gear.

CAUSE: The cause may be, that during the overhaul process, 2009 and up Valve Body Gaskets were used on a spacer plate that was for 2002-08 models, covering holes in the spacer plate, causing the condition.

CORRECTION: Refer to Figure 1, and verify the gaskets that are being used are compatible with the spacer plate. The illustration shows the area that changed. Ensure that the gasket being used does not cover any holes in the spacer plate.
