# Technical Service Information

## AUDI 01J ENGAGEMENT ISSUES

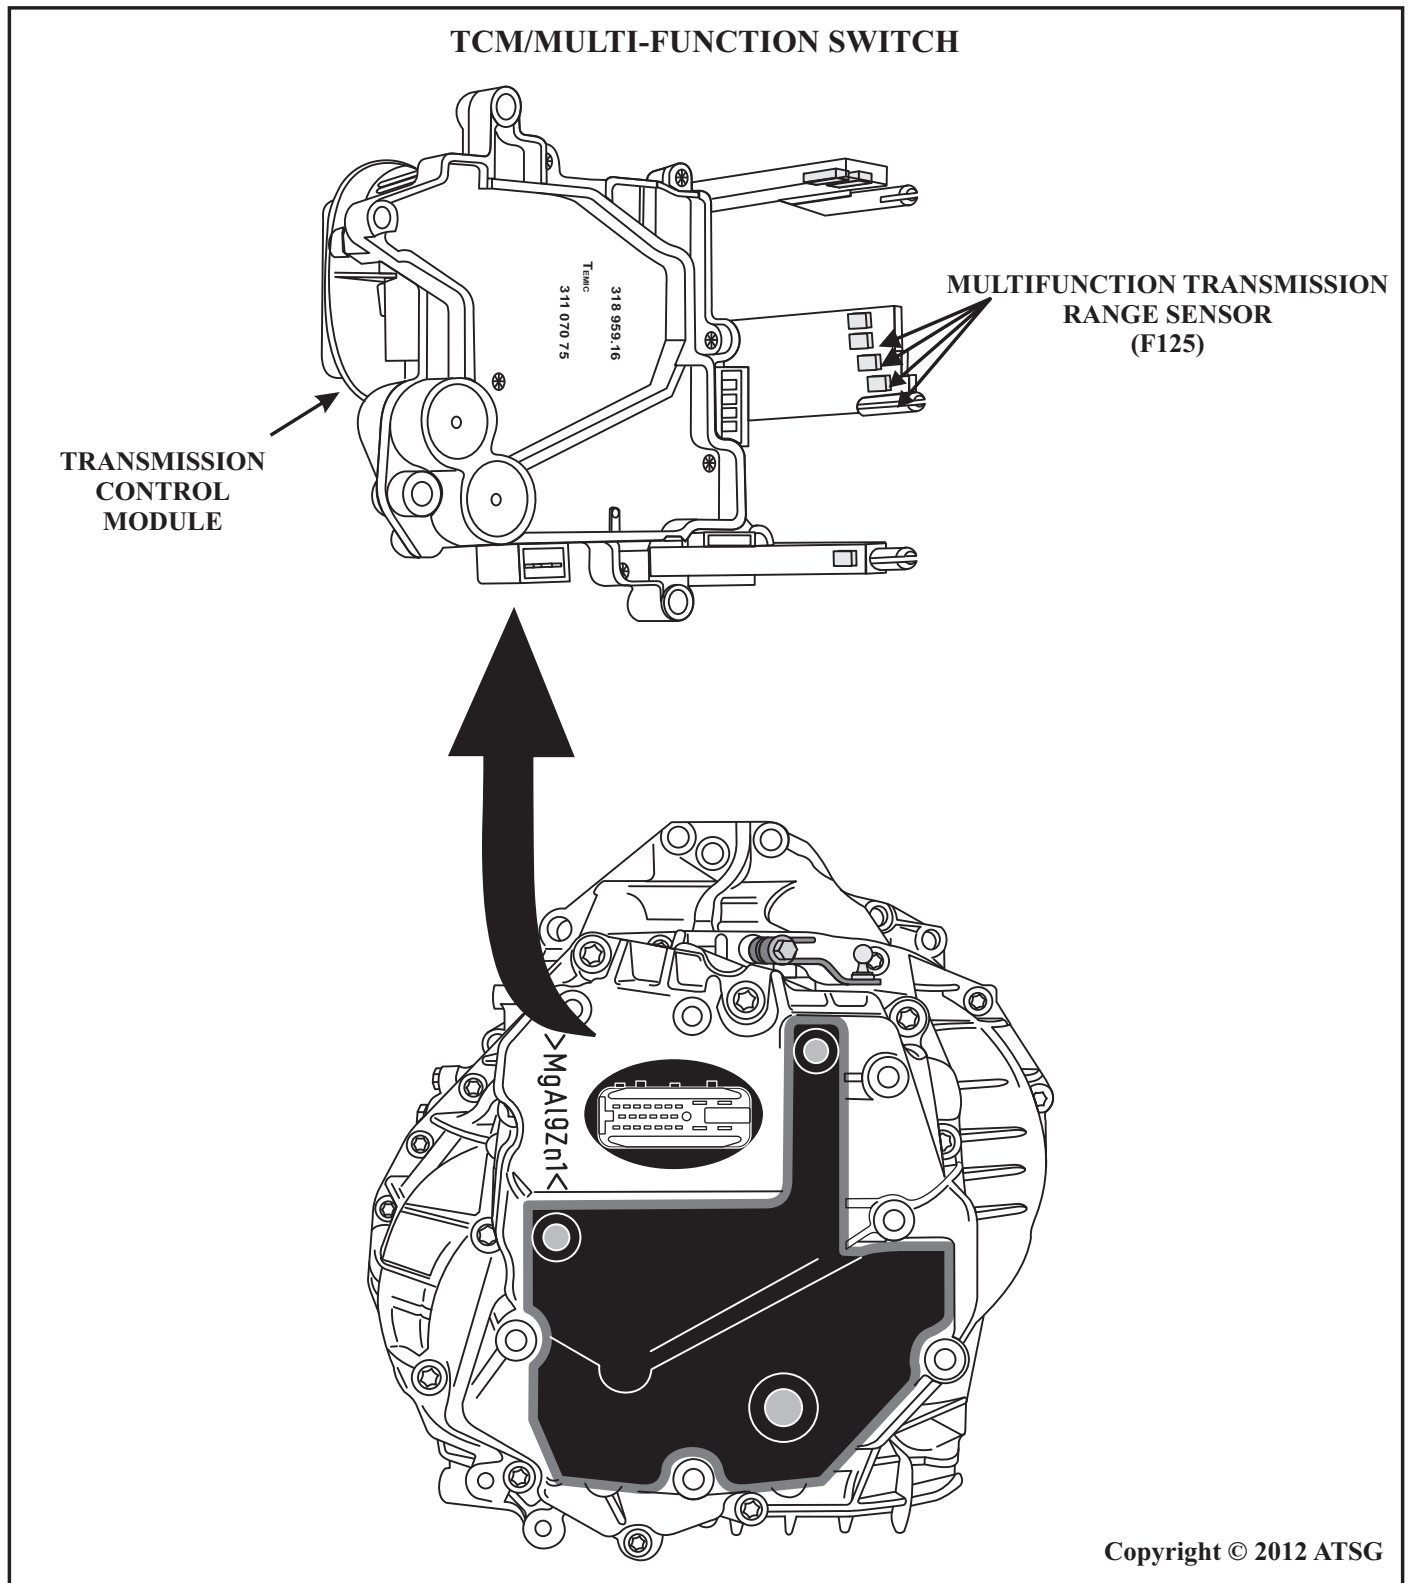
Figure 1

**COMPLAINT #1:** No reverse with VAG Code 17090 stored for a Multi-Function Switch Implausible Signal.

**CAUSE #1:** The Transmission Control Module is faulty.

**CORRECTION #1:** Replace the Transmission Control Module, Refer to Figure 1.
