BMW/FORD ZF6HP26/6R60

3-4 OR 4-5 FLARE

Technical Service Information

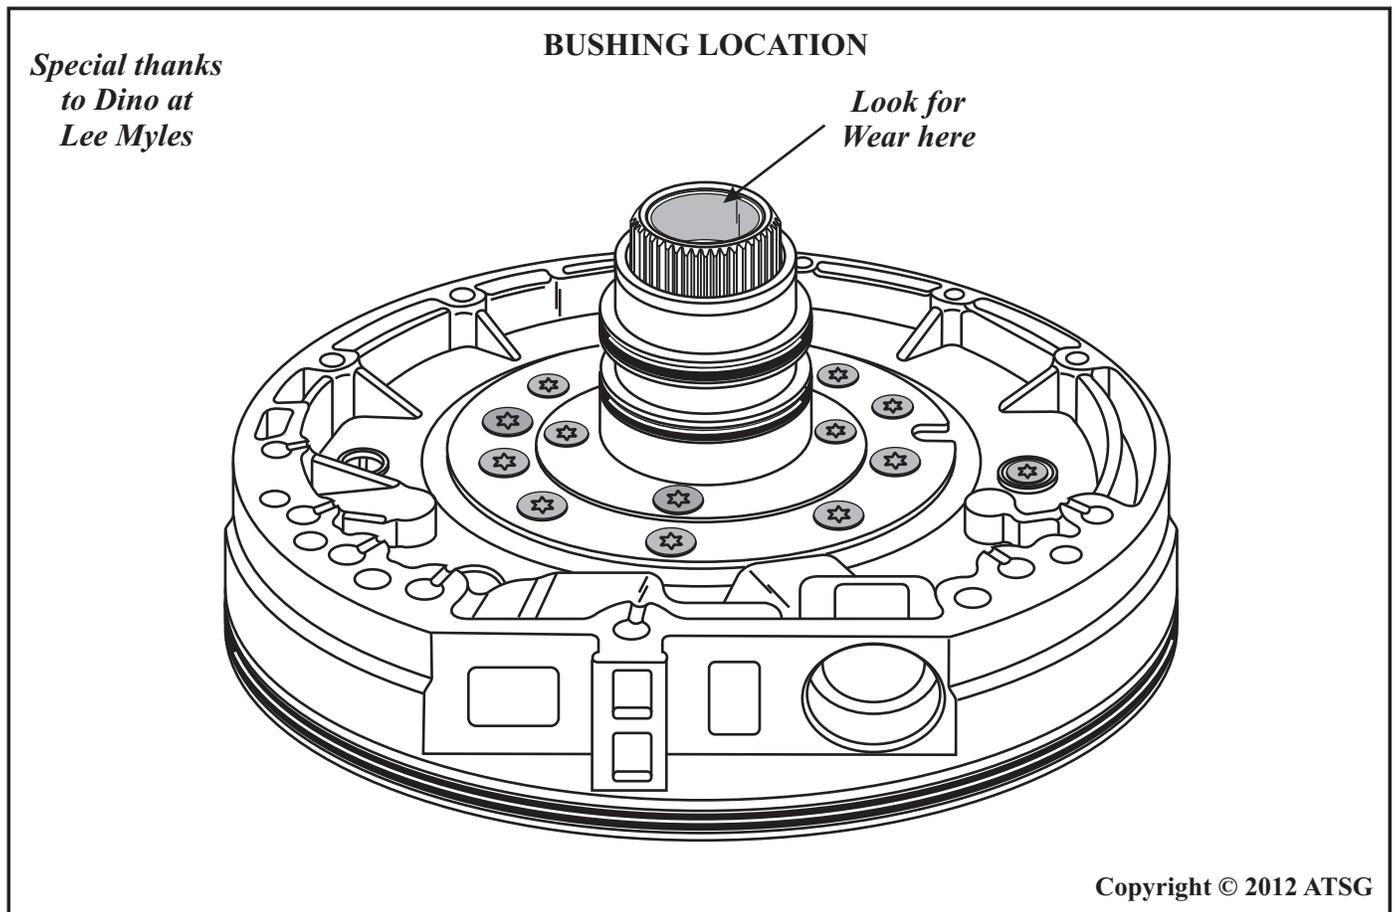
CAUSE: The cause may be, that the bushing in the back of the pump stator, as shown in Figure 1, is worn causing a leak of "E" Clutch apply pressure. Refer to Figure 2 for a component application chart.

CORRECTION: To correct this condition, replace the bushing in the back of the pump stator as shown in Figure 1 and refer to Figure 3 to make sure that the ring lands on the drum are not worn. Replace as necessary.

This bushing is not sold separately than the Pump from ZF at this time. Erickson Industries has a bushing available, call 800-388-4418, or call your local Transmission parts distributor.
