# Technical Service Information

## AUDI 01J

### DELAYED FORWARD ENGAGEMENT/SHUDDER ON TAKE OFF

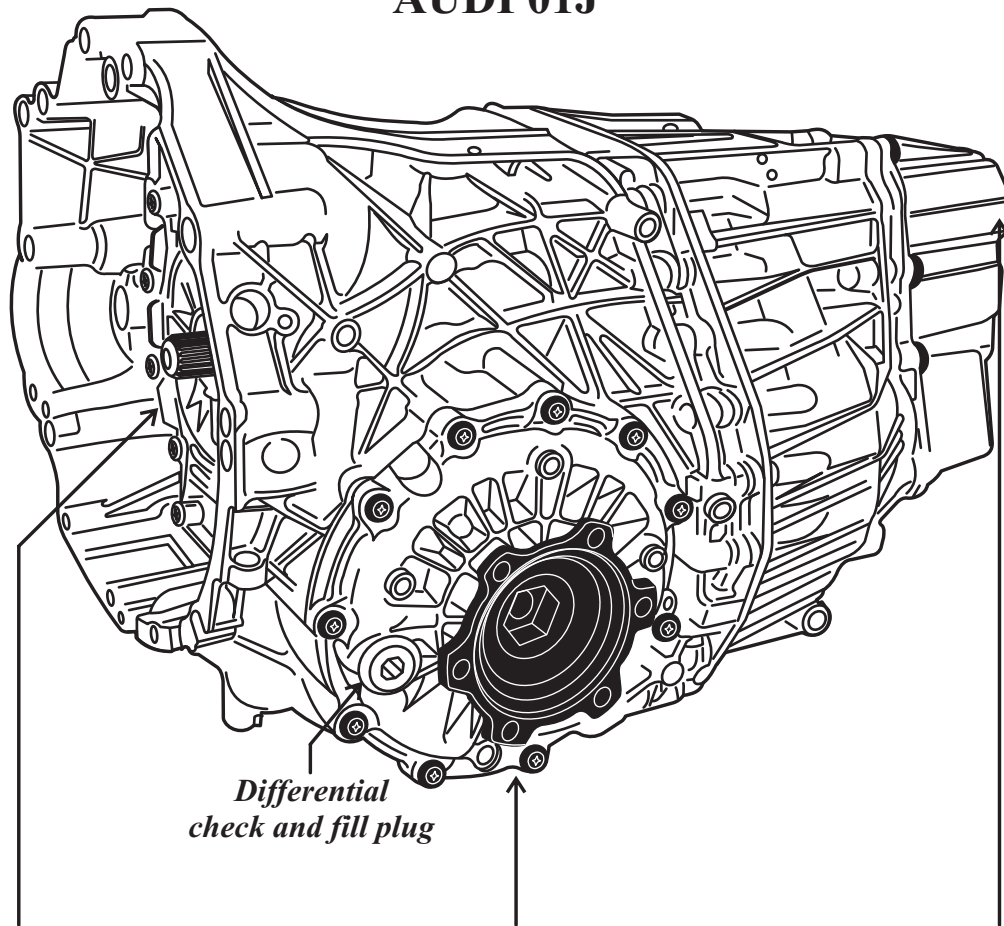
Figure 1

When removed, the front cover gains access to the forward clutch and reverse clutch assemblies. The planetary assembly is integral to the forward drum and is pressed into the cover with a retaining snap ring located behind the front seal.

When removed, the differential cover gains access to the pinion shaft seal. Behind the seal is a retainer spacer ring around a snap ring which needs to be removed to press out the drive and driven pulley assembly should any service to the Entrainment pump or pulley assembly is needed.

If the Entrainment pump needs to be serviced, the rear cover, TCM, valvebody and pulley case cover will need to be removed. Care must be taken to not mistaken the sender wheels as seals. These must be removed with care.

**CORRECTION:** Once the transmission is removed, the forward clutch assembly can be inspected by removing the front cover (Figure 1).

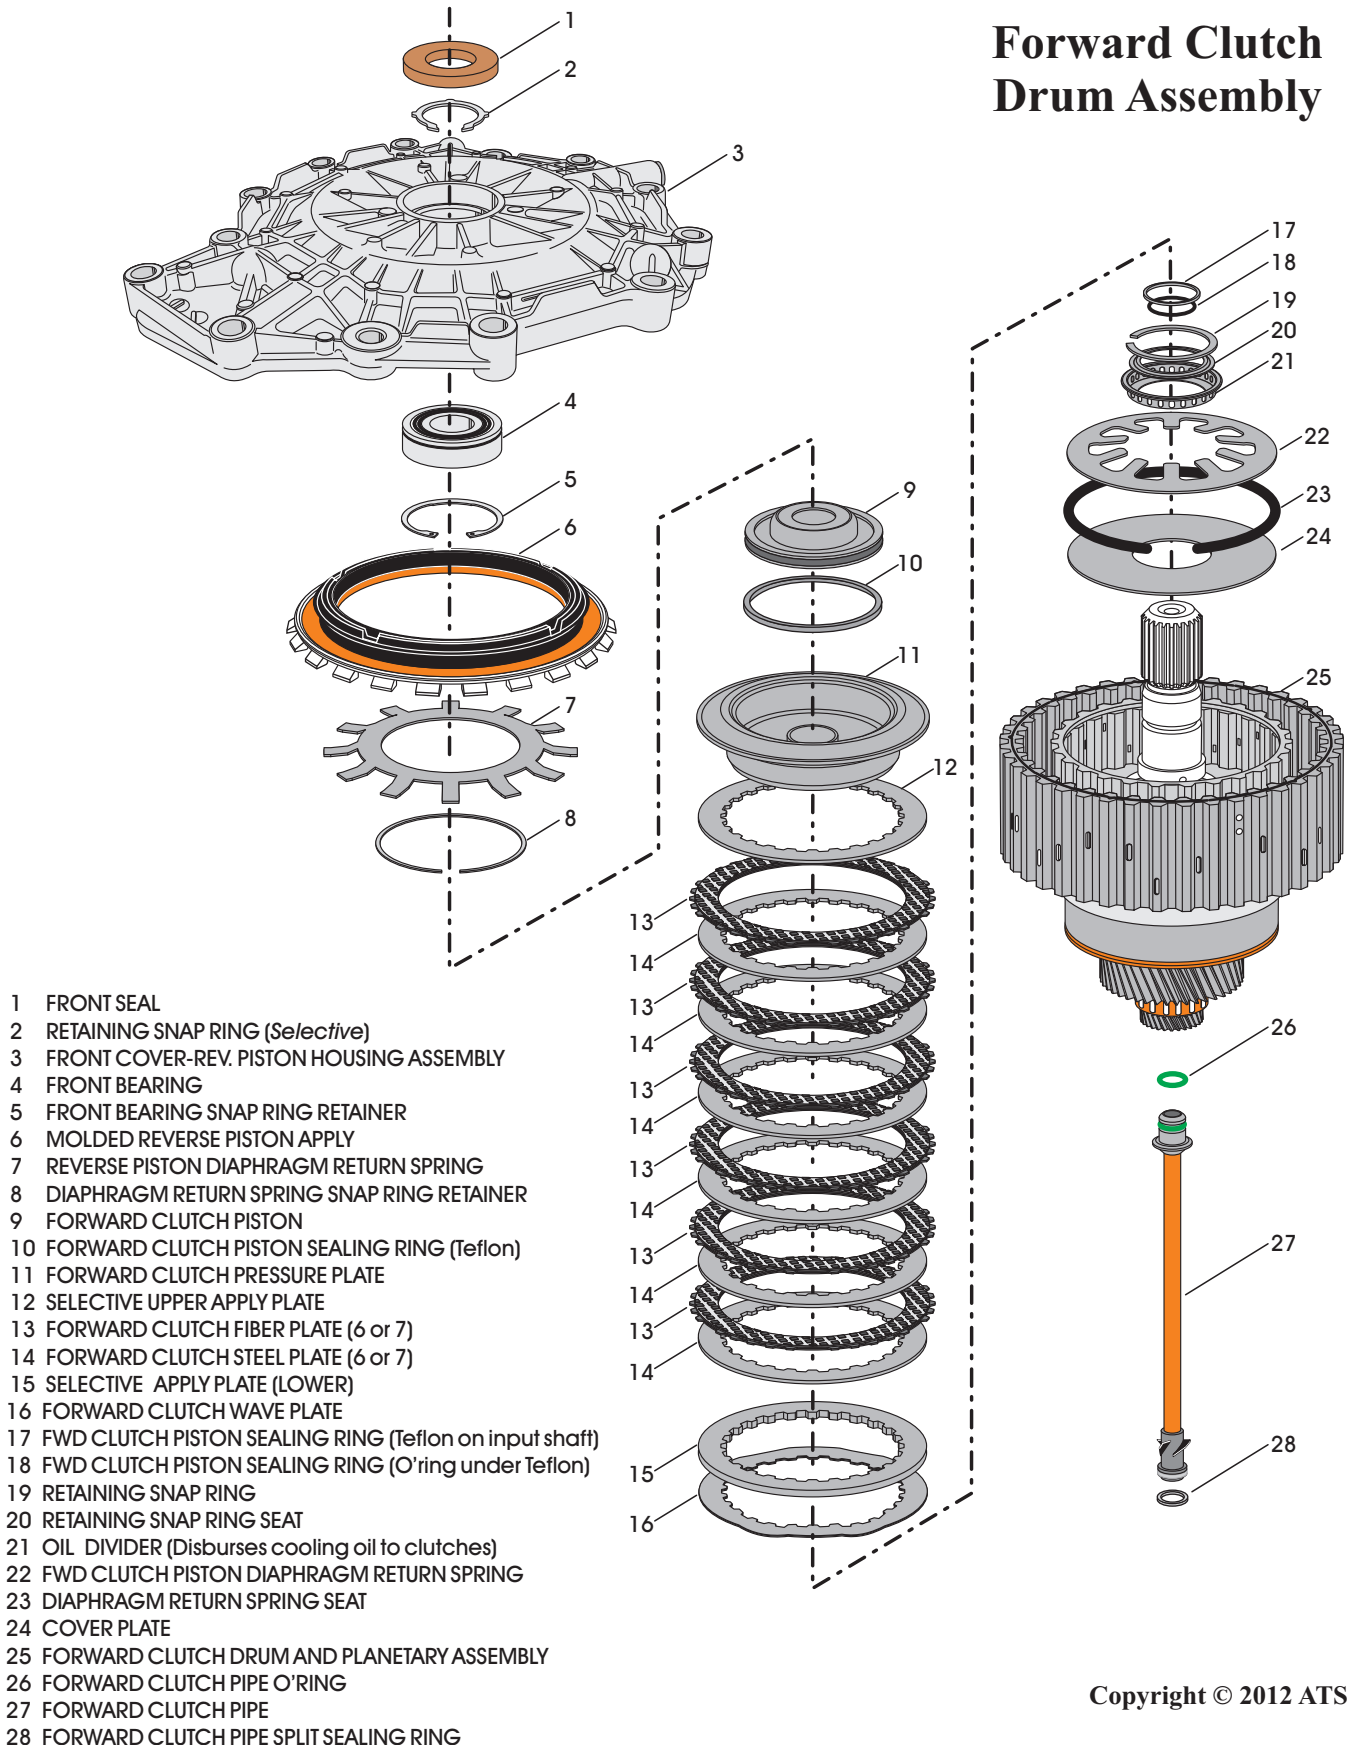
Figure 2

Remove the front seal (1), retaining snap ring (2) and forward clutch feed pipe (27) then carefully press the input shaft, forward clutch and planetary assembly (25) from the cover (3) as seen in Figure 2. Be sure to fully support the cover during this pressing operation as it is very easy to snap the cover.

Once the assembly has been removed from the cover, the forward clutch assembly can be inspected (13 & 14). The planetary assembly is integral to the forward drum and can not be disassembled.

Inspect the forward clutch piston seals and sealing surfaces. The outer seal (10) on the forward clutch piston (9) seals inside the pressure plate (11). The inner seal is located on the input shaft which consists of an inner o-ring (18) and outer Teflon ring (17) and seals against the inside of the pressure plate (11). Both the seals and sealing surfaces are critical for proper operation. Some kits contain a new forward clutch piston with the outer seal installed.

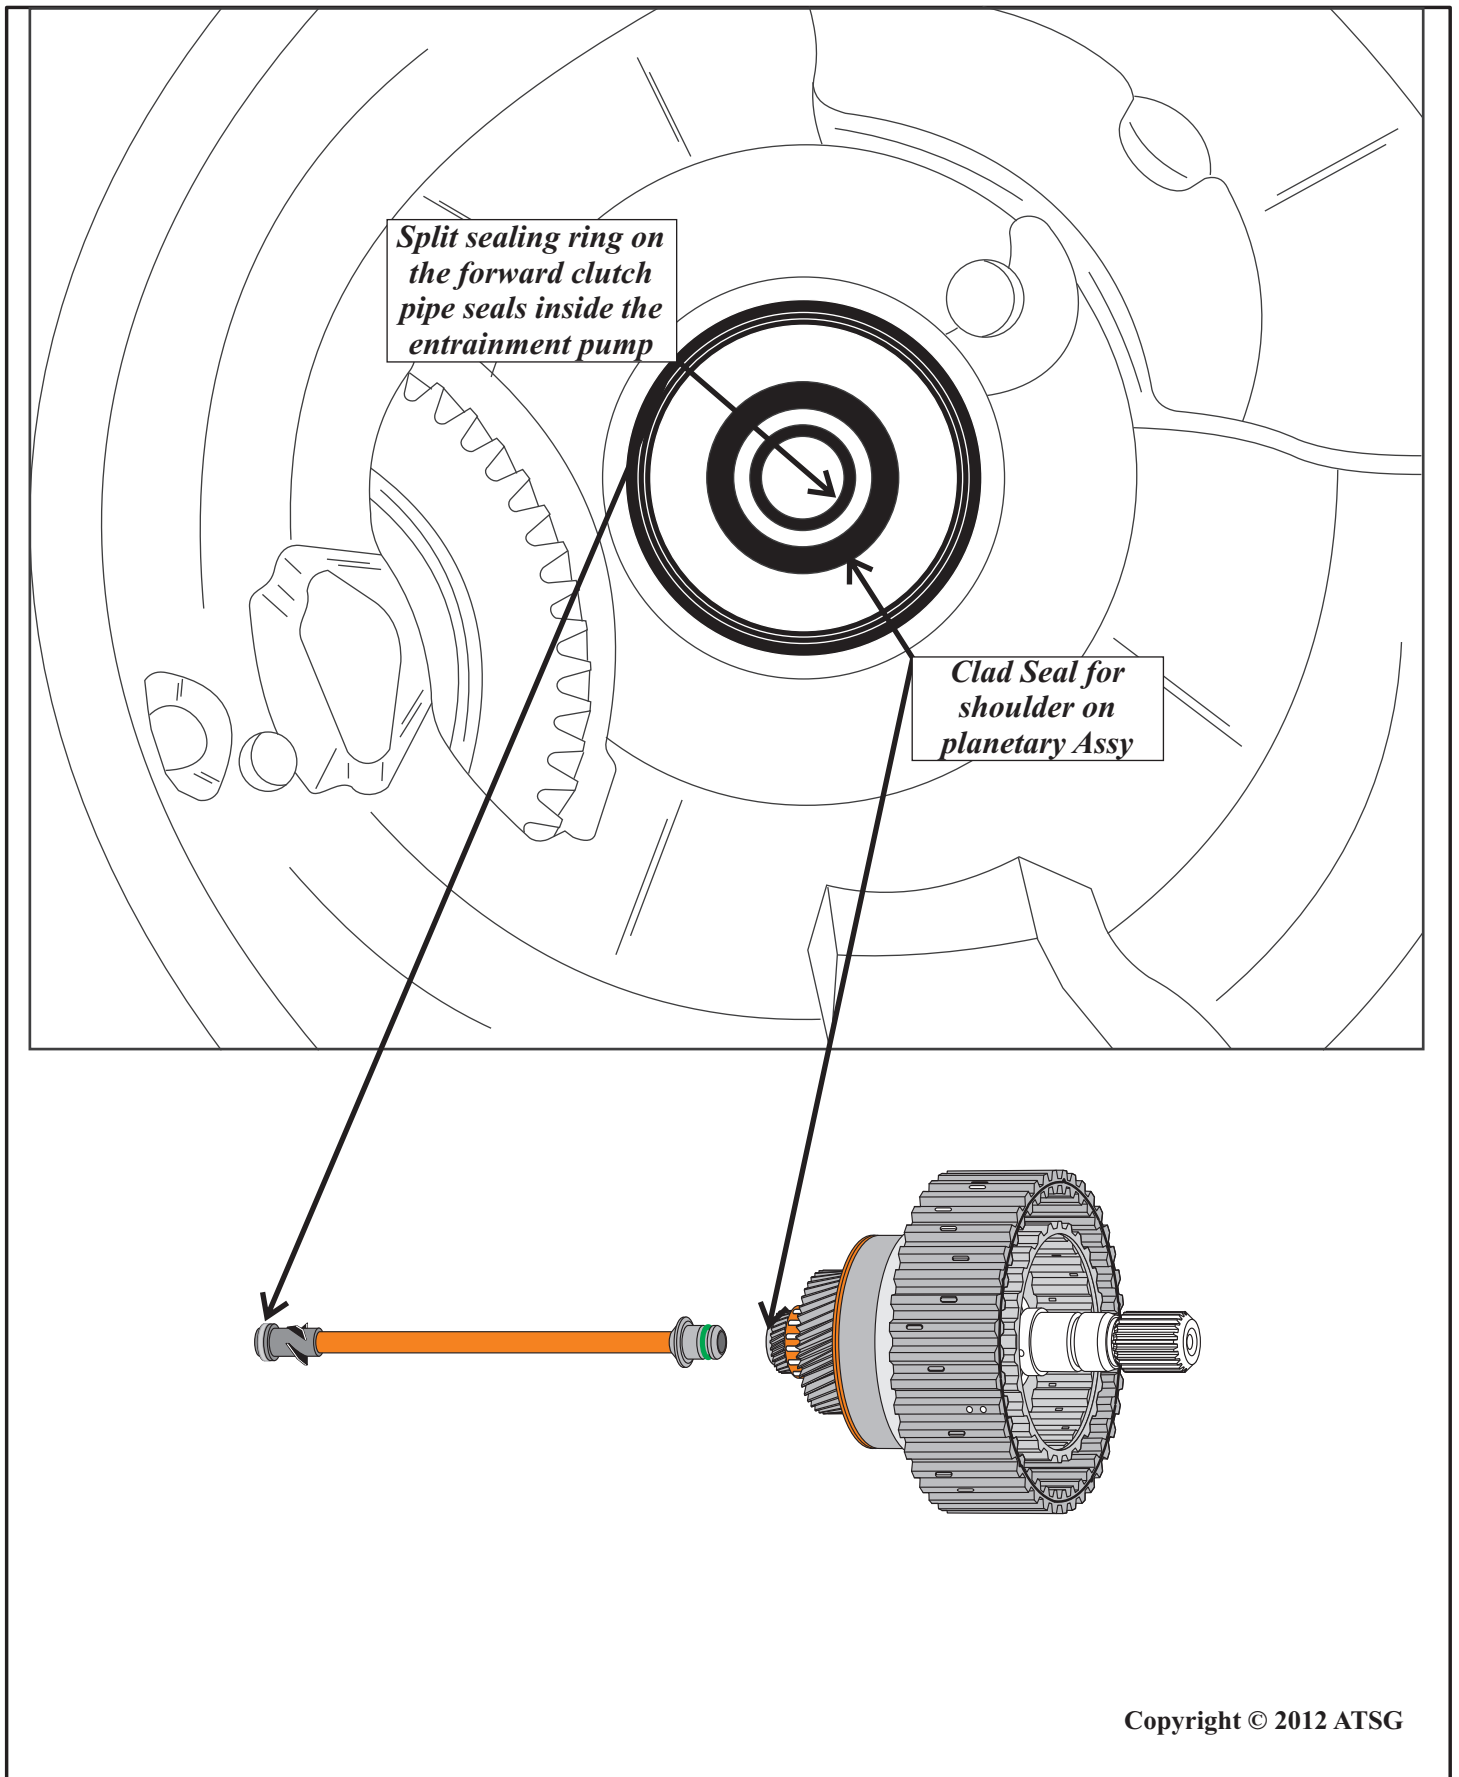
Figure 3

There are two sealing rings on the forward clutch feed pipe (27), an o-ring (26) and a split ring (28). These too are critical sealing areas for the forward clutch hydraulic circuit. The sealing area for the split ring is located in the entrainment pump inside the transmission and should not be grooved. If it is, the entrainment pump will need to be replaced (See Figure 3).

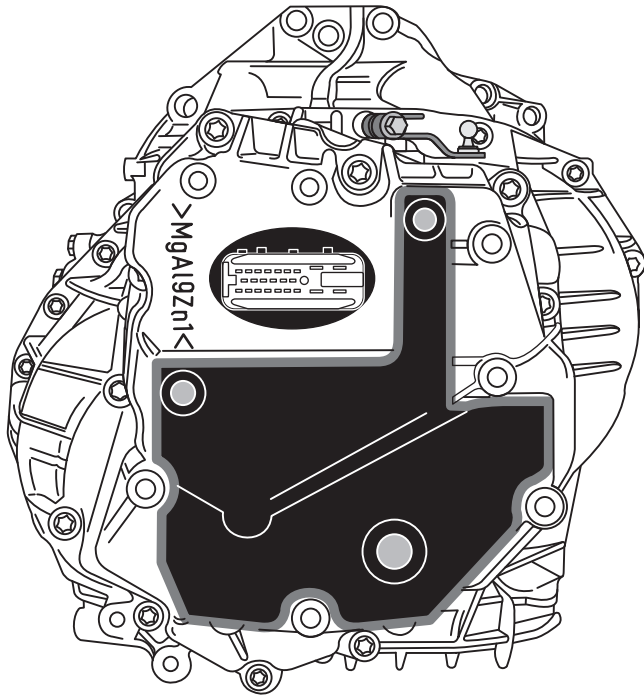
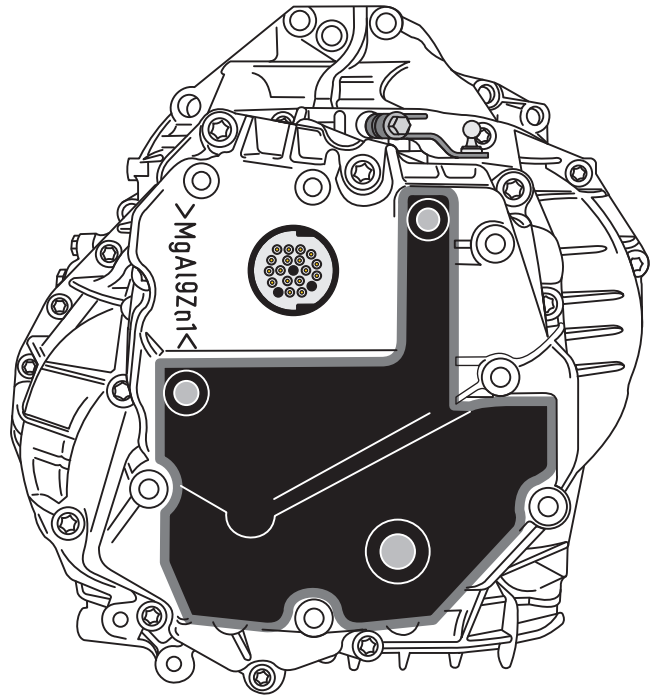
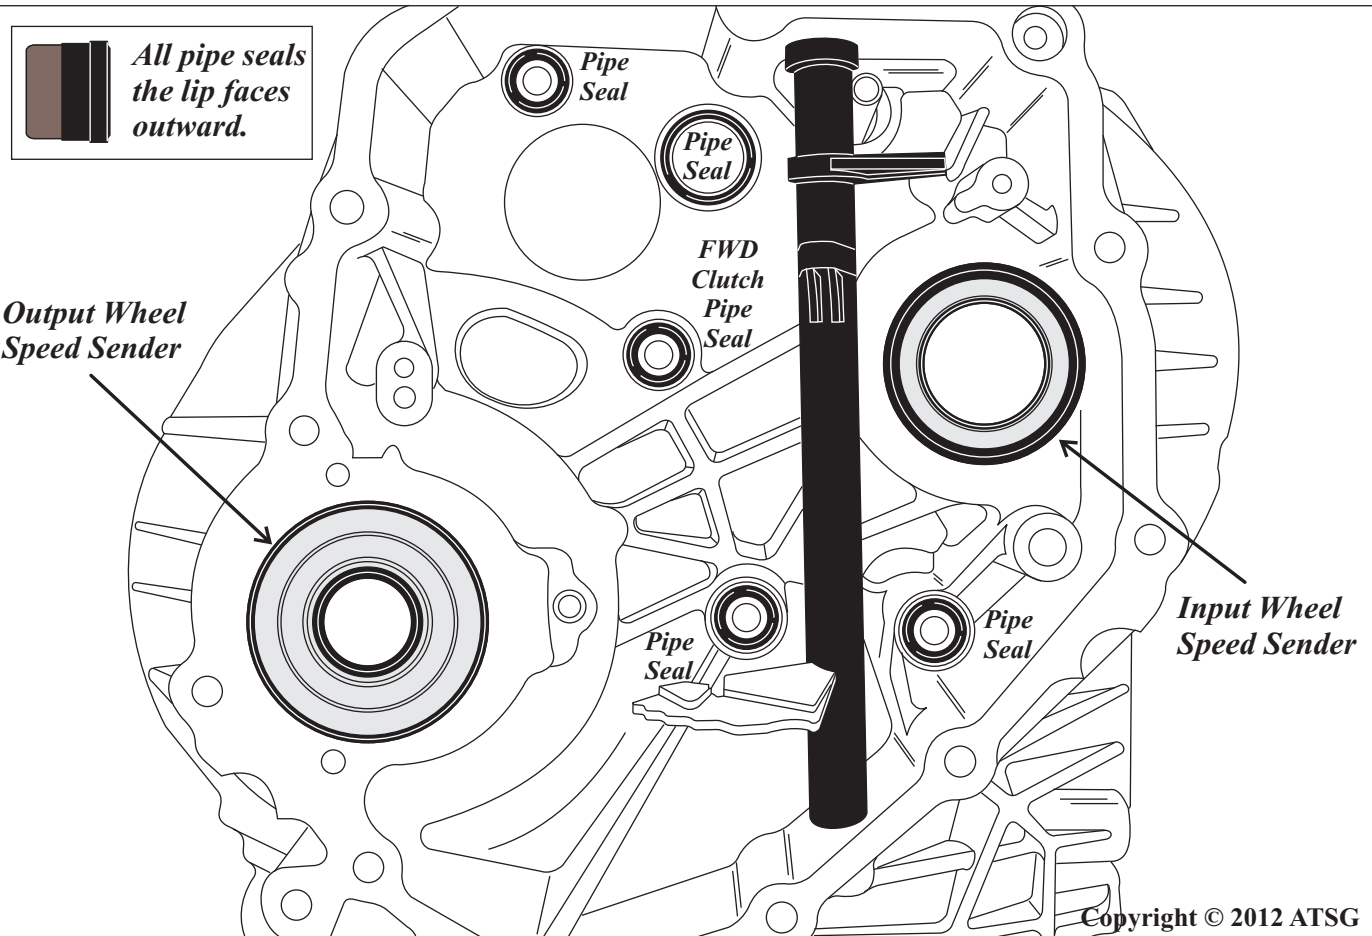
Figure 4

When the valve body is removed, there will be 5 small pipe seals, 1 larger pipe seal and 2 speed sender wheels (See Figure 4). These speed sender wheels are not to be mistaken for oil seals which are then popped off with a hammer and screw driver. If you distort these speed sender wheels they will need to be replaced. These speed senders have magnetic strips in them that provide a rotation signal to hall affect sensors built into the TCM. Any distortion of the sender wheel will cause various transmission complaints including delayed engagements, shudder on take off and a loss of the hill holding feature. Some kits have mistakenly thought these were just oil seals and had aftermarket sources make them without magnets and when used there is a complete loss of a speed signal. Some kits that have the right sender wheels will usually have them in their own separate bag for protection along with installation instructions.

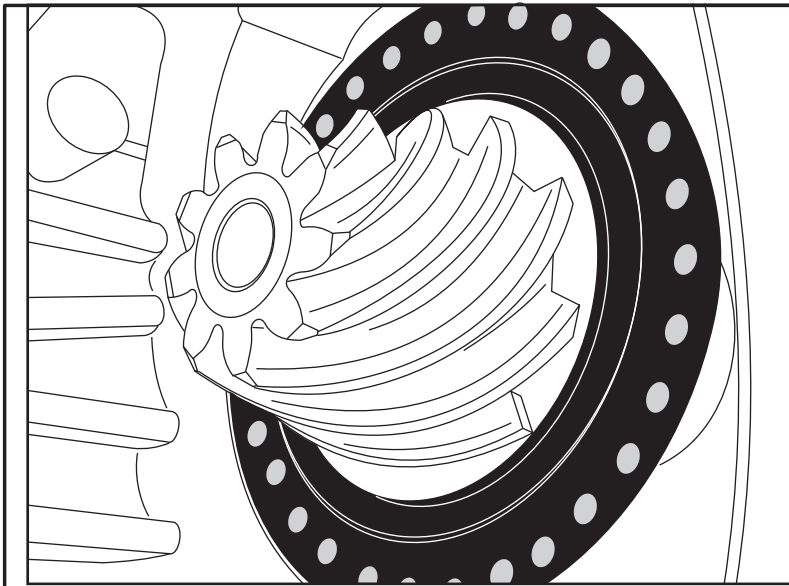
*Remove Pinion Seal.*

With the differential out of the main case, remove the pinion shaft oil seal as seen in Figure 5. After the seal has been removed, there is a retainer spacer that must be carefully lifted out of place (Figure 5). This retainer is not serviced separately so you must be careful not to distort it during removal as it must be reused during assembly. Once the retainer is removed, the retaining snap ring can be removed (Figure 5).

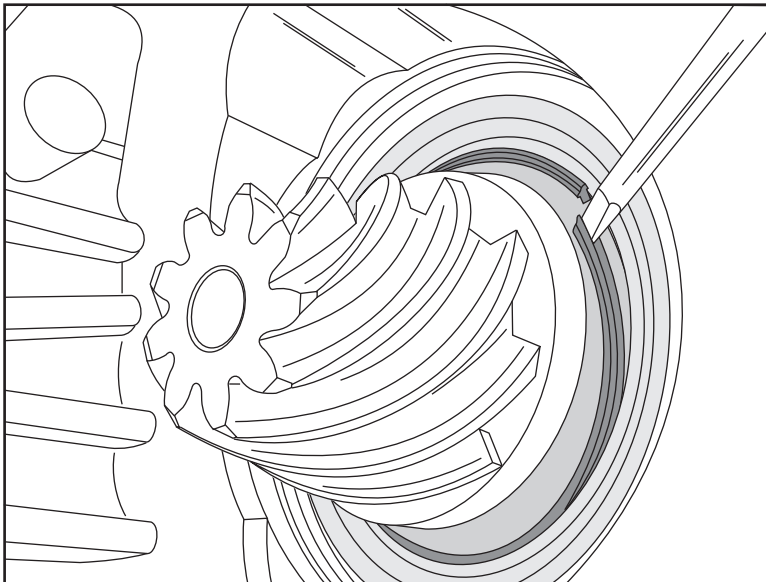
*Remove the Retainer Spacer from around the inner snap ring being careful not to distort it as it will need to be reused. This part is not yet serviced separately.*

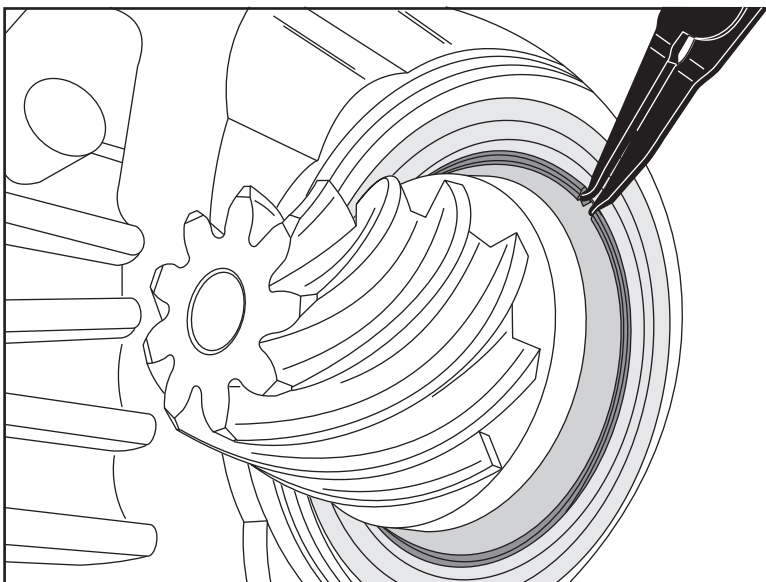
*Remove the inner snap ring.*

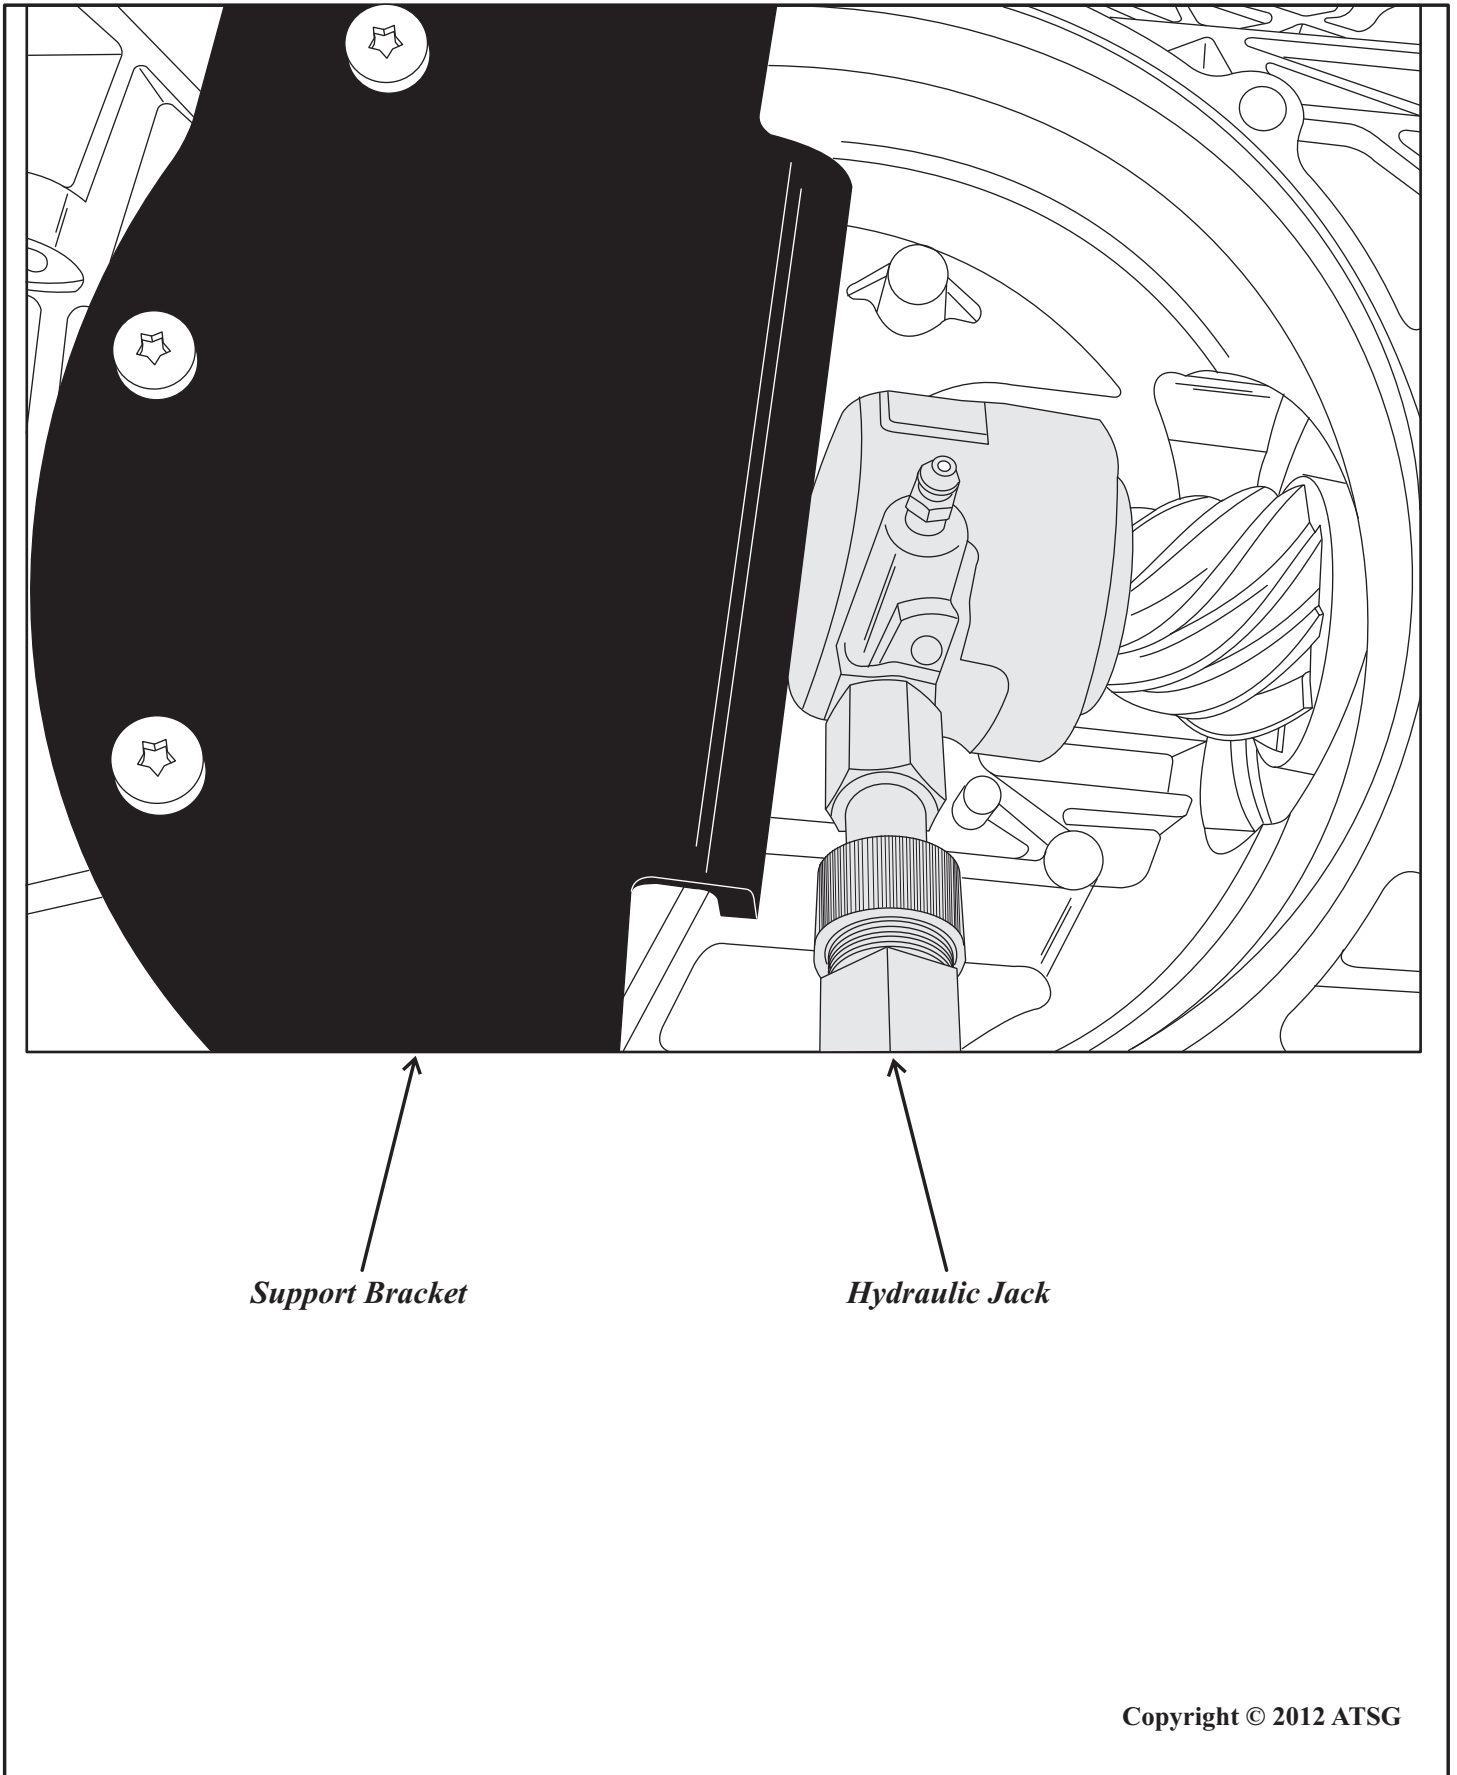
Figure 6

The variator is now ready to be removed. To do so will require a metal brace and hand pump press. With the metal brace acting as a support, place the press between the support brace and pinion gear. Slowly press the shaft out of the case while another person carefully guides the variator assembly from the main case (See Figure 6).

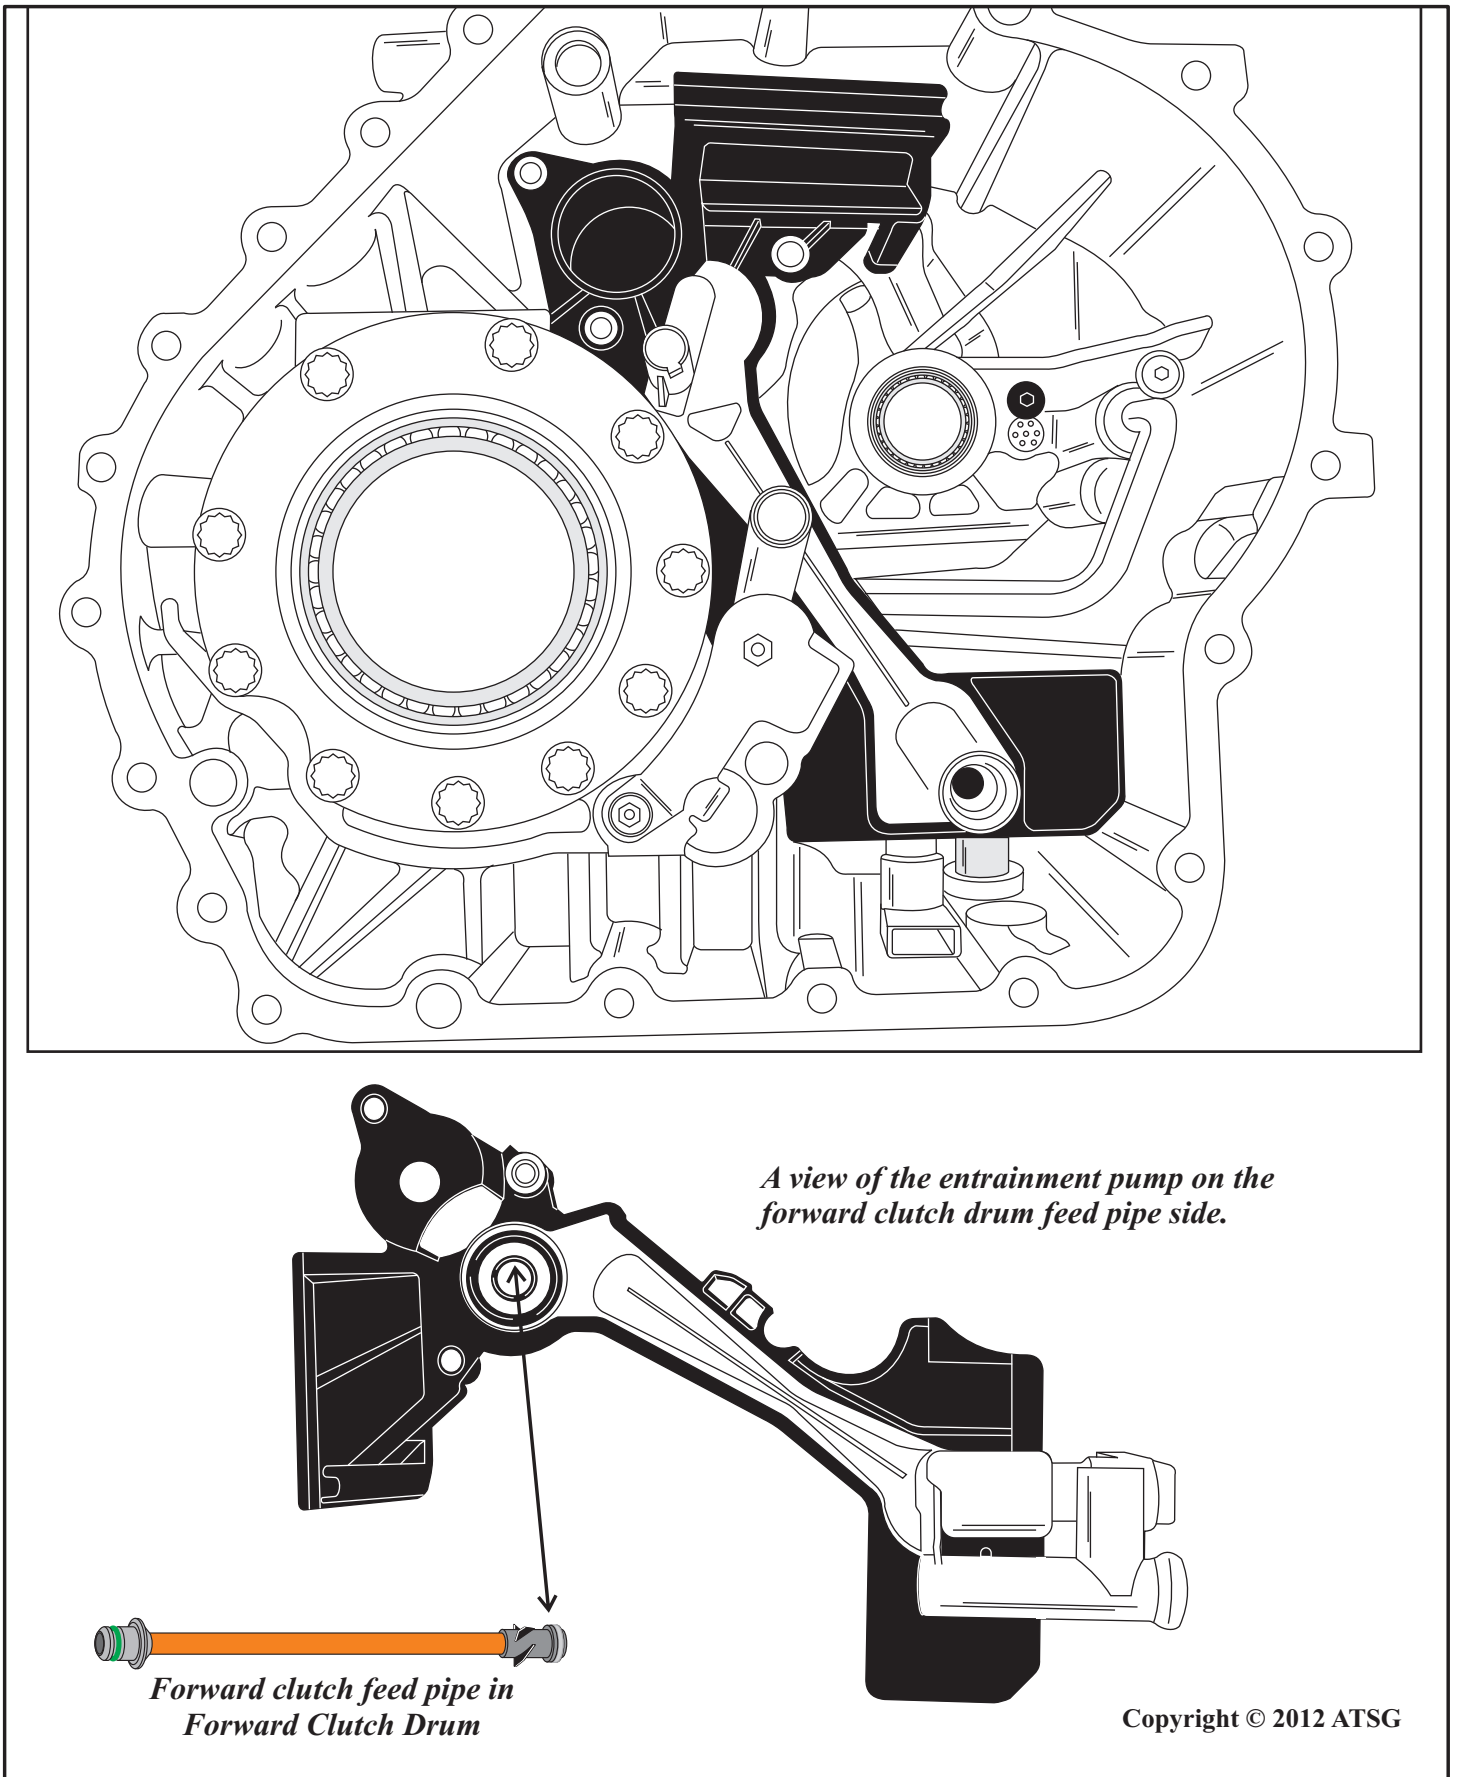
Figure 7

With the variator assembly removed, the entrainment pump becomes accessible for removal and replacement (See Figure 7).

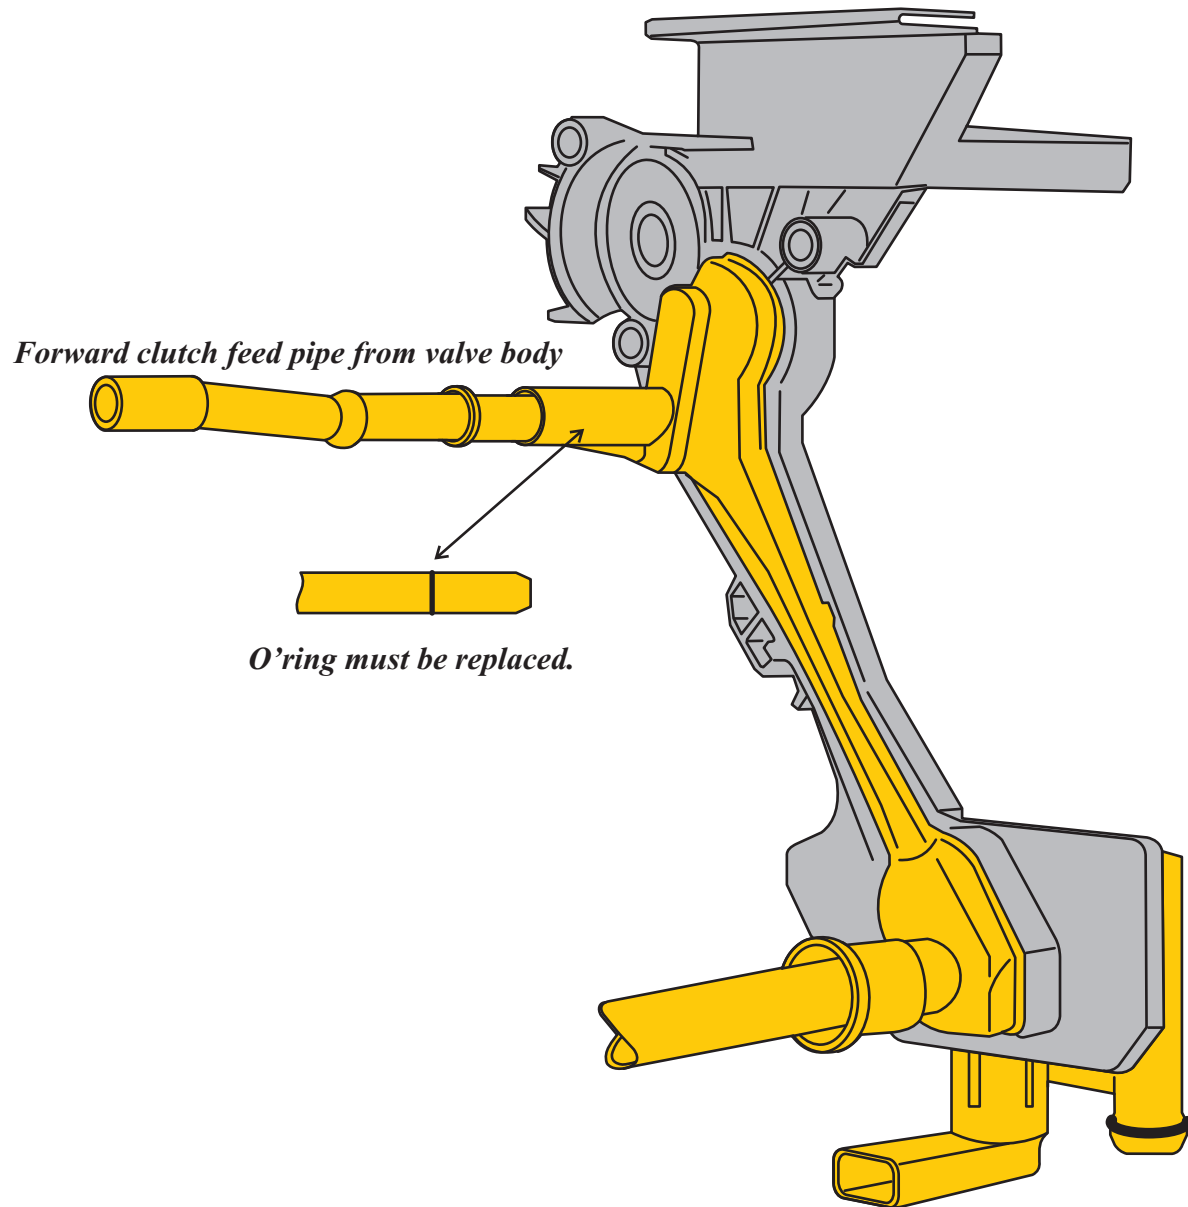
Figure 8

There is another very critical seal in the forward clutch circuit that will need to be replaced. It is located on the forward clutch feed pipe that runs from the valve body and fits into the entrainment as seen in Figure 8.

*A view of the entrainment pump on the forward clutch feed pipe valve body side.*

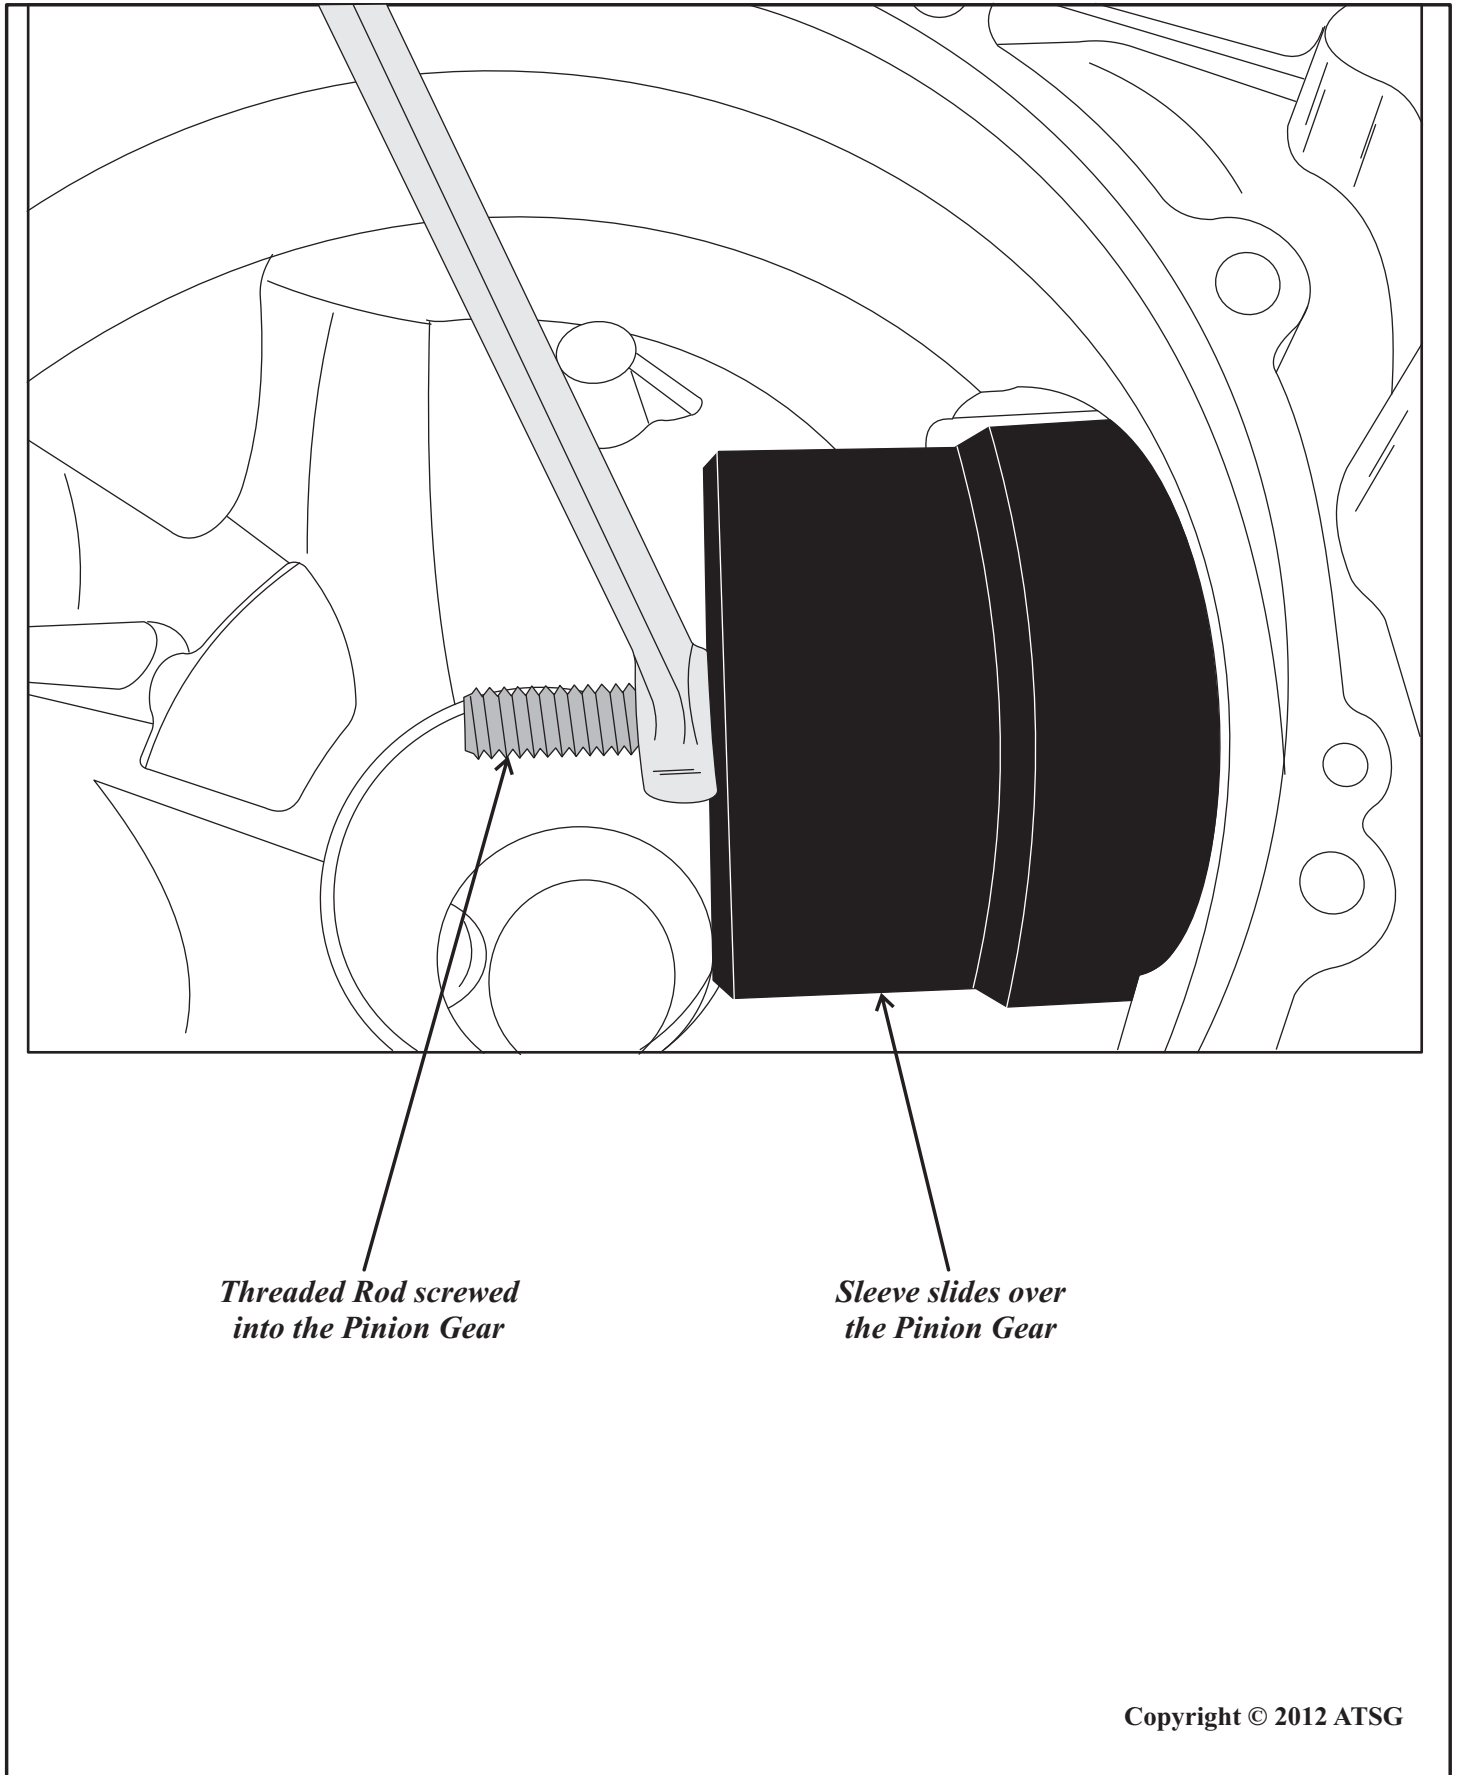
Figure 9

To reassemble the variator assembly into the main case, carefully slide it into position as far as possible. With a threaded rod, screw it into the tip of the pinion shaft from the differential cavity. Slide a sleeve over the threaded rod and screw a nut onto the threaded rod. With a wrench, slowly tighten the nut pulling the pinion shaft into place while an assistant carefully guides the variator assembly into the case as it is being pulled in (See Figure 9).

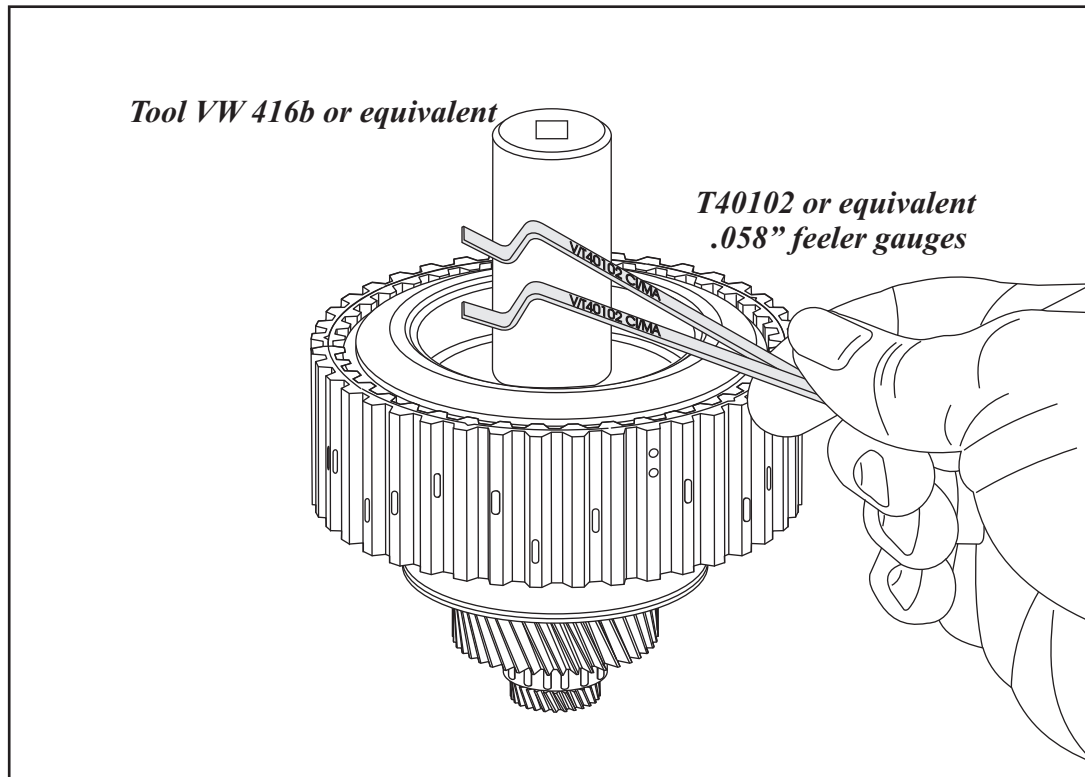
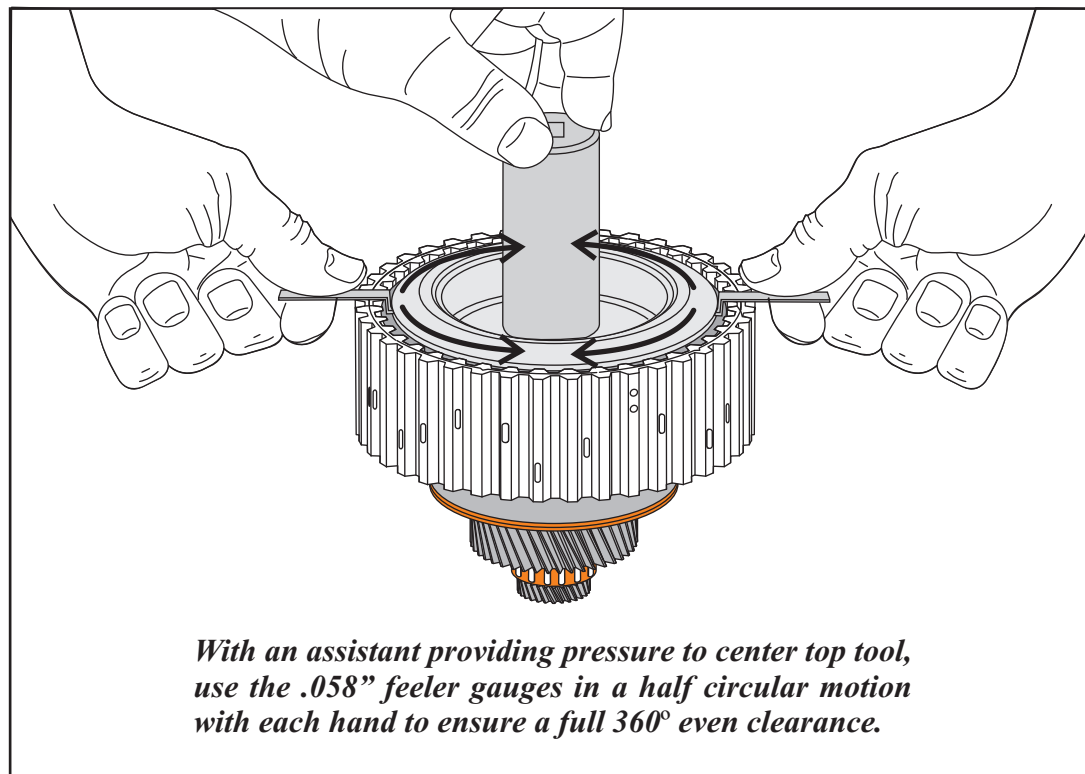
Figure 10  
AUTOMATIC TRANSMISSION SERVICE GROUP

Assemble the drum completely. Once the forward clutch is re-assembled, a suitable tool or part number VW 416b must be used to push down on the pressure plate by a second technician as seen in Figure 10.

Using part number T40102 or equivalent .058" feeler gauges, move the two feeler gauges back and forth to complete a full 360° circle beneath the pressure as the arrows in figure 10 illustrates.

The entire circular area needs to be inspected. The two feeler gauges **MUST** always move freely without any resistance whatsoever. If the gauges can not freely move around the pressure plate the forward clutch stack up will need to be adjusted by changing the selected shims.

It is essential to obtain a successful 0.058" even clearance (or slightly tighter) all the way around the pressure plate otherwise problems will be encountered when driving off from a standstill.
