TOYOTA A540/541E SERIES TRANSMISSIONS

ENGINE CHUGS COMING TO A STOP

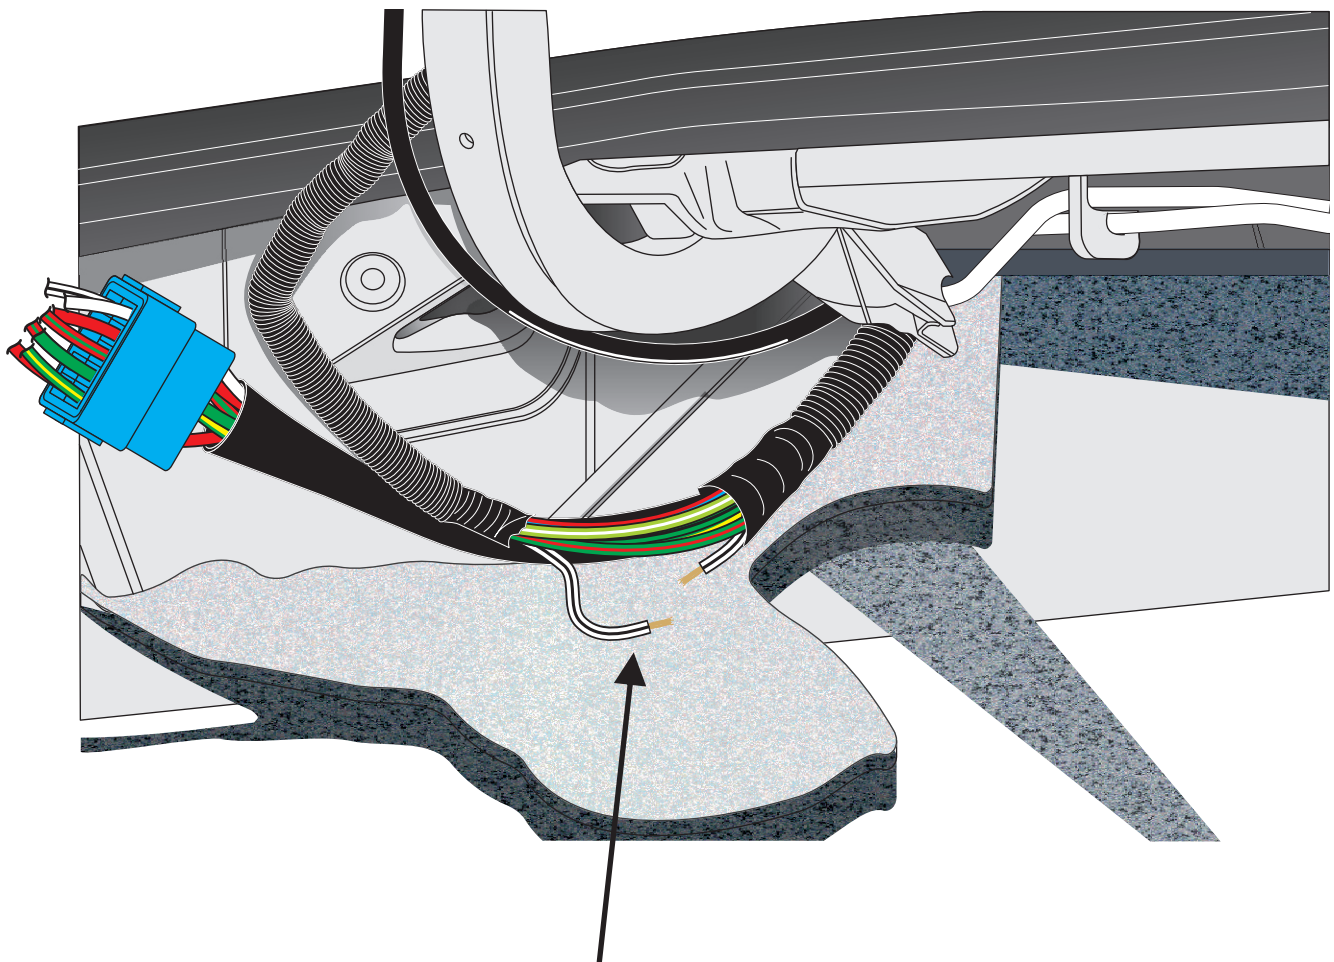
CAUSE: One cause may be a broken Brake Lamp and/or Reverse Back Up Lamp ground wire in the harness which is routed through the luggage compartment of the vehicle. The harness that includes the Brake and Reverse Back Up Lamp ground wires runs very close to the deck lid hinge. Through repeated opening and closing of the deck lid, the wire harness is stretched and/or rubs on the hinge until finally one of the wires in the harness breaks. See Figure 1 for wire harness location in the luggage compartment. If the ground wire for the Brake and/or Back Up lamps is one of the broken wires, it may cause a PCM logic issue allowing the TCC Solenoid to inadvertently be activated when the brake pedal is depressed causing the engine to chug or lug as the vehicle is braking to a stop because the Torque Converter Clutch is applied. As the vehicle is approaching a complete stop and the downshift into first gear is achieved, TCC application is uncoupled because there is no oil pressure fed to the TCC solenoid in first gear.

Ground wire broken
in the harness.

NOTE: 1999 Toyota Avalon XLS wiring information used for the sample diagram. Since wiring diagrams, connector, splice, and ground information may vary from year to year and model to model, consult the appropriate factory manual for the vehicle you are working on. Repair the harness as necessary, and move or tie the harness away from the deck lid hinge to reduce possibility of future contact.
