Technical Service Information

JEEP/NAG1 TRANSMISSION OVERHEAT

JEEP/NAG1

TRANSMISSION OVERHEAT

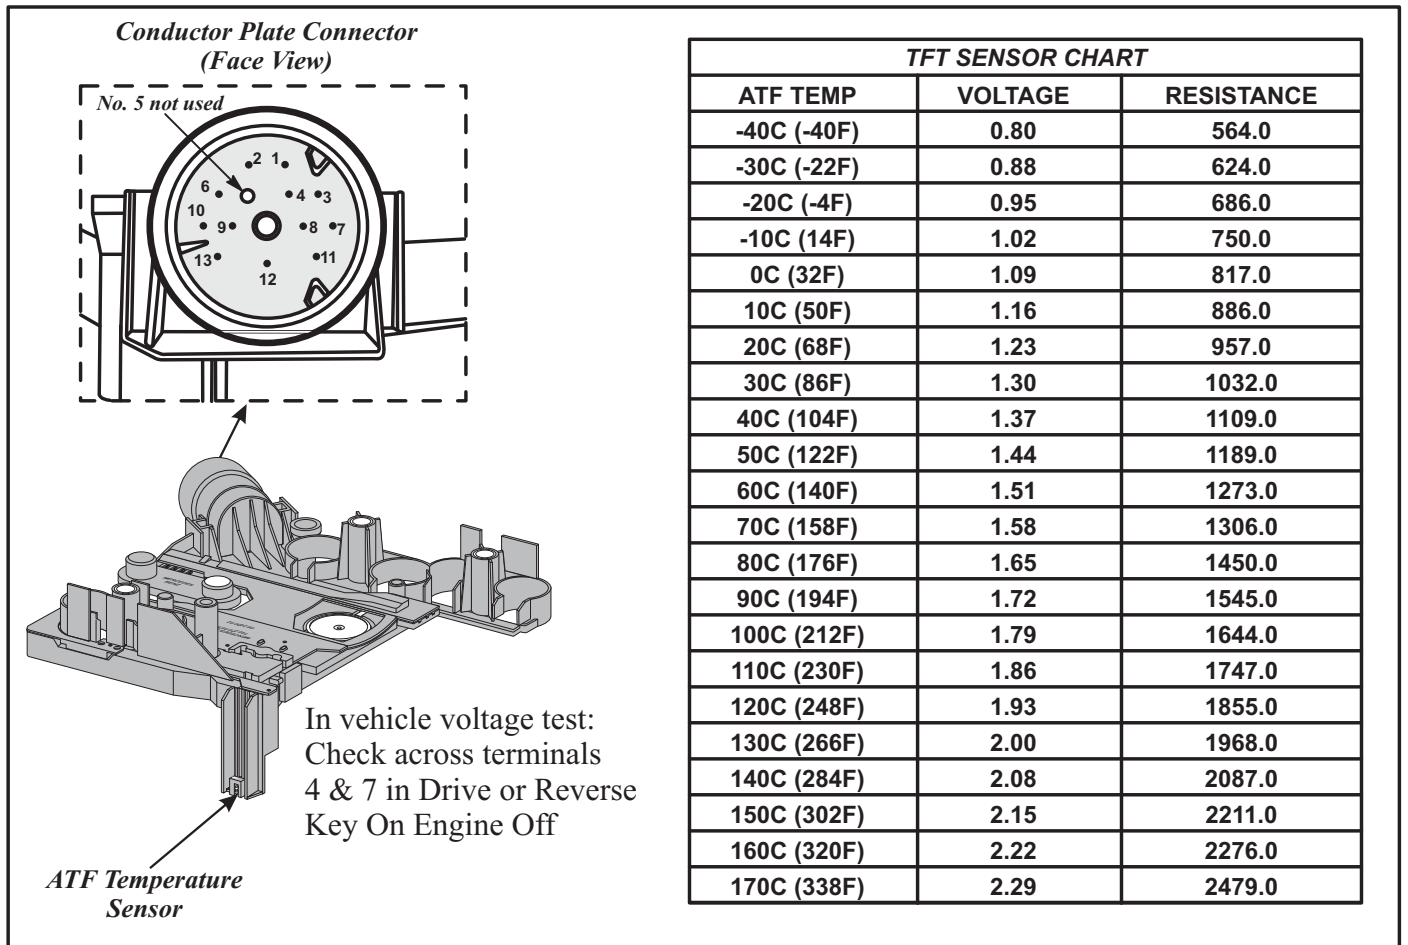
Figure 1

COMPLAINT: Jeep Grand Cherokee with a NAG1 transmission develops an illuminating transmission over-temperature light on the dash. The temperature sensor is part of the conductor plate inside the transmission (Figure 1).

This sensor is wired in series with the transmission Park/Neutral switch. The Transmission Control Module (TCM) expects to see a valid voltage level from the sensor when the shifter is in Reverse or any forward Drive position. The TCM also expects to see an open circuit condition when the shifter is in the Park or Neutral position.

As an attempt to resolve the problem the conductor plate was exchanged with a new one yet the overheat problem persists and the light continues to come on.

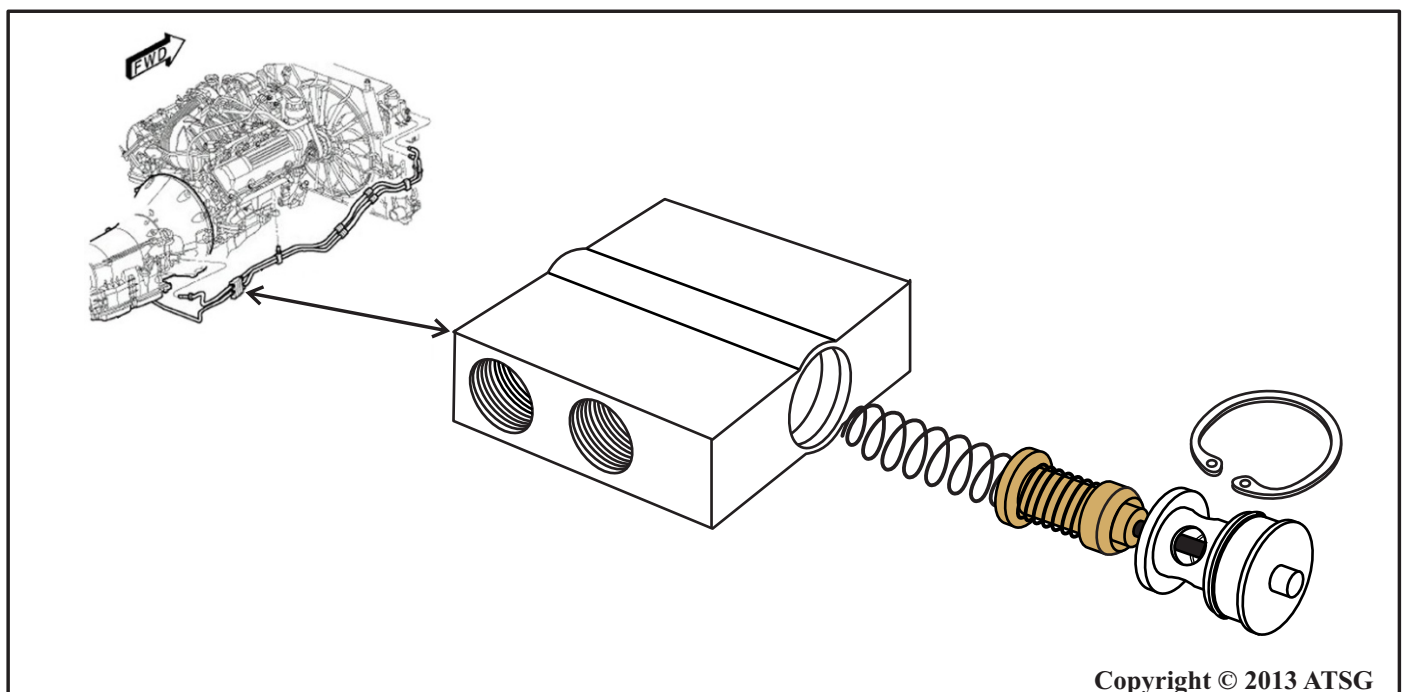
Figure 2

CAUSE: One cause may be a malfunctioning thermal by-pass valve assembly located in the cooling lines between the transmission and cooler (See Figure 2). This thermal-bypass valve prevents transmission fluid from reaching the cooler when temperatures are below 160 °F. Once temperature rises above 160 °F the thermal valve changes position causing the fluid to be directed to the cooler (See Figure 3).

When this thermal valve malfunctions, it no longer directs the fluid to the cooler causing the fluid temperature to rise above normal triggering the transmission over-temperature message to be displayed in the dash.

CORRECTION: Replace the Thermal By-Pass Valve Assembly

Thermal By-Pass Valve Assembly.....1-55111005AC

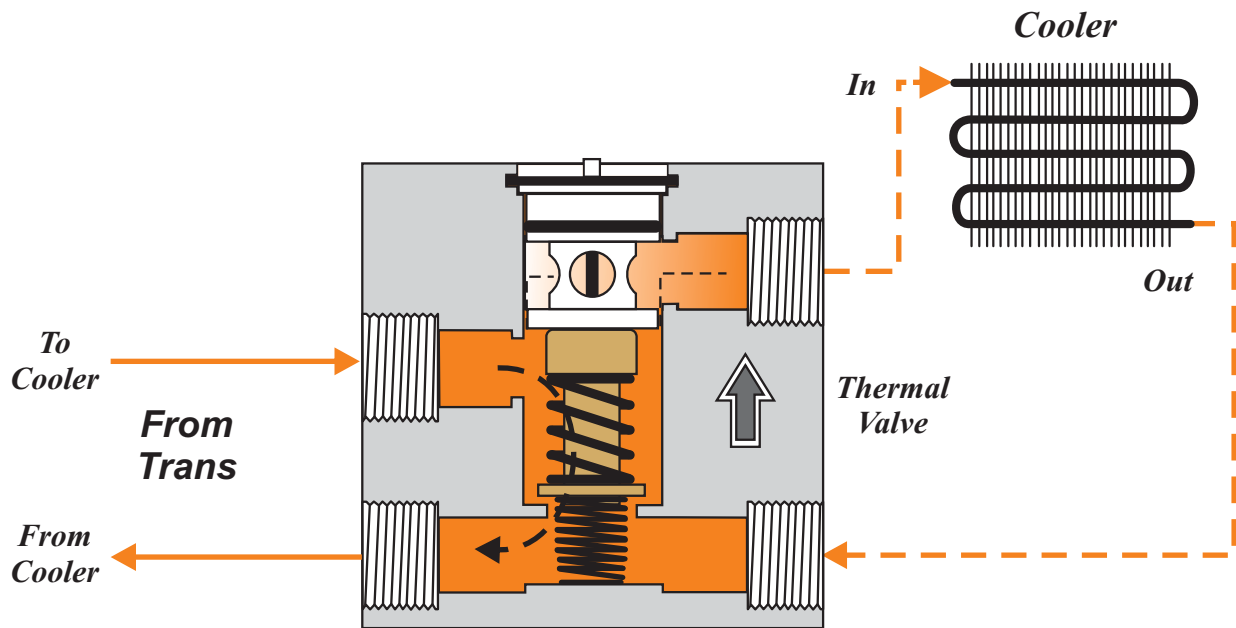
COOLER BYPASS IN USE BELOW 160°

*Summary: When ATF temp is Below 160°F the Thermal Valve is against the aluminum Plug closing the connection to the cooler, although there is residual pressure going to the cooler from the clearance between the plug and the bore(.006")
In this position the bottom of the thermal valve opens the connection from the To cooler passage, from the Trans, to the From Cooler passage, bypassing the Cooler.*

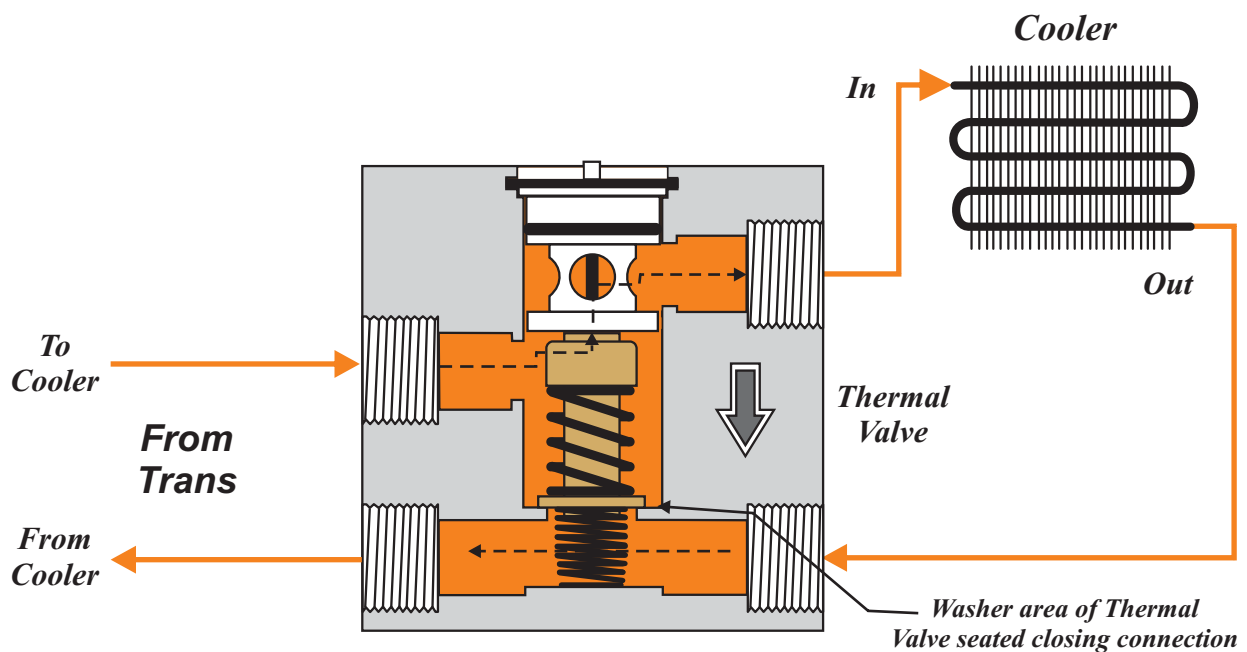
COOLER BYPASS NOT IN USE ABOVE 160°

*Summary: When ATF temp is Above 160°F the Thermal Valve moves away from the aluminum Plug opening the connection from the Trans, to the cooler.
In this position the bottom of the thermal valve closes the connection for the bypass and the To Cooler passage is connected solely to the Cooler.*
