## ZF5HP24 NEUTRALIZATION WHEN HOT FORWARD CHATTER ON TAKE OFF

## ZF5HP24

### NEUTRALIZATION WHEN HOT

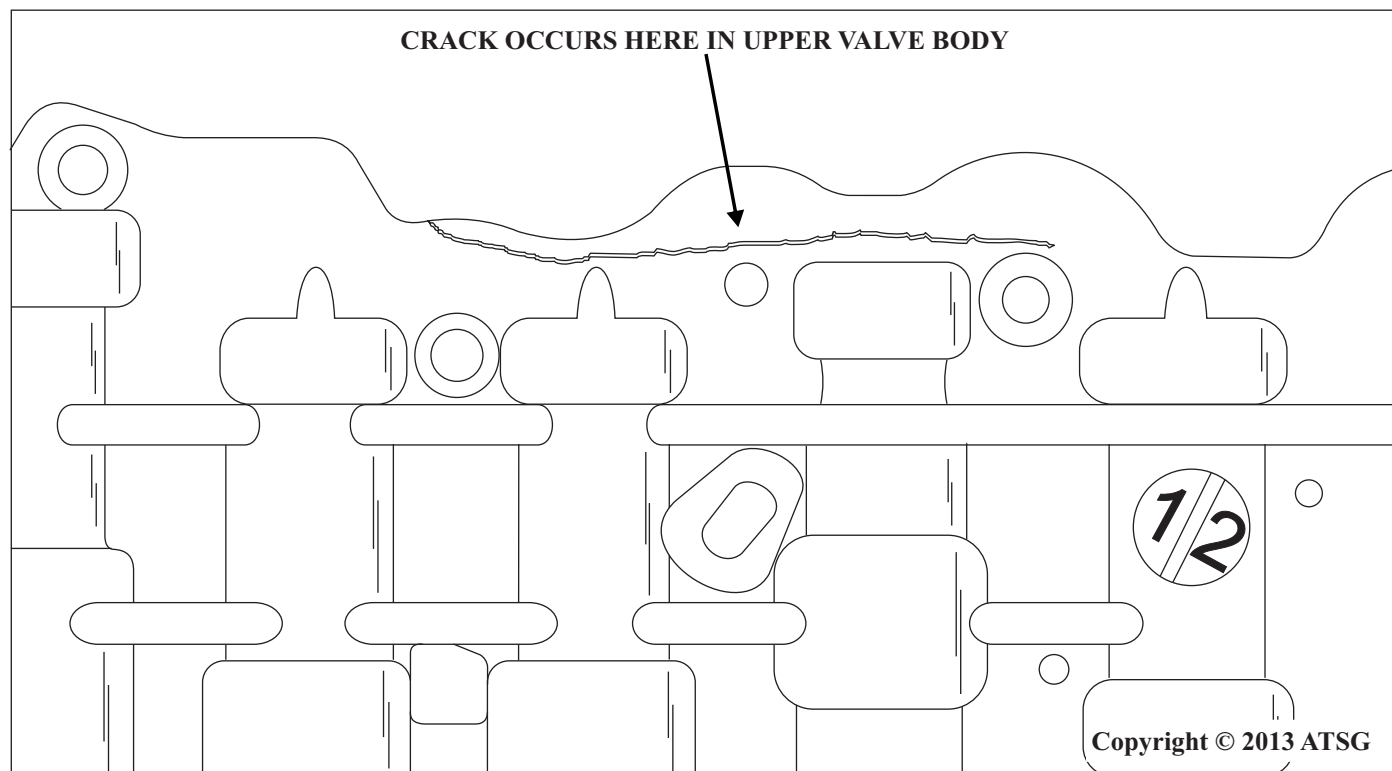
Figure 1

**CAUSE:** A crack develops in the upper valve body (Refer to figure 1) in the “F” clutch circuit as seen in figure 2 which results in a loss of “F” clutch oil. The “F” clutch is on in park, reverse and neutral as well as manual low as shown in the clutch application chart in figure 3. Since the complaint of neutral at a stop affects forward movement, yet it does not affect reverse is due to the “F” clutch being fed in park and neutral by the “F” clutch valve but in reverse it is fed line pressure through the reverse valve as shown in Figure 2. The reason first gear is affected is because oil pressure is being supplied to the closed “F” clutch valve through the hydraulic circuit that is affected by the crack from shift valve 1 as seen in figure 2. This circuit is connected to the “A” clutch in first gear only. So the loss of pressure going to the “F” clutch valve is enough to cause the “A” clutch to release at engine idle RPMS when hot and slip the clutch on initial take-off, hence the first gear ratio codes and the remaining forward gears will not be affected.

**CORRECTION:** Replace the upper valve body or the complete valve body assembly.
