## DODGE 48RE PARTIAL ENGINE STALL/SUDDEN ENGINE RPM INCREASE

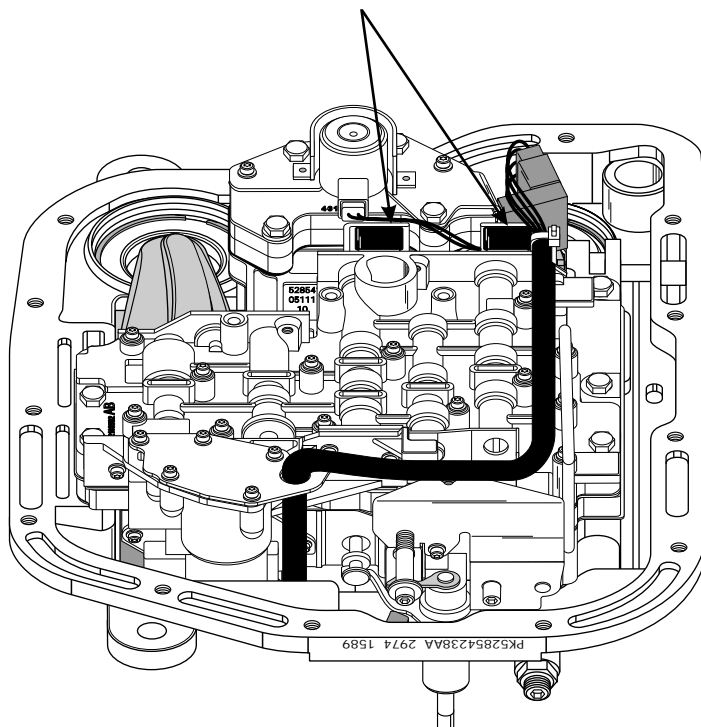
Figure 1

**CAUSE:** The cause may be, that the Torque Converter Clutch solenoid, located in Figure 1, is partially restricted, causing the Lock-up valve and Lock-up switch valve to stroke applying the Torque Converter Clutch. The 48RE transmission unlike the 46/47RE has 1st gear TCC capability, as shown in the partial oil circuit diagram in Figure 2, and when the solenoid is mechanically restricted it will cause the TCC to apply in 1st gear. The ECM, on these Diesel applications can bring engine rpm up when the TCC is applied to keep the engine from stalling. **Note: Customers that have had this complaint have found that if the vehicle is hard to stop, pushing the selector in to neutral, with the brake depressed will stop the ECM from driving up the engine rpm and will allow the vehicle to stop much easier.**

### LOCK-UP AND OVERDRIVE SOLENOID ASSEMBLY

**CORRECTION:** To correct this condition, replace the Lock-up and Overdrive solenoid assembly, as they are assembled together as shown in Figure 1.

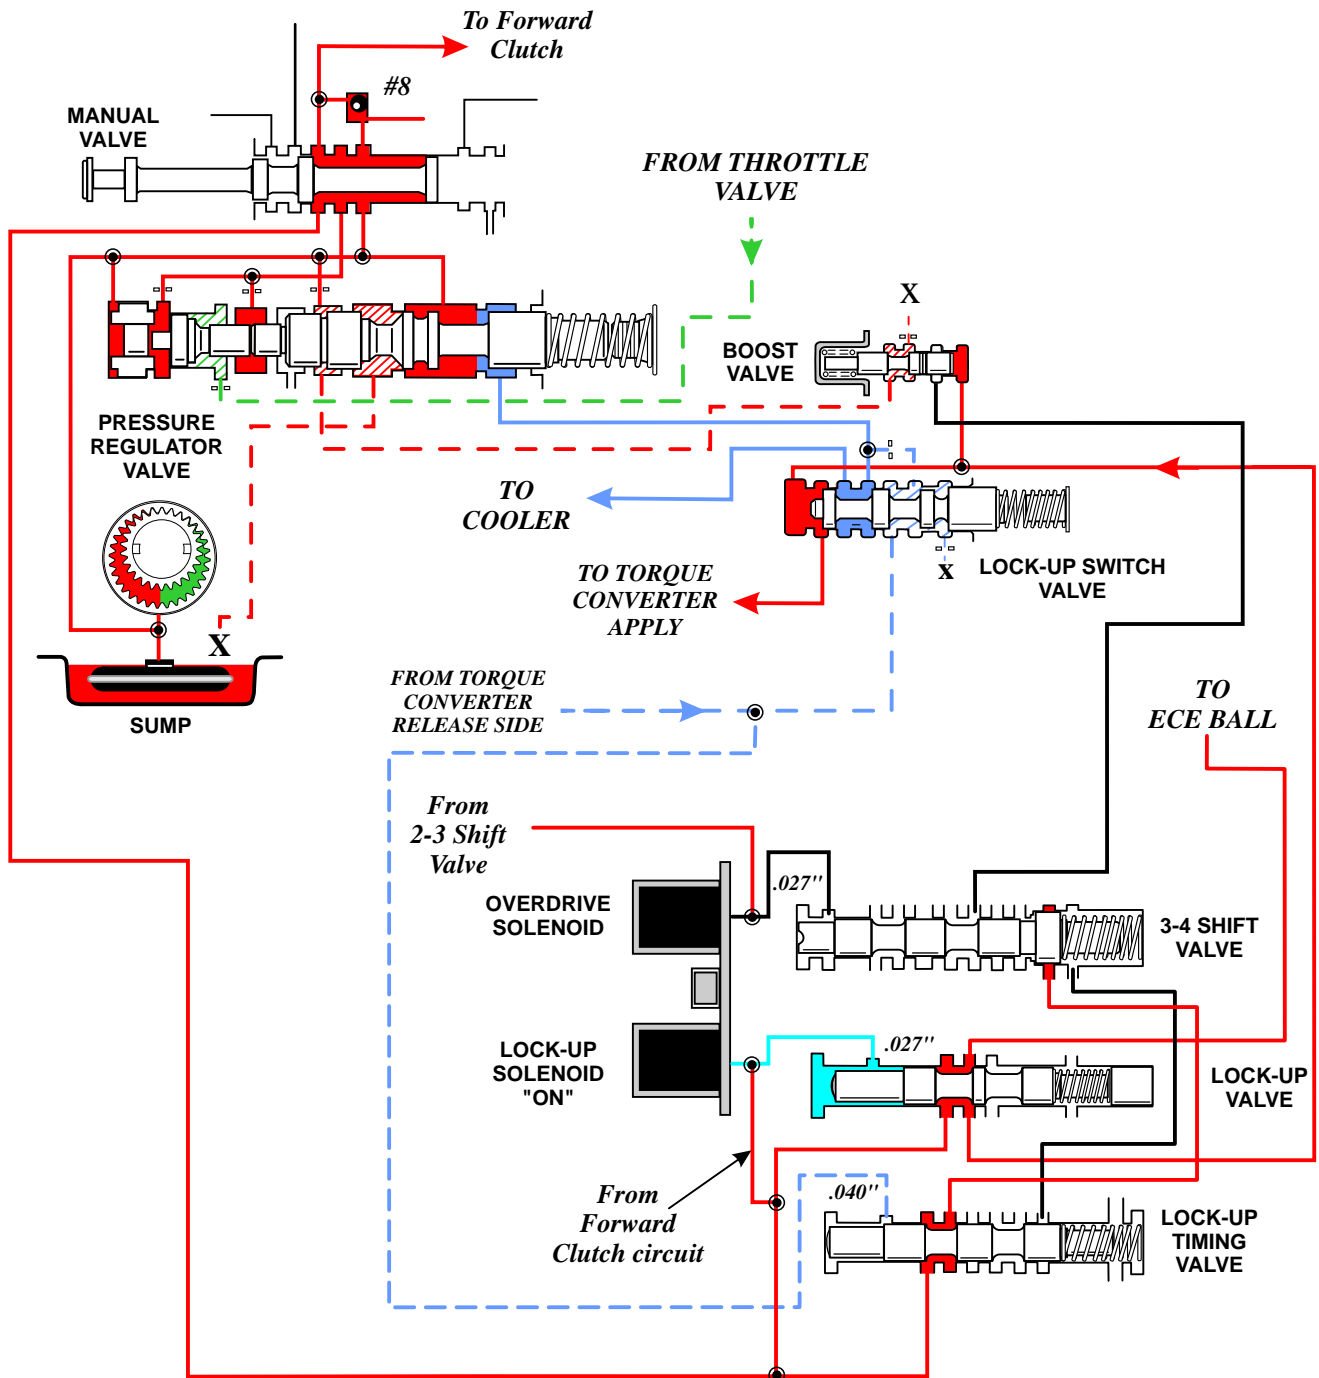
Figure 2

## 48RE PARTIAL HYDRAULIC SCHEMATIC "DRIVE" POSITION 1st GEAR WITH TCC "ON"

*Note: A partially restricted Lock-up Solenoid can cause engine stumble in Drive 1st Gear.*
