HONDA/ACURA V6 5 SPEED OVERHEATED TORQUE CONVERTER

HONDA/ACURA OVERHEATED TORQUE CONVERTER

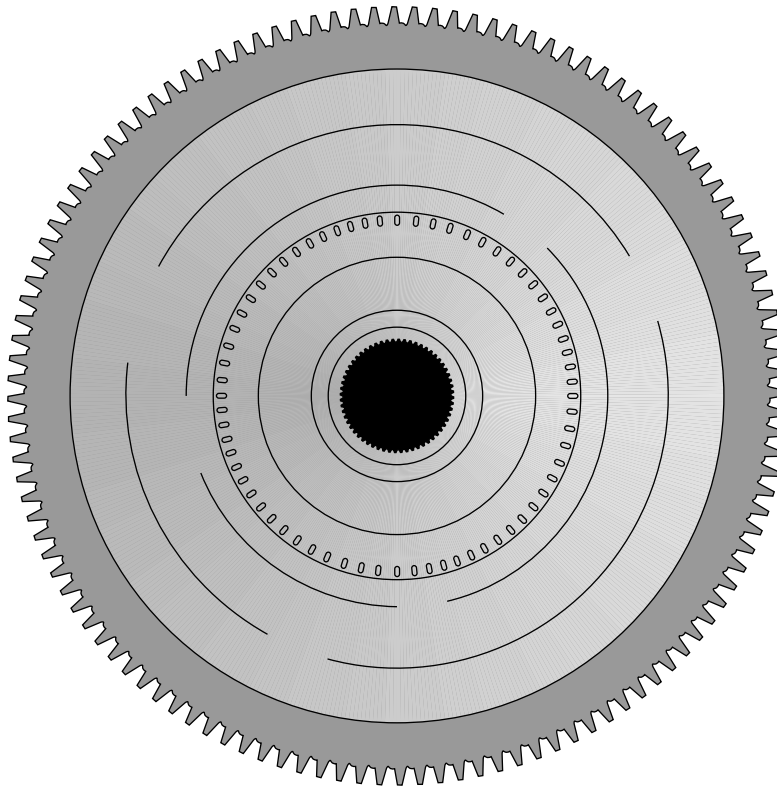
Figure 1

COMPLAINT: Honda or Acura V6 5 speed applications may come in with the torque converter discolored due to severe overheating, see Figure 1.
The vehicle may come back after transmission repairs with the same complaint. In both instances Diagnostic Trouble Code P0740 for converter clutch slippage may also be stored.

OVERHEATED TORQUE CONVERTER

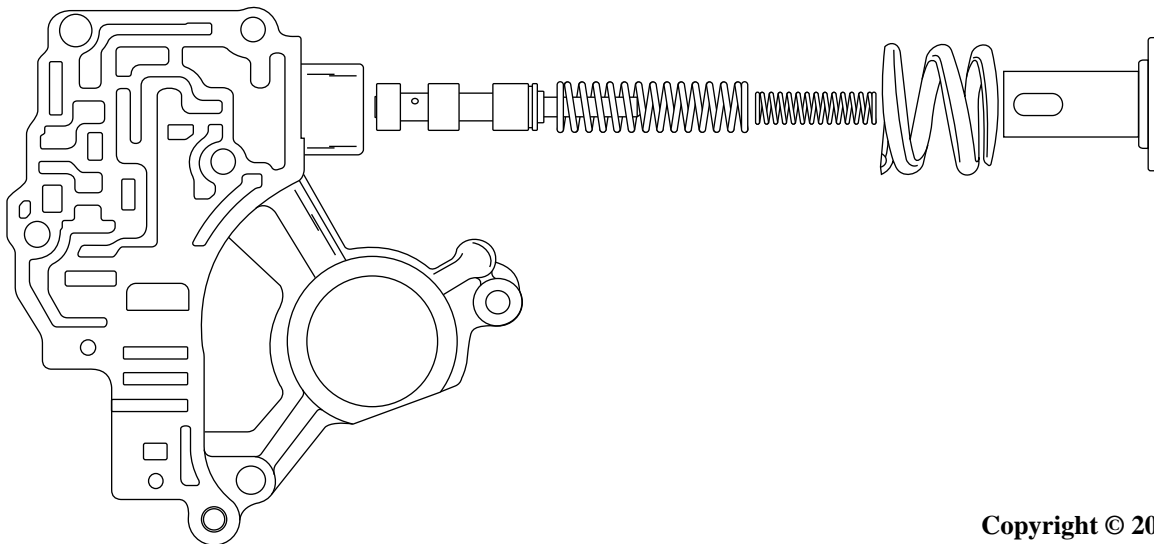
Figure 2

1. Pressure Regulator Valve issues, Figure 2.
2. Leaking bore plugs on the Lock-Up Shift and Lock-Up Control Valves.
3. A leaking TC Check Valve which is usually located between the front case half and the main valve body.
4. A restricted fluid warmer for those units that have them mounted on top of the transaxle.
5. A restricted factory inline filter.
6. Warped valve body sections.
7. Wear in the pump gear area.
8. A poor fit between the converter neck o-ring and the inner pump gear.
9. The use of poor quality transmission fluid.

PRESSURE REGULATOR VALVE ASSEMBLY
