Technical Service Information

MERCEDES 722.9 CHECK BALL FUNCTION AND LOCATION

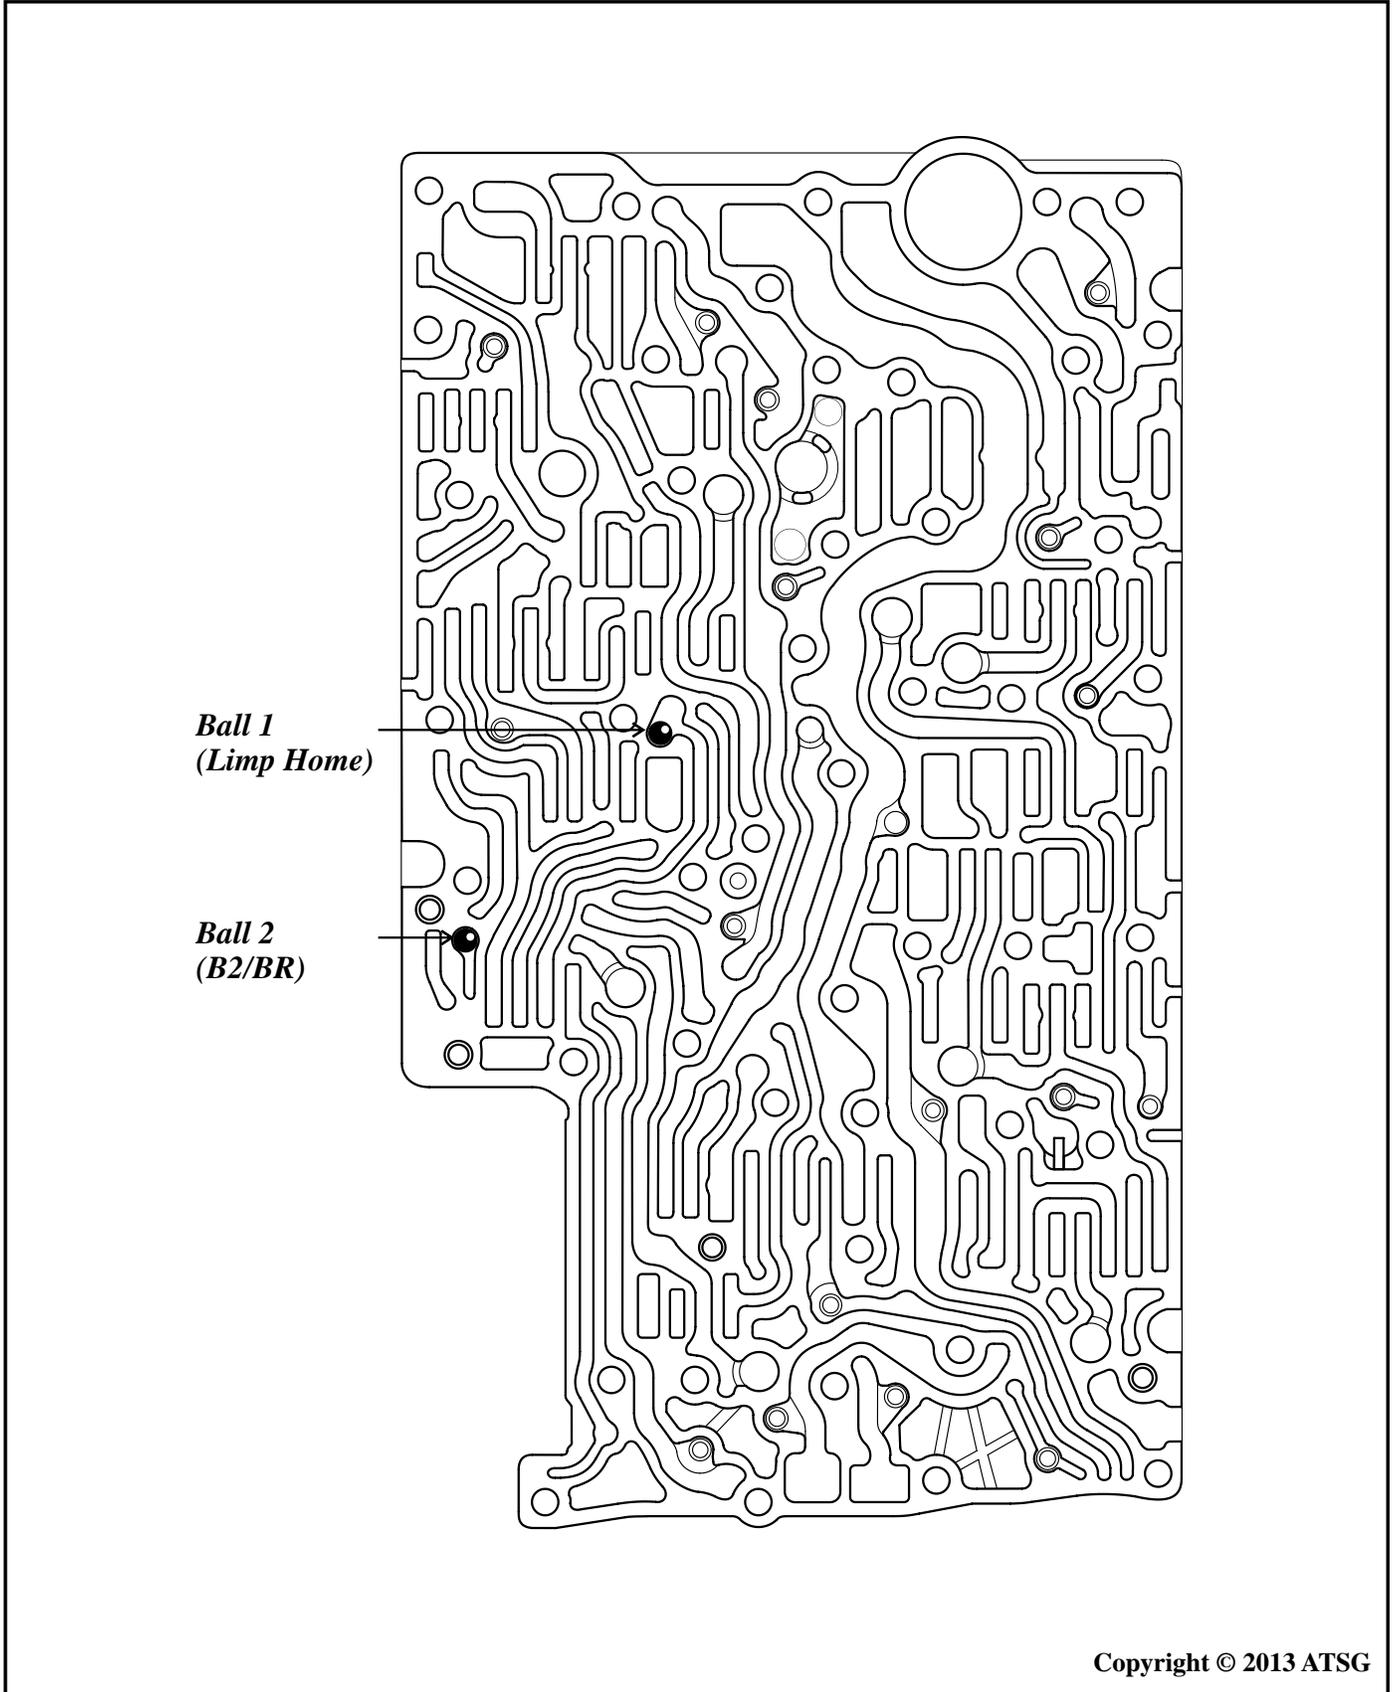
Figure 1

CAUSE: There are only two black Teflon style check balls in the 722.9 valve body that are used in the hydraulic activity of the transmission (Figures 1 and 4). The other 14 steel check balls are not (Figures 2 and 4). By gravity, these check balls seal off test ports used during the assembly process in the factory. Should any one of these balls be left out or misplaced a leak in a clutch circuit or a solenoid's signal oil circuit will occur causing some of the above mentioned complaints depending upon which ball or balls is missing or not sealing.

2 Black Check Ball Identification and Location

CORRECTION: Inspect each check ball for proper location and that each of the steel balls are in place and sealing off the test port so that their respective circuits are no longer dumping to exhaust.

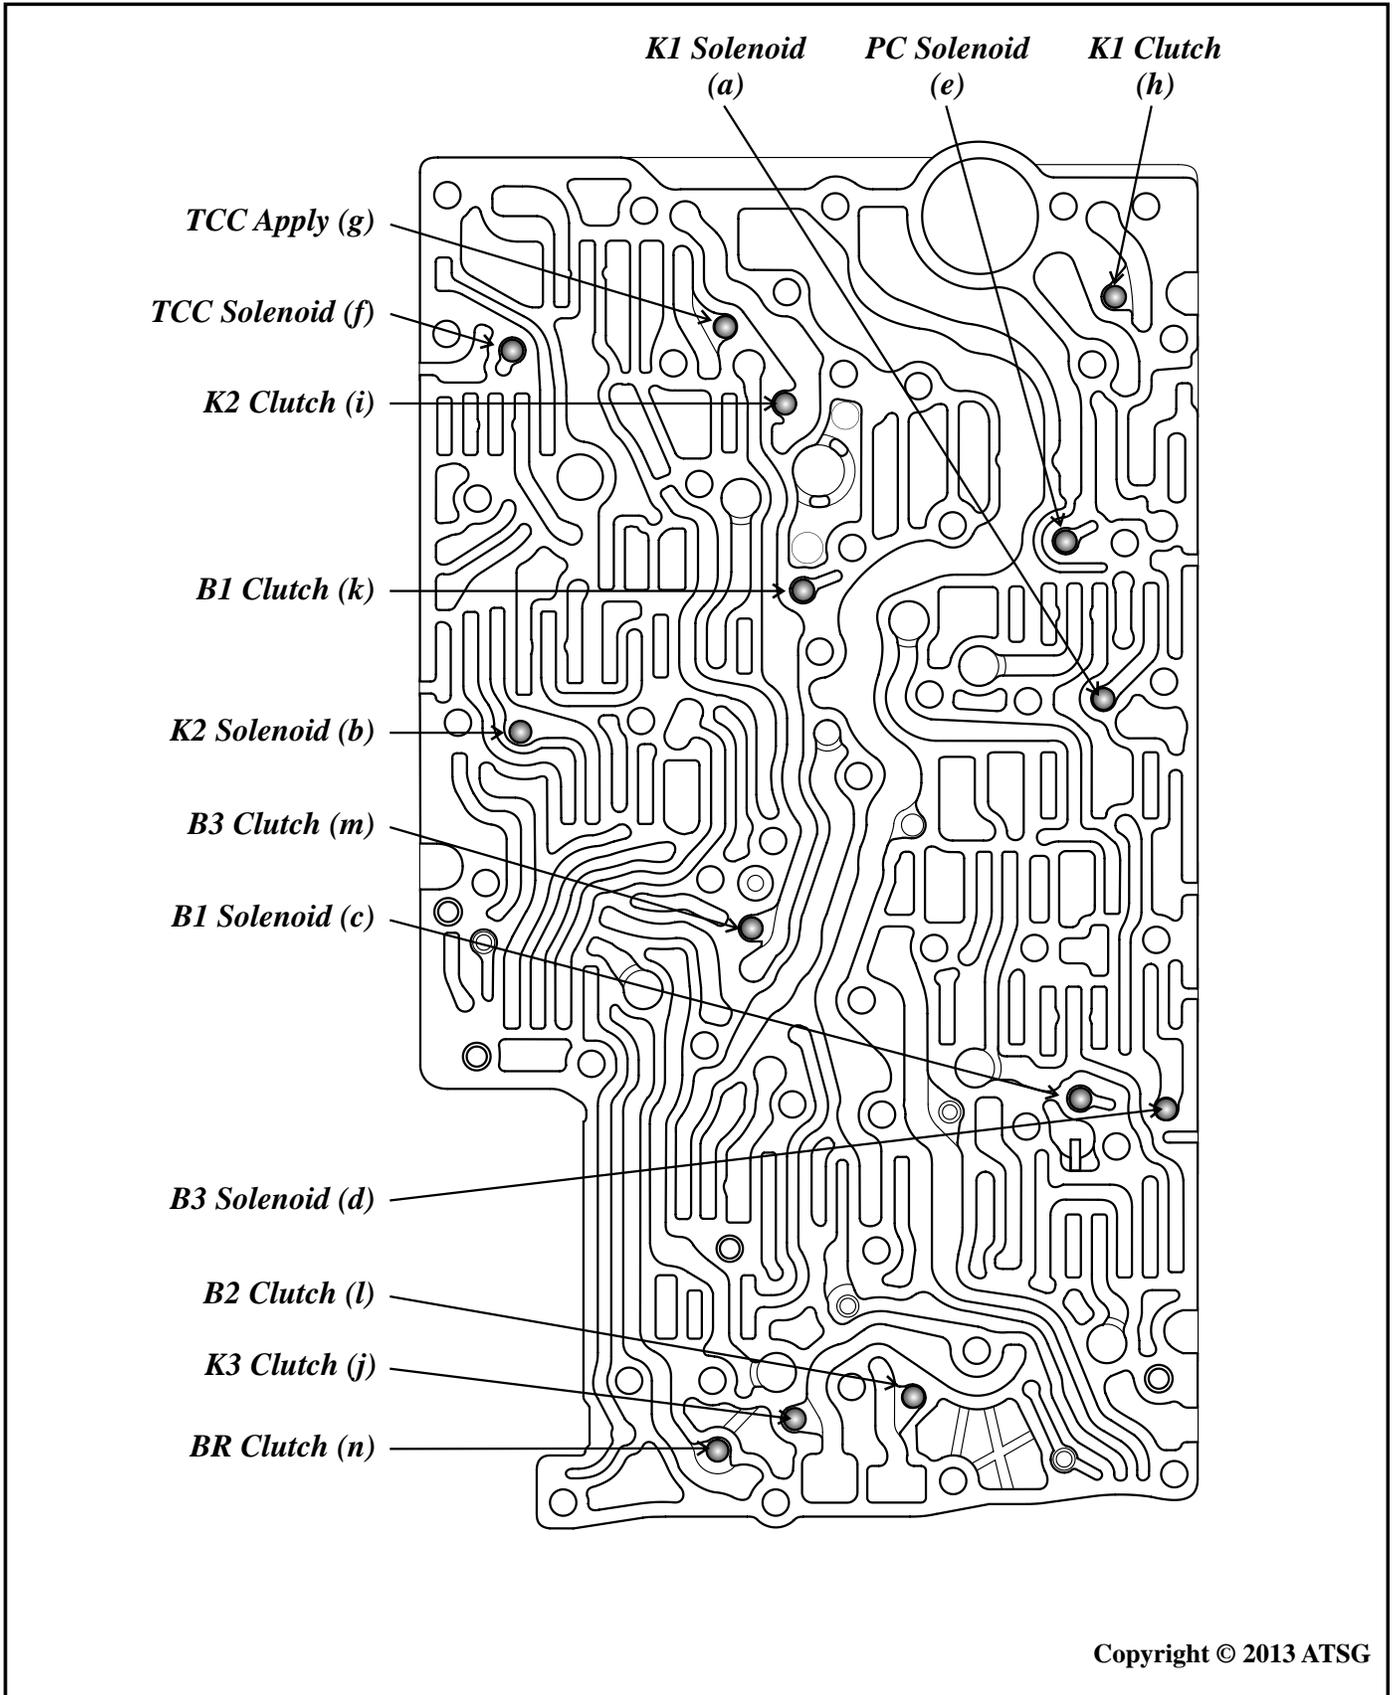
Figure 2

14 Steel Check Ball Identification and Locations Sealing Off Factory Measuring Points

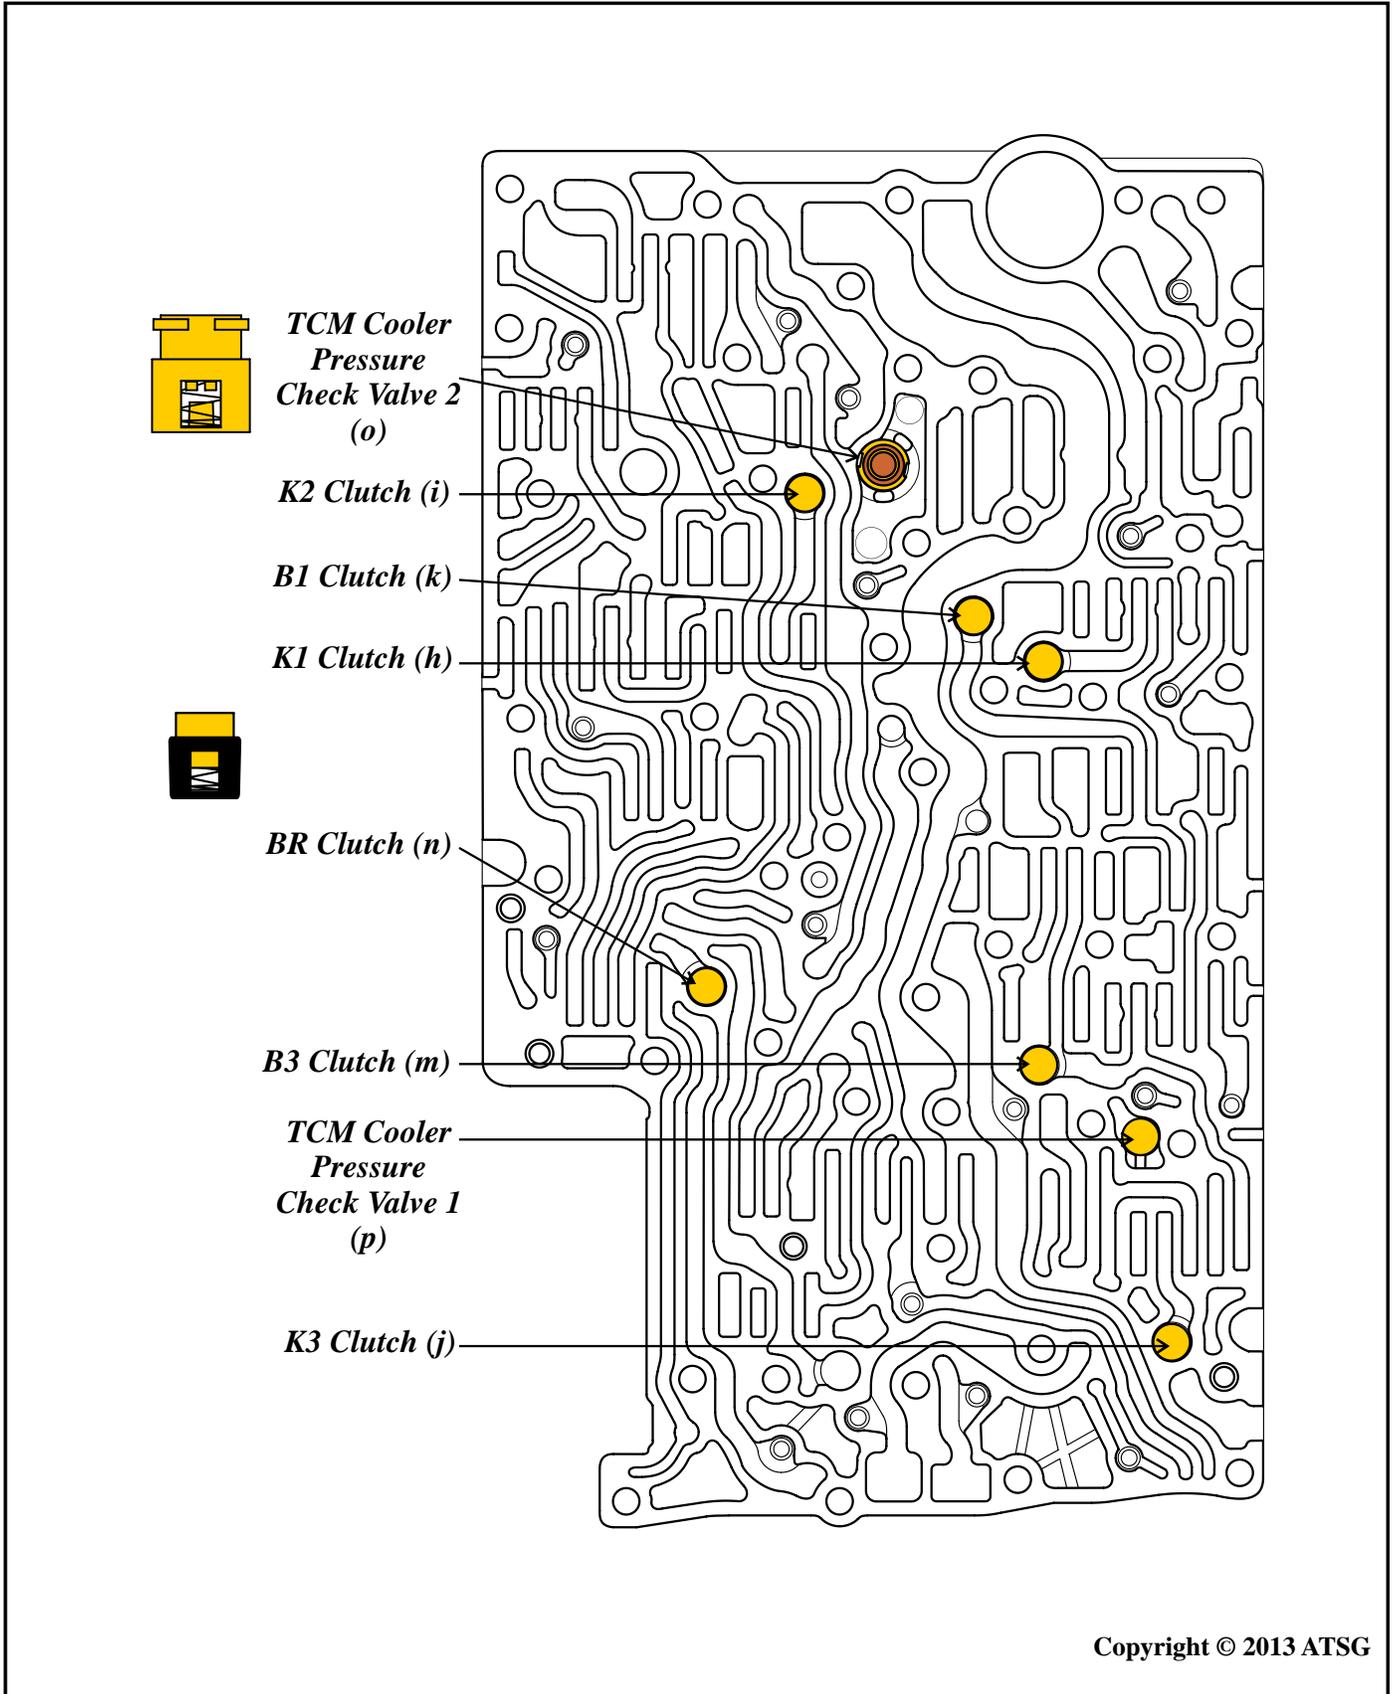
Figure 3

8 Check Valve Identification and Location

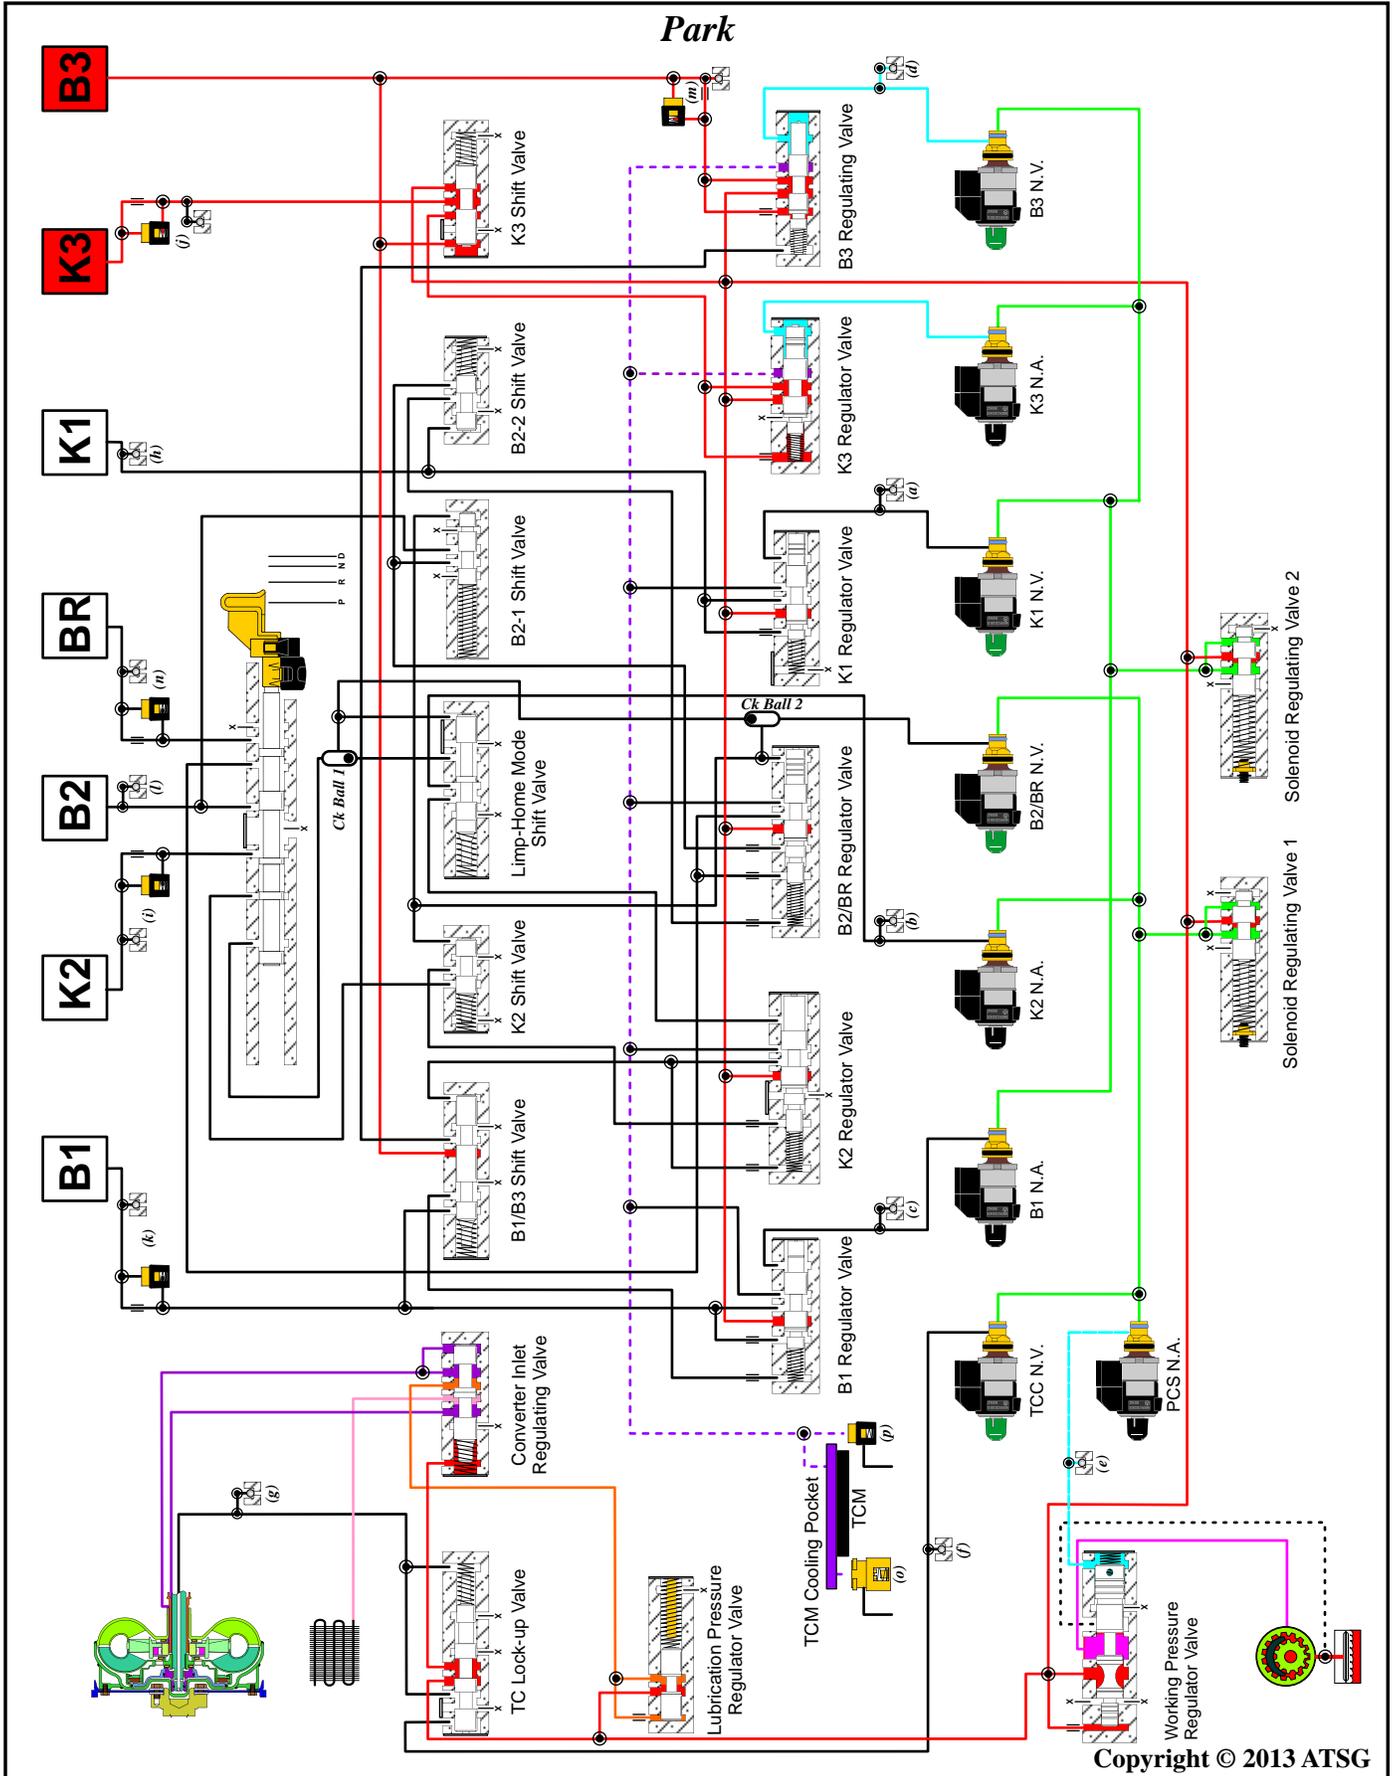
Figure 4

In addition to the steel check balls being specifically identified in figure 2 and the check valves in figure 3, a lower case letter has been assigned to show its location in the hydraulic schematic provided in figure 4.
