Technical Service Information

NISSAN RE5R05A FLARE 3-4 NO 5th GEAR

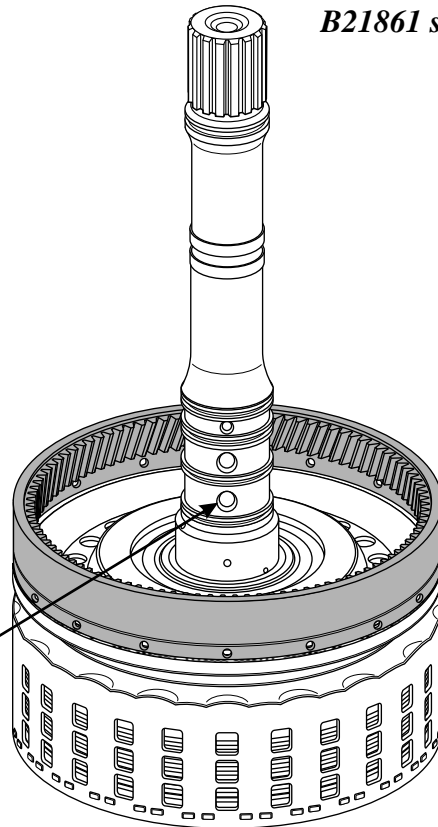
CAUSE: The cause may be, the Input Clutch/Turbine shaft sealing rings, as shown in Figure 1, were stretched too far when they were installed causing a slight bend in the ring or the plastic rings are not conforming to the inside of the pump stator, creating a leak in the Input Clutch circuit.

INPUT CLUTCH/TURBINE SHAFT SEALING RINGS

Do NOT spread the ends of the sealing ring apart to install over the turbine shaft- it will bend and not seal

CORRECTION: To correct this condition, inspect the sleeve area of the back of the pump, shown in Figure 2, and ensure that it is not grooved and the support bearing is in good shape, replace as necessary. Air test the Input Clutch and make sure that it is solid shown in Figure 1, if the air test does not pass, refer to Figure 3 and renew piston seals and re-check. Contact your aftermarket supplier and locate Input Clutch rings made out of a teflon material, as it may conform to the inside of the pump stator easier than the plastic type. ***Special note:*** refer to Figure 1 to see instructions on how to install the sealing rings into the sealing ring land. Do not spread the sealing ring ends open like a you would a metal ring, as it will make a small bend in the ring and not allow the sealing ring to seal causing a leak. Install the ring 1 leg at a time into the ring land.

Bring 1 leg at a time into the sealing ring groove

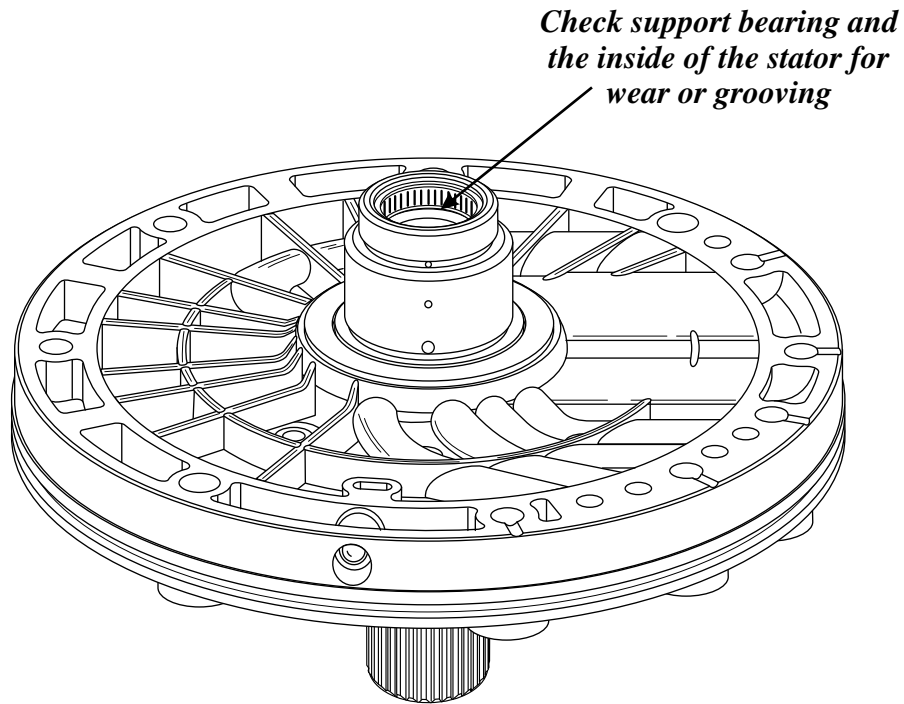
Figure 2

STATOR SHAFT
