Technical Service Information

GM 4L60/65E

NO ENGAGEMENT -REPEAT PUMP ROTOR DESTRUCTION

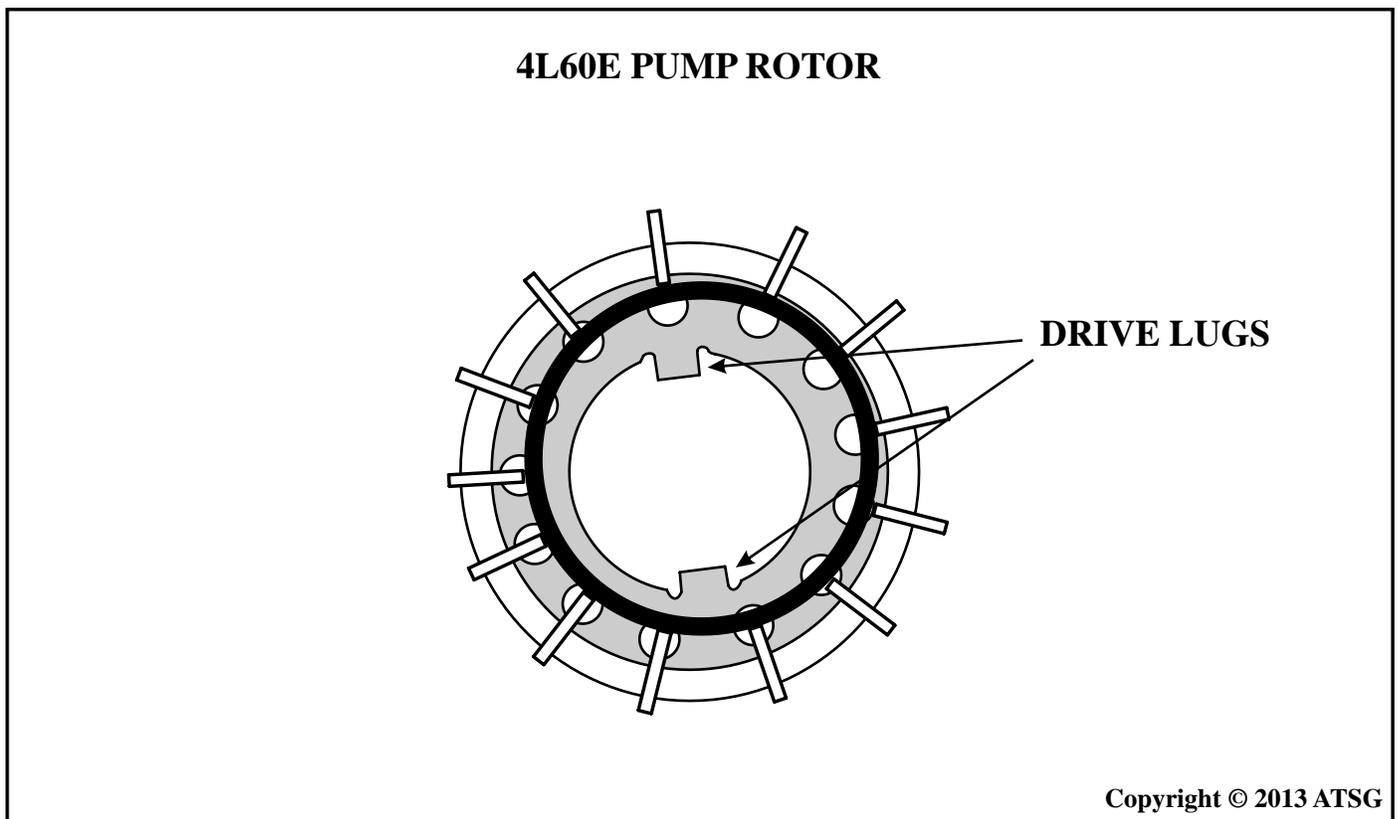
Figure 1

COMPLAINT: After overhaul, 02 and up Chevy Trailblazers equipped with the 4.2-6 cyl. and the 300 mm. B-85 Torque Converter with the stall code of VJCX, may exhibit a no engagement concern due to the pump rotor drive lugs breaking.

CAUSE: The cause may be, that during the Torque Converter rebuilding process a shorter converter drive hub was used which caused the build height to be too short. This will allow the Torque Converter drive hub to come out of the Pump rotor when a hard throttle passing gear maneuver occurs, and when the drive hub tries to index itself back into the Pump rotor, it is not aligned breaking the drive lugs off, as shown in Figure 1, which will in turn cause no line pressure/no engagement. *Note: This can be missed by the R&R tech as the bell housing is enclosed and the Torque Converter to Flex plate bolts are installed thru a small access hole underneath the structural oilpan.*

CORRECTION: Replace the Pump Rotor and or Pump as sometimes the pump is destroyed when the rotor breaks, and refer to Figure 2 and ensure that the Build Height is approximately 6 and 7/16.”

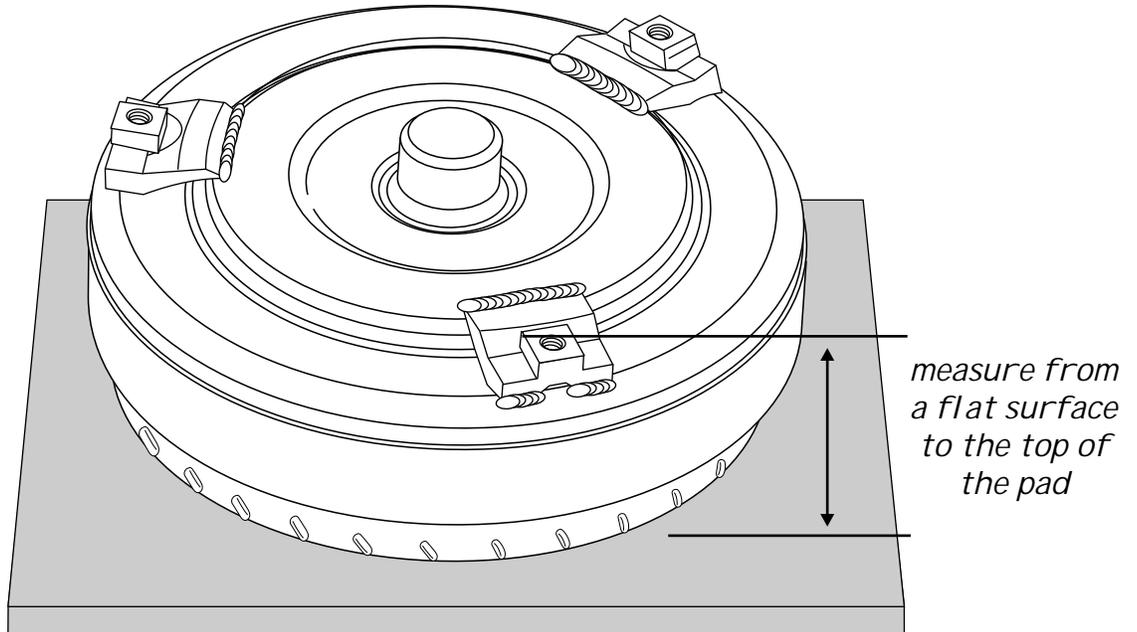
Figure 2

CHECKING OVERALL BUILD HEIGHT

**B-85 VJCX Build Height is approximately 6 and 7/16"
some reman converters measure 6 and 1/2"**

Place Torque Converter on a flat surface neck side down and measure from that surface to the top of the pad as shown above.
