Technical Service Information

DODGE/JEEP RE SERIES TRANSMISSIONS FORWARD CLUTCH FAILURE

COMPLAINT: Pre-mature failure of the forward clutch.

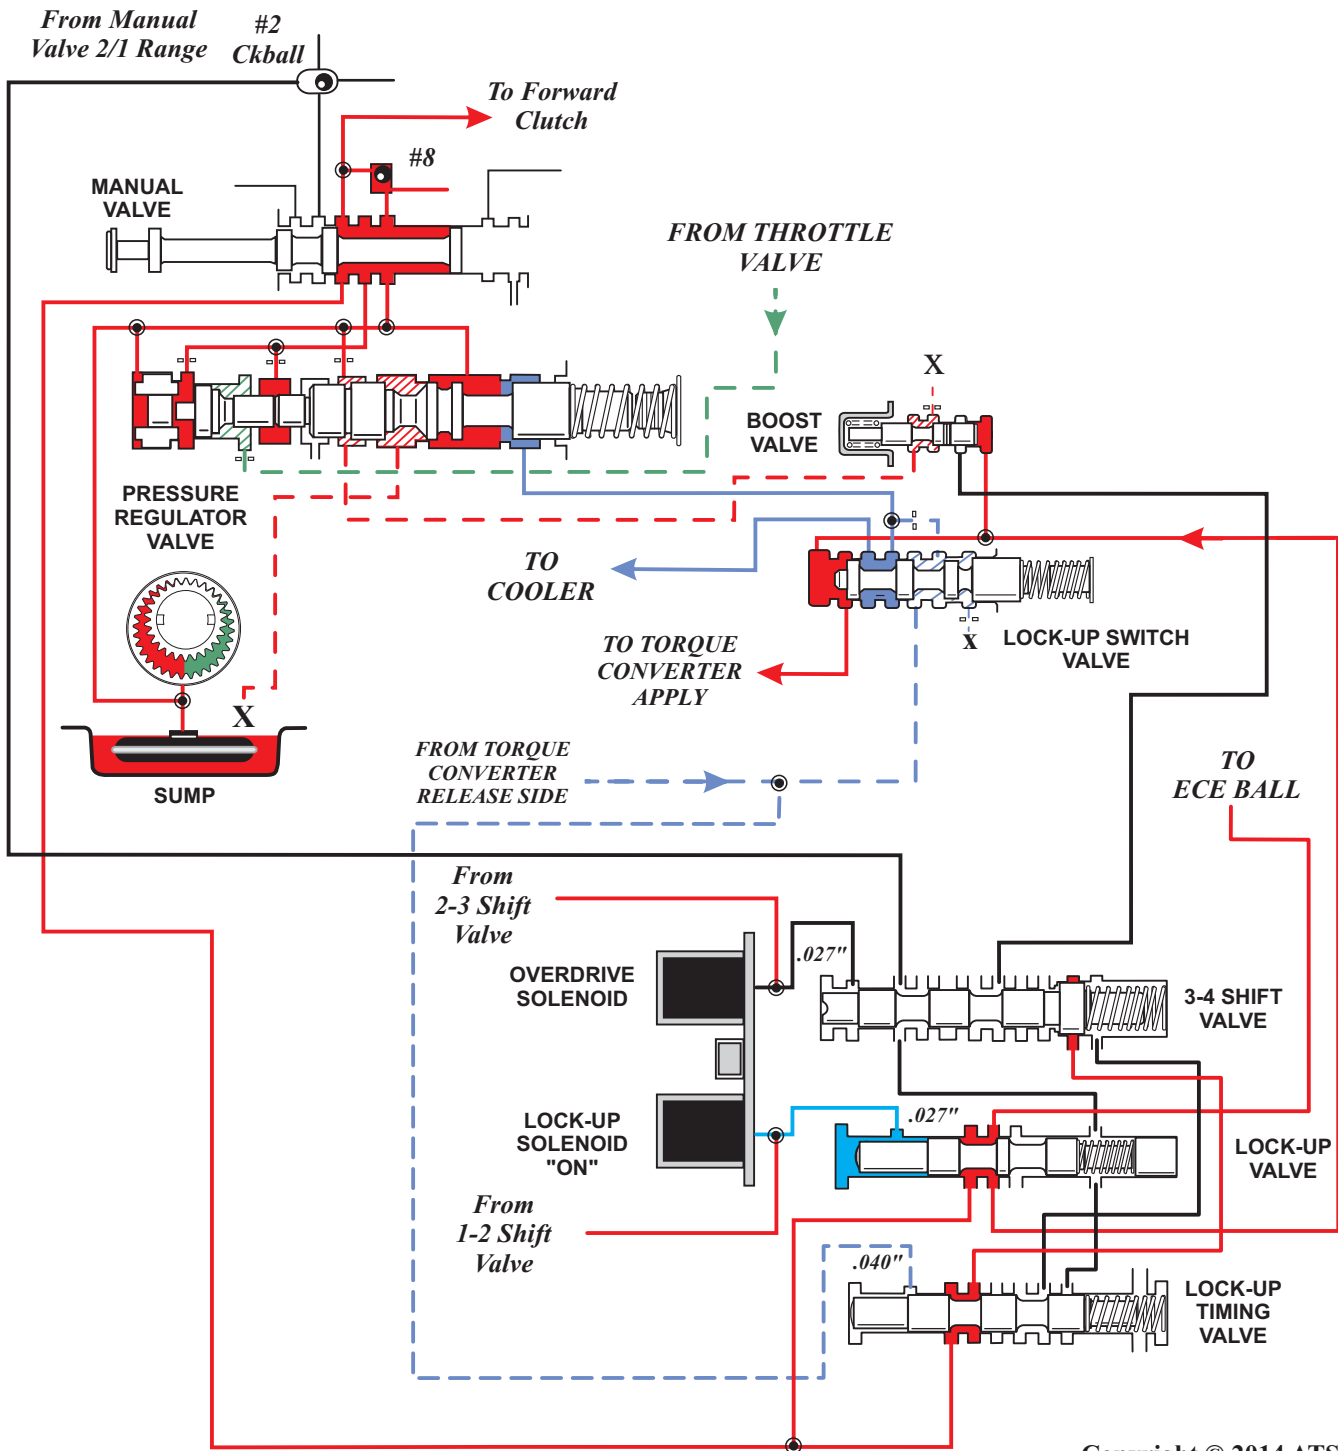
Figure 1

1. Manual valve alignment is critical as the forward clutch is fed directly from the valve as seen in figure 1. If the manual valve becomes mis-positioned, pressure to the clutch drops as it dumps to an exhaust through the neutral circuit. There are two areas of wear that takes place in the valve body that causes the manual valve to be mis-positioned

1. There are aftermarket sources which provide repair kits that correct the wear conditions related to the detent lever restoring the integrity of manual valve alignment. Otherwise, replace the valve body with one that does not have wear in the locations mentioned.
2. Replace the stator bushing.
3. There are aftermarket sources that provide modified inner lip seals for increased durability and pressure retention. Be sure to properly prepare the seal's surface area with 600 grit wet/dry paper.
4. Replace the forward drum assembly. If the power program/performance chip is kept in place, there are companies that provide modified performance parts designed to withstand the increased torque. The shaft and hub (# 104 in Figure 4) are usually billet in design or hardened 1 piece design.
5. Adjust end play according to manufacturer's procedures and specifications.

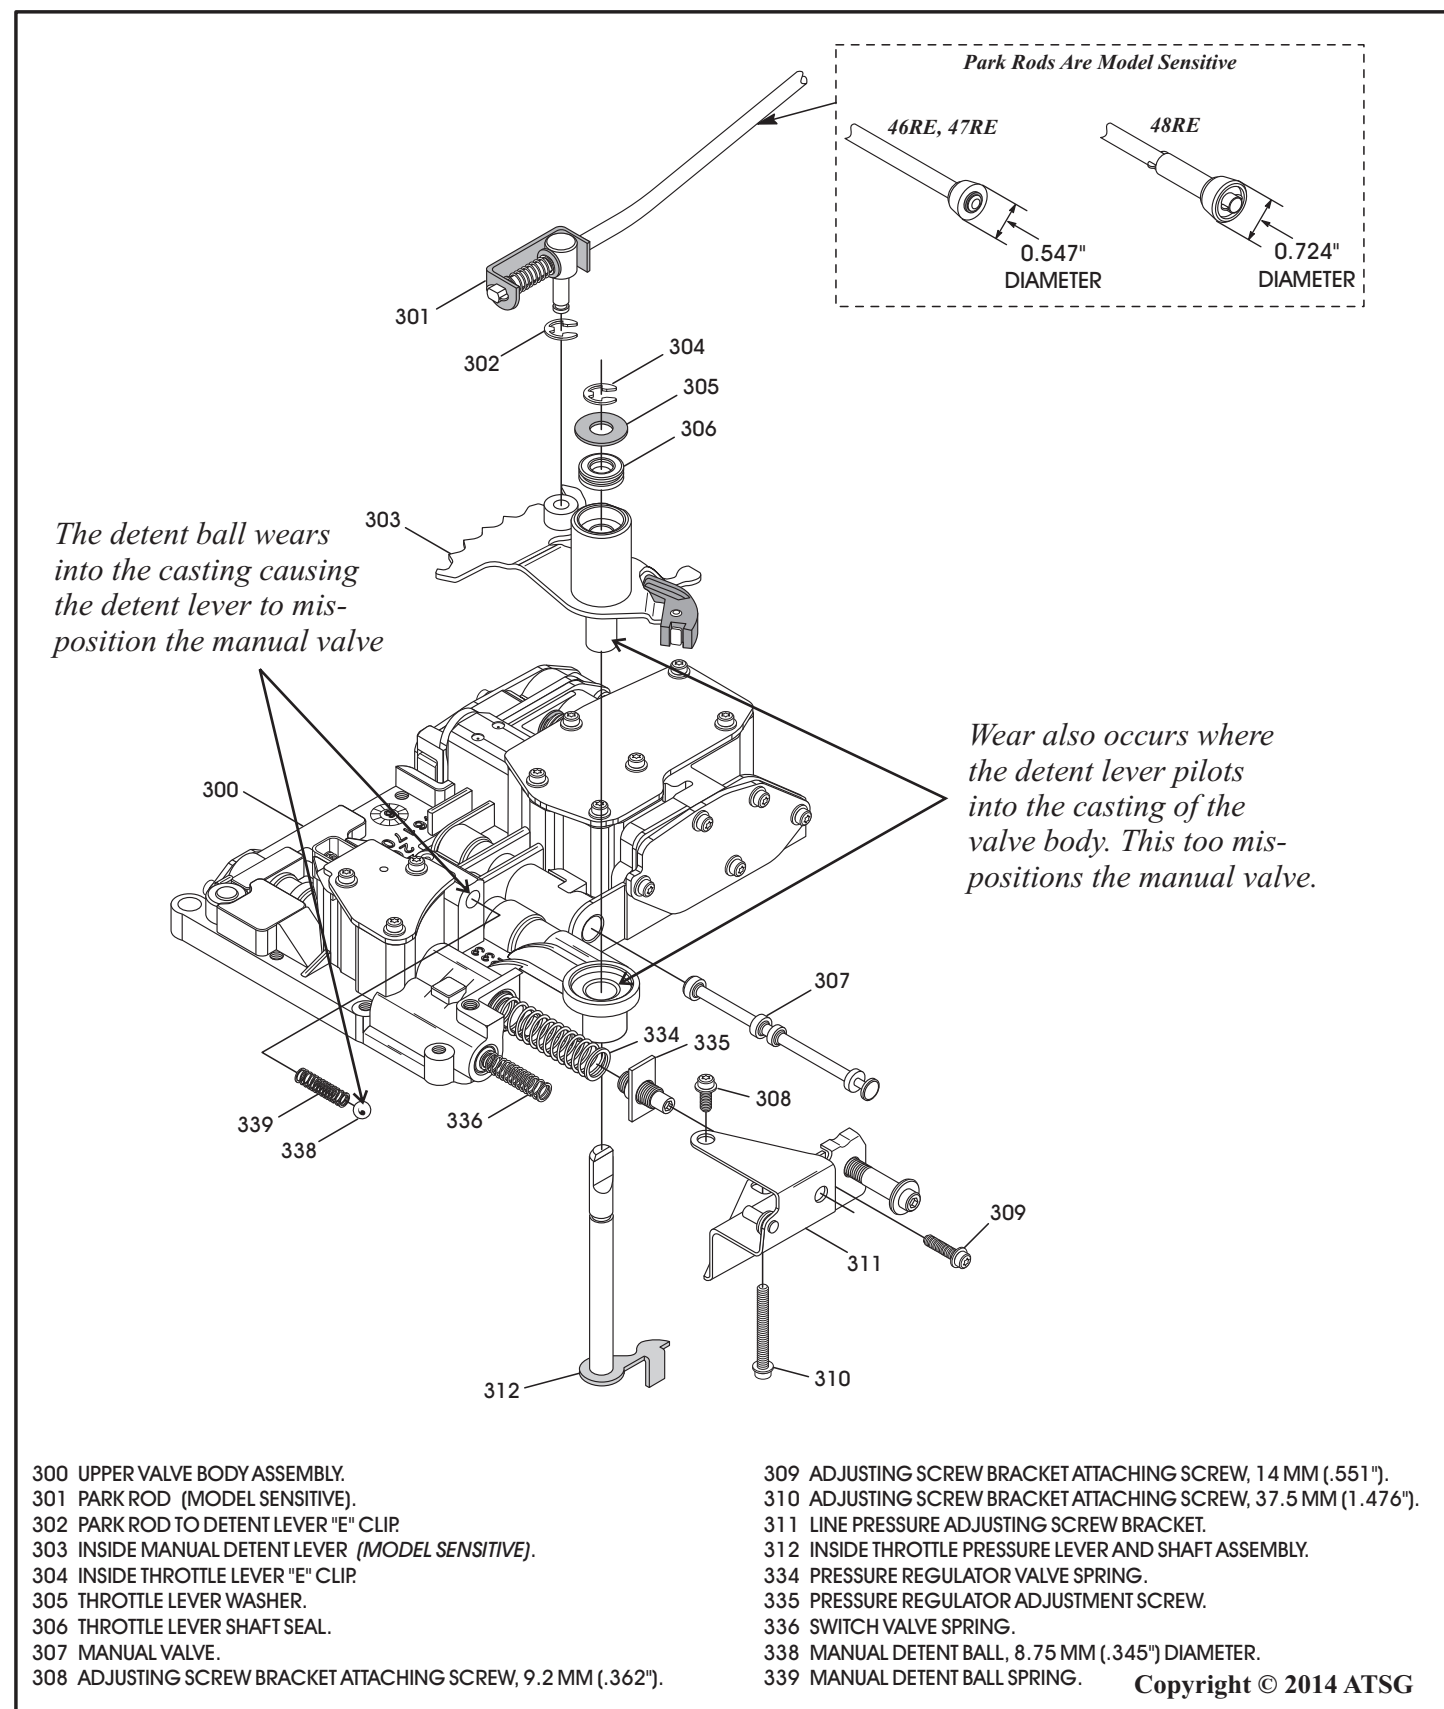
Figure 2

- a. The detent ball wears into the valve body due to the continuous movement and vibration of the manual valve linkage (Figure 2).
 - b. Wear also occurs where the detent lever pilots into the casting of the valve body. This too mis-positions the manual valve (Figure 2).

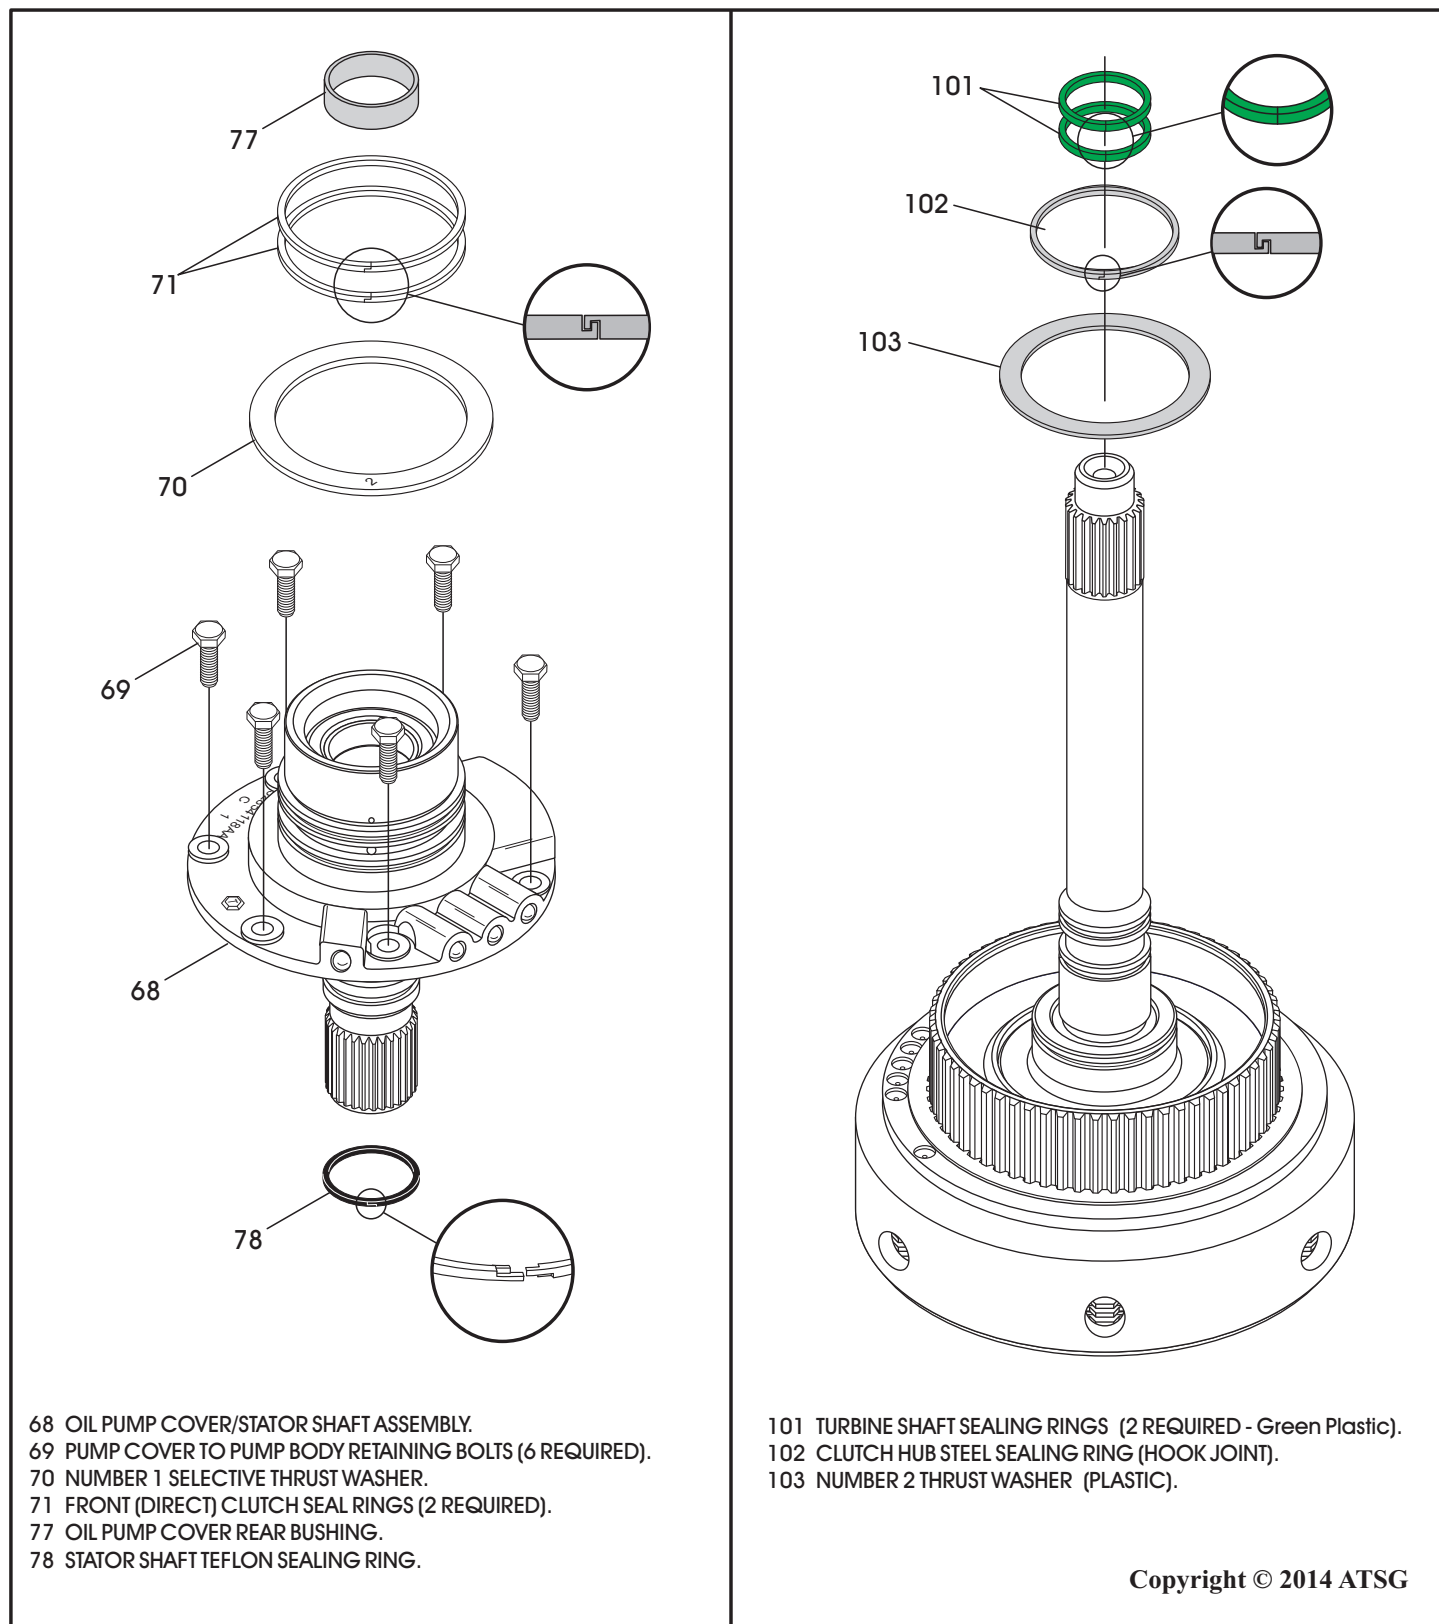
2. The stator support bushing (# 77 in Figure 3) is critical for proper support of the Input Shaft, particularly for the proper sealing of the green plastic style rings now being used in all the RE units (Figure 3). Poor support will compromise the ring's pressure retention causing the forward clutches to burn.

5. Excessive end play clearance allowing the forward clutch drum to move too far forward causing sealing ring # 102 in figure 3 to move far enough out of the pump to produce a leak in the forward clutch circuit.

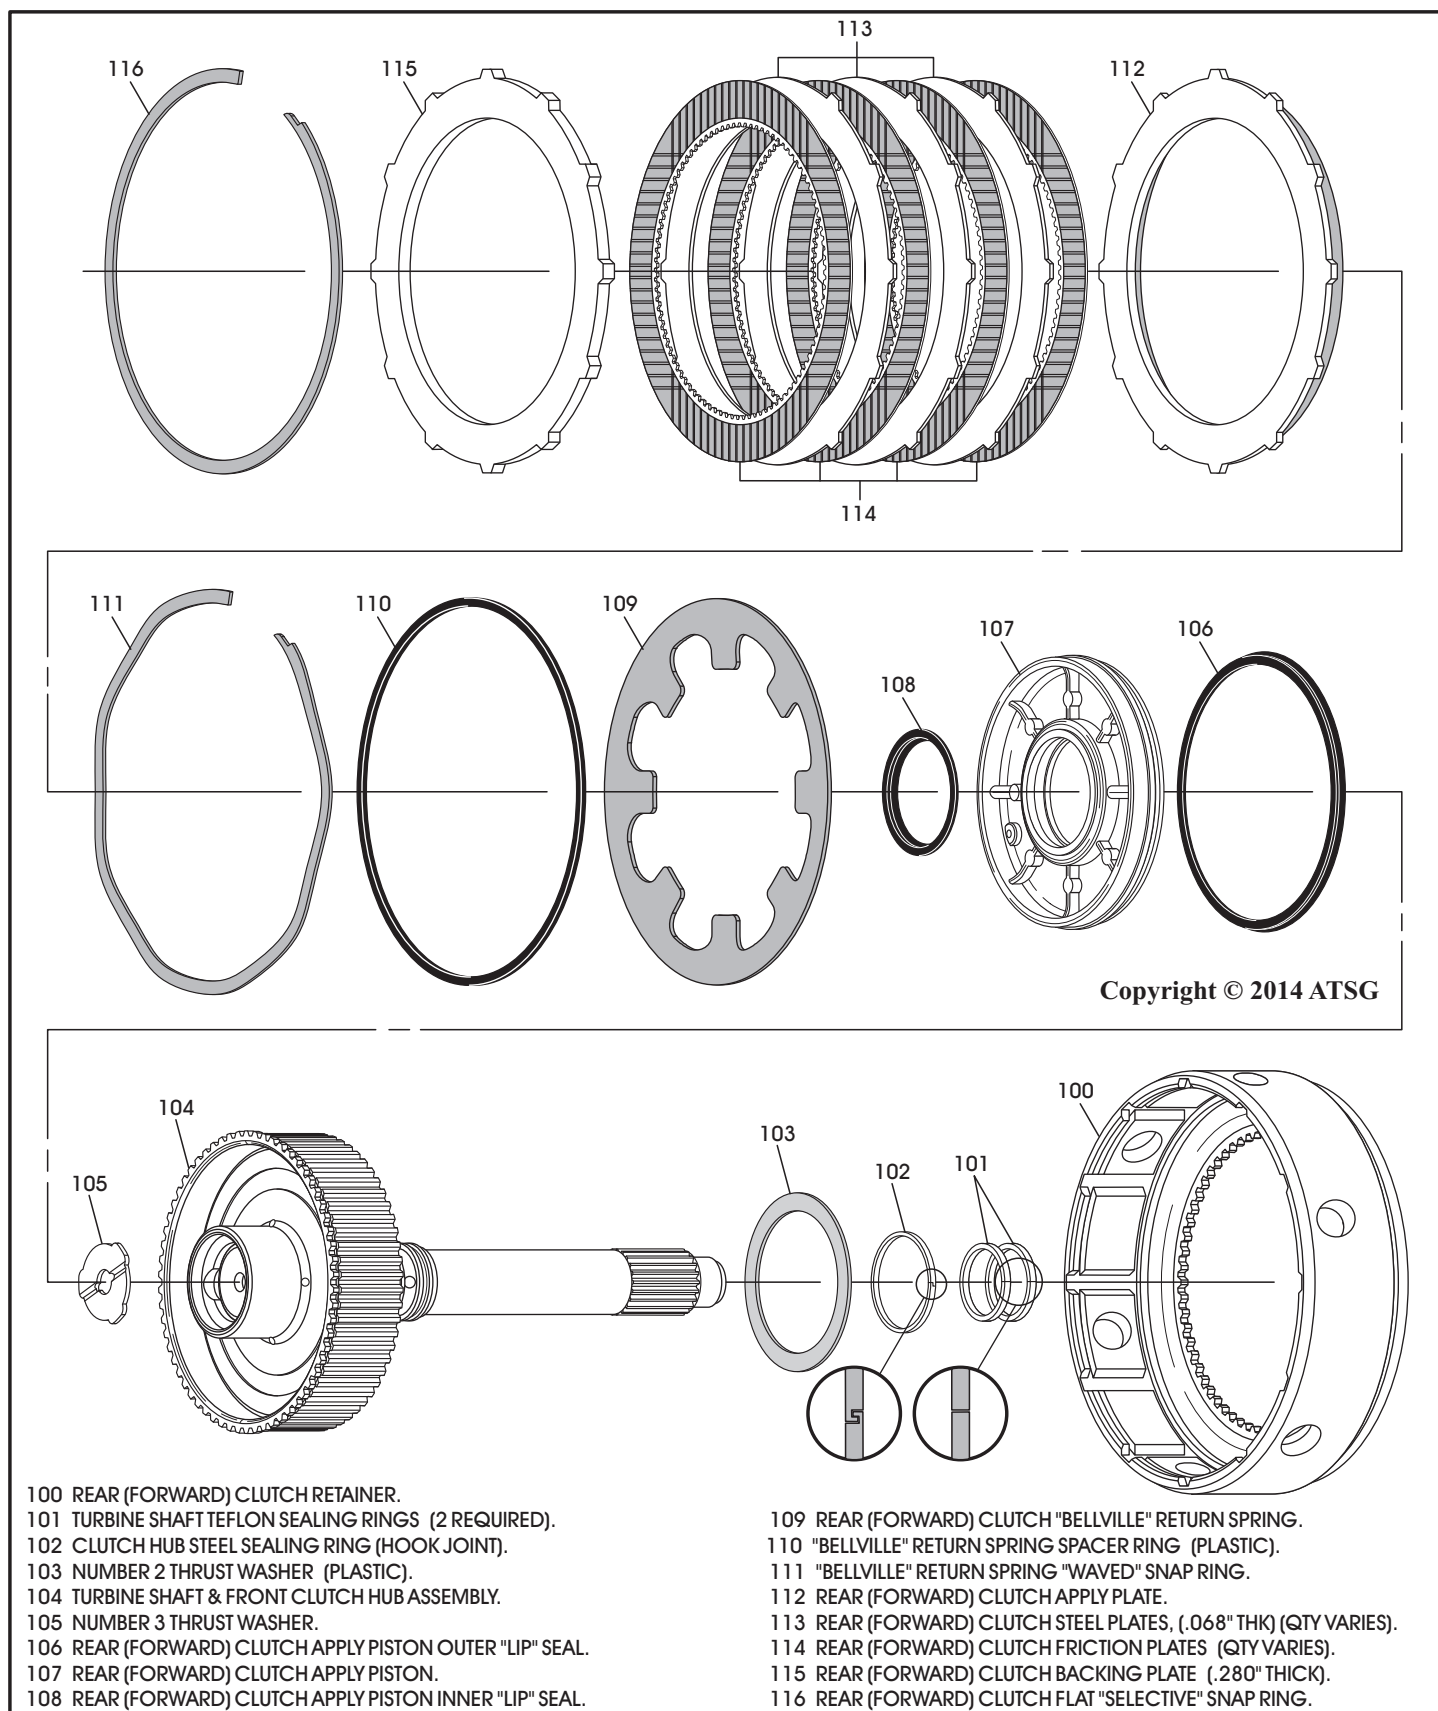
Figure 4

3. The forward clutch piston inner lip seal (# 108 in Figure 4) is known to shrink or deteriorate causing a loss of pressure.
4. Modified power programmers/performance chips designed to increase engine torque have been known to loosen the input shaft splines to the drum causing a loss of forward clutch pressure between these pieces.
