AS68RC

EARLY TCC APPLY AND NO PTO OPERATION OR NO 5th, 6th, TCC APPLY

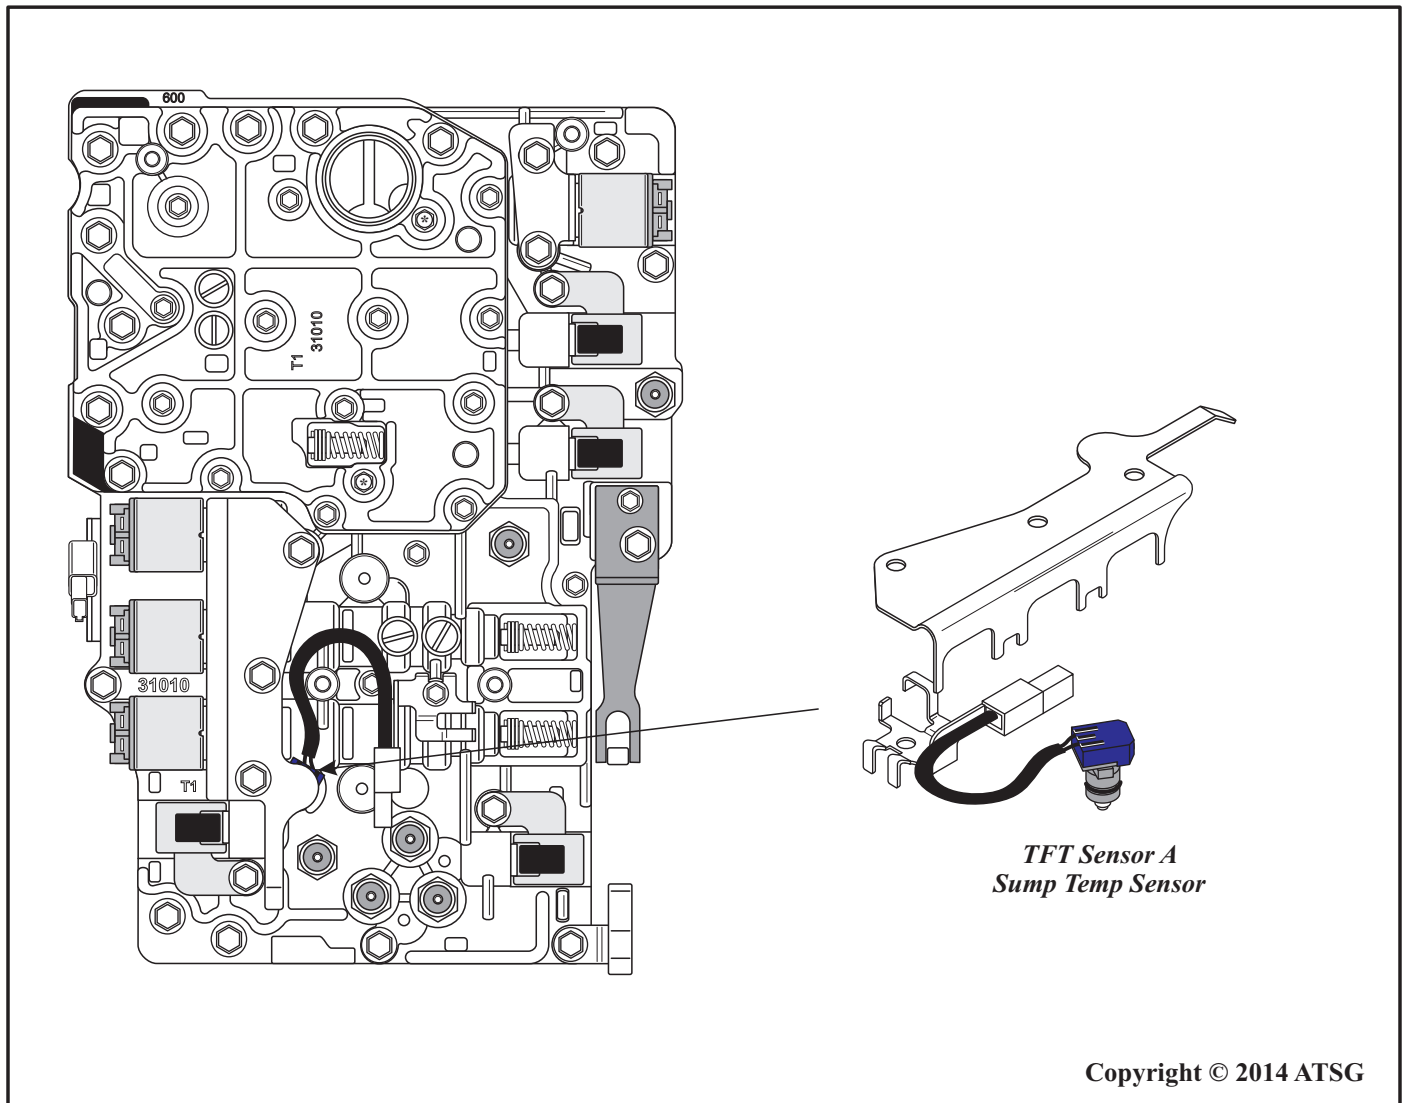
Figure 1

CAUSE: One cause may be malfunctioning temperature sensors. There are two temperature sensors used with this transmission, TFT Sensor A located in the sump (Figure 1) and TFT Sensor B located in the "To Cooler" fitting on the transmission (Figure 2). TFT Sensor B monitors converter out temperature which is typically hotter than the sump which TFT sensor A monitors.

CORRECTION: Compare scan data temperature readings with an actual reading using an Infrared Thermometer Gun on the transmission pan and cooler out line. If the high temperature reading appears to be valid then there is a transmission malfunction. This actual transmission overheat malfunction can be due to a defective torque converter, or a defective pump (turned stator shaft), or in some applications a malfunctioning thermal bypass valve in the cooling system.

If the reading taken by the thermal gun is normal yet the scan tool reports a much higher temperature, the sensor itself is malfunctioning and will need to be replaced.
