AUDI 01J

DTC 17114 GEAR RATIO MONITORING: INCORRECT GEAR RATIO

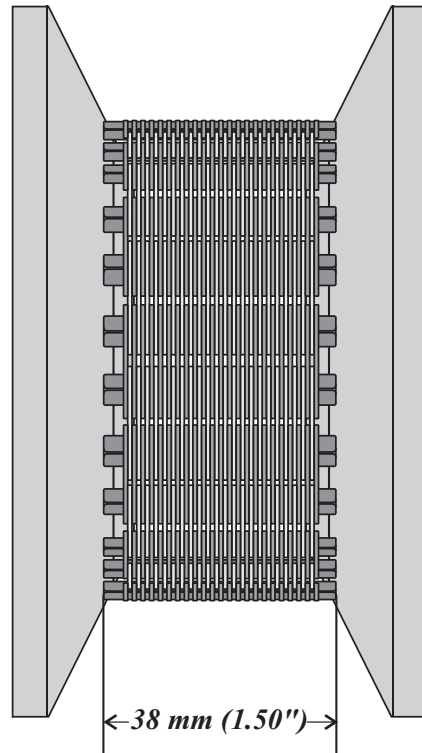
Figure 1

COMPLAINT: After a rebuild, an Audi 01J CVT exhibits a gear ratio error code 17114 only after the transmission has reached and held its highest ratio while cruising. If driven around town in stop and go traffic the transmission operates correctly. Even if its highest ratio is reached for a short period of time.

CAUSE: During the rebuild process an incorrect width chain was installed.

MEASURING CHAIN WIDTH

CORRECTION: 34 mm (1.34") and a 38 mm (1.50") are the two different width chains available depending on the model (figure 1). There are no charts that indicate which CVT models takes the 34mm or 38mm chain. So if you are to replace the chain, you should measure the original and order a new one according to the year, make, engine size and transmission code. The 3 digit transmission code such as a JZT or a GYJ can be located on the bottom side of the case as seen in figure 2.
